TEST REPORT

Report Ref. No. 13EMC-RT-0774

- Product PTZ Camera
SNP-5300HN, SNP-5300HP, SNP-6201HN, SNP-6201HP,
SNP-6320HN, SNP-6320HP, SNP-5430HN, SNP-5430HP,
SCP-3371HN, SNP-3371HP, SCP-2271HN, SNP-2271HP,
- Model SCP-2371HN, SNP-2371HP, SCP-2372HN, SNP-2372HP,
SCP-2272HN, SNP-2272HP, SCP-3371THN, SNP-3371THP,
SCP-2371THN, SNP-2371THP, SCP-3372HN, SNP-3372HP,
SCP-3372THN, SNP-3372THP

Standard IEC 62262 and IEC 60068-2-75

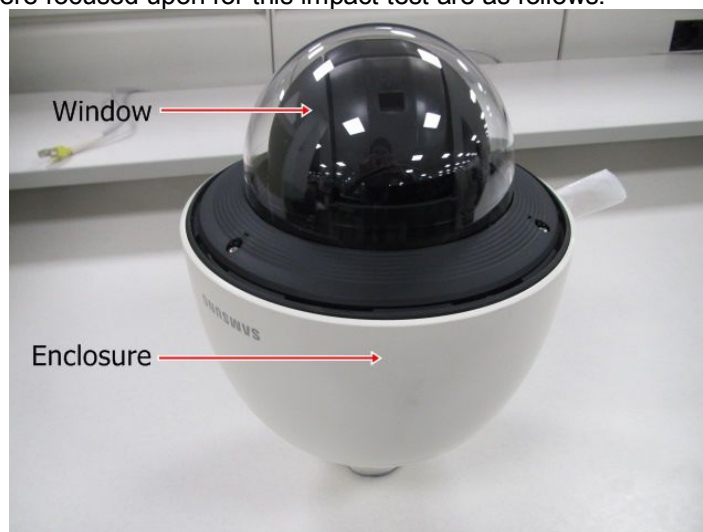
5. Drop Zones:

The areas that were focused upon for this impact test are as follows:

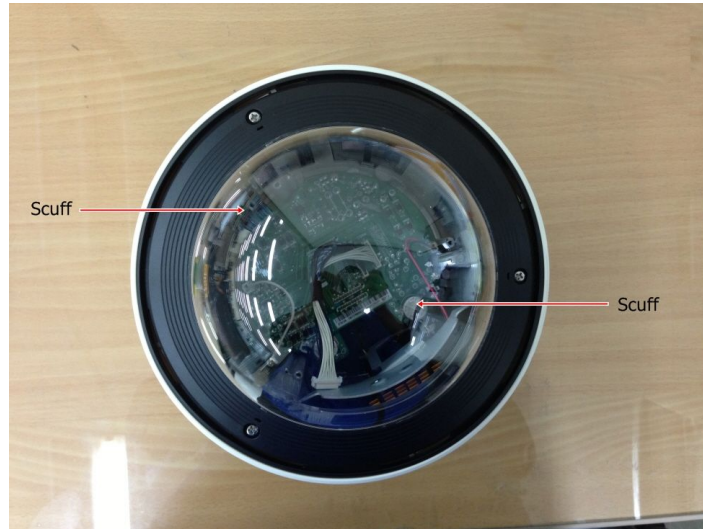
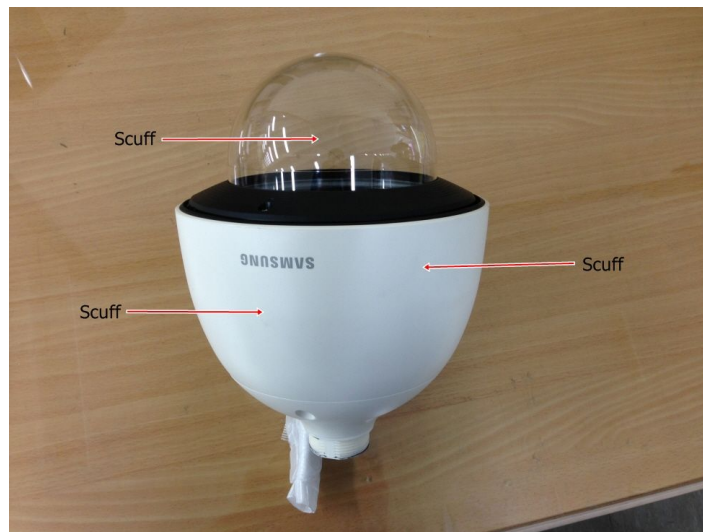
7. Images

Drop Zone: Enclosure		
Drop #	Orientation / Results	Pass / Fail
Drop 1	Normal to surface of enclosure. Scuff	Pass
Drop 2	Normal to surface of enclosure, about 90° circumferentially from previous drop. Scuff	Pass
Drop 3	Normal to surface of enclosure, about 90° circumferentially from previous drop. Scuff	Pass
Drop 4	Normal to surface of enclosure, about 90° circumferentially from previous drop. Scuff	Pass
Drop 5	Normal to surface of enclosure, about 90° circumferentially from previous drop. Scuff	Pass

Drop Zone: Window		
Drop #	Orientation / Results	Pass / Fail
Drop 1	Vertical drop onto center of Window. Scuff	Pass
Drop 2	Normal to surface of side Window. Scuff	Pass
Drop 3	Normal to surface of side Window, about 90° circumferentially from previous drop. Scuff	Pass
Drop 4	Normal to surface of side Window, about 90° circumferentially from previous drop. Scuff	Pass
Drop 5	Normal to surface of side Window, about 90° circumferentially from previous drop. Scuff	Pass
