# TEST REPORT

Report No.:  
KR16-YYP0228

**3. Name of Product and Model** : CCTV Camera /  
HCM-9020VQ\* (\* N: NTSC / P: PAL)

**6. Test method used** : IEC 62262: 2002 (IK 10)

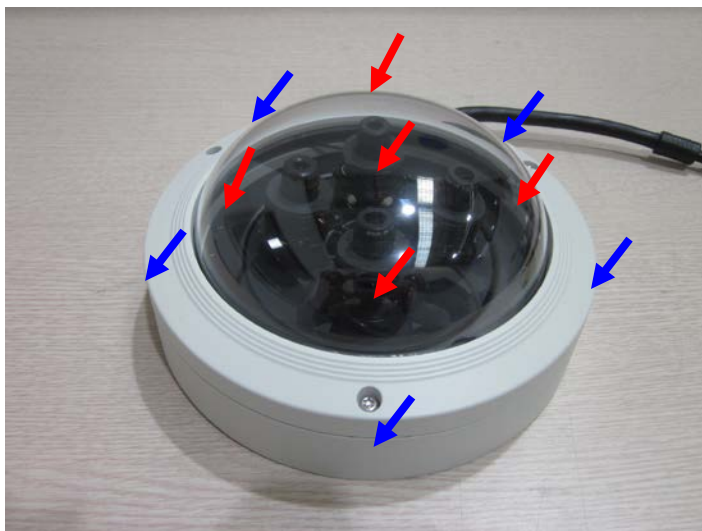
- 1) Test method used: IEC 62262: 2002 (IK 10)
- 2) Energy: 20 J
- 3) Mass: 5.0 kg
- 4) Heigh: 400 mm
- 5) Pretreatment: None
- 6) Location and number of impact: Window 5 impact, Enclosure 5 impacts

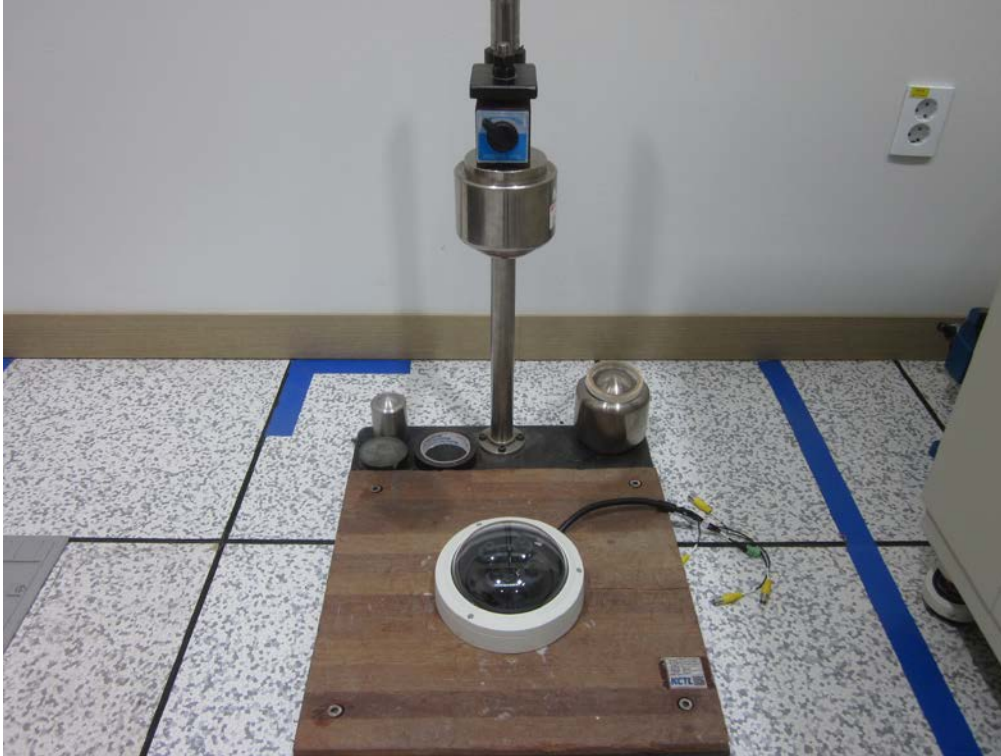
[During the test\_Window]

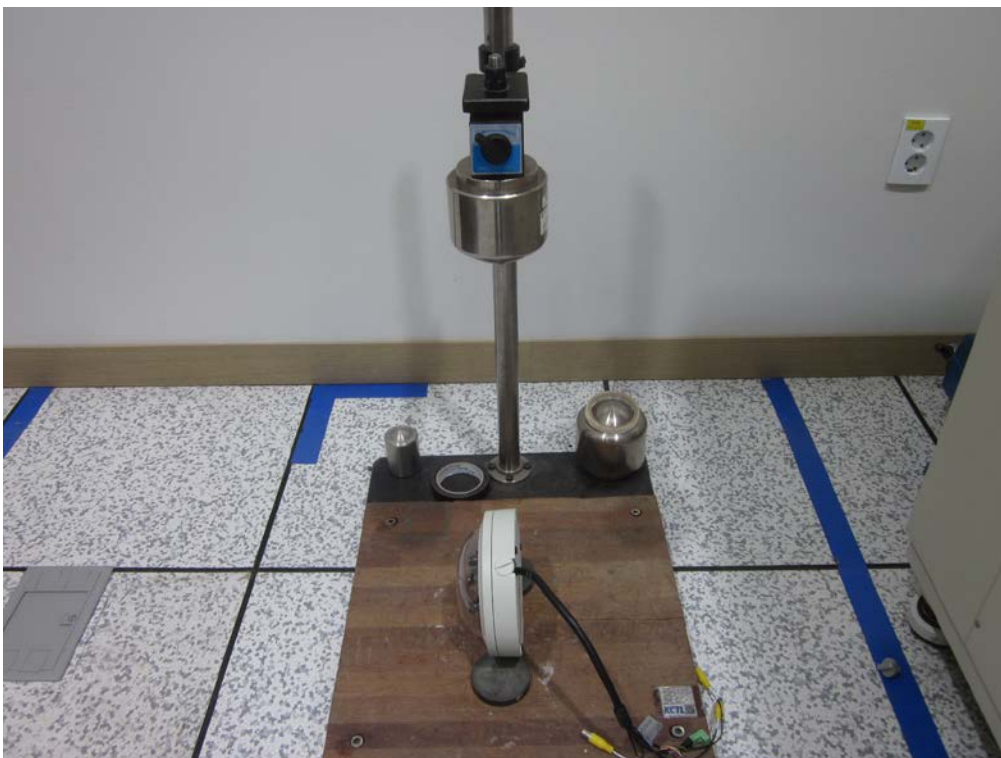
[During the test\_Enclosure]

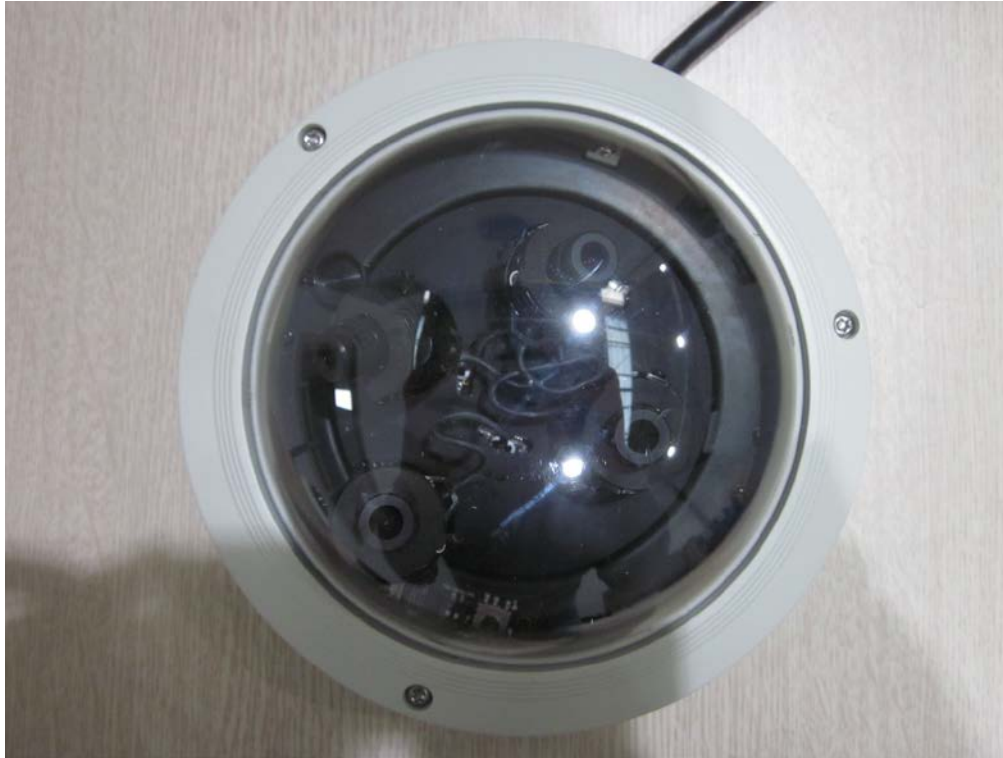
[Test result confirme\_Window]

Check List	Test Result
<ol style="list-style-type: none"> <li>1. Window part <ul style="list-style-type: none"> <li>- Visual inspection after impact test (Damage, crack, separation occur)</li> <li>- Protected against access to hazardous parts</li> </ul> </li> <li>2. Enclosure part <ul style="list-style-type: none"> <li>- Visual inspection after impact test (Damage, crack, separation occur)</li> <li>- Protected against access to hazardous parts</li> </ul> </li> </ol>	<p align="center">No abnormal was found (Refer to 3.1.7)</p>

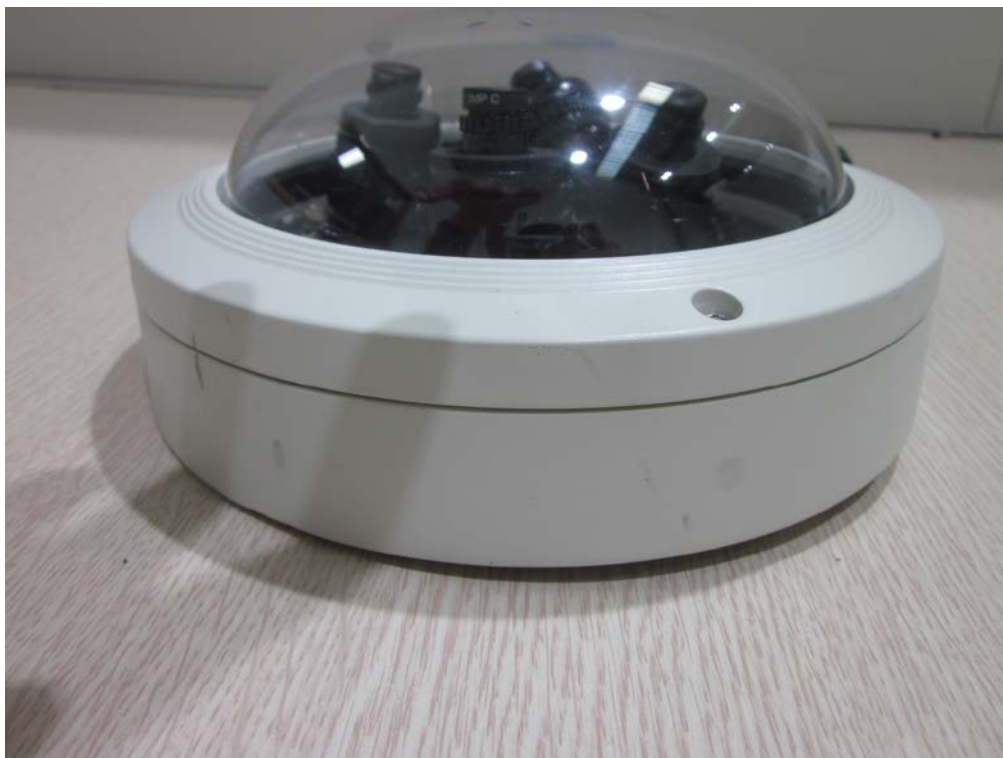
[Test result confirme\_Enclosure 01]

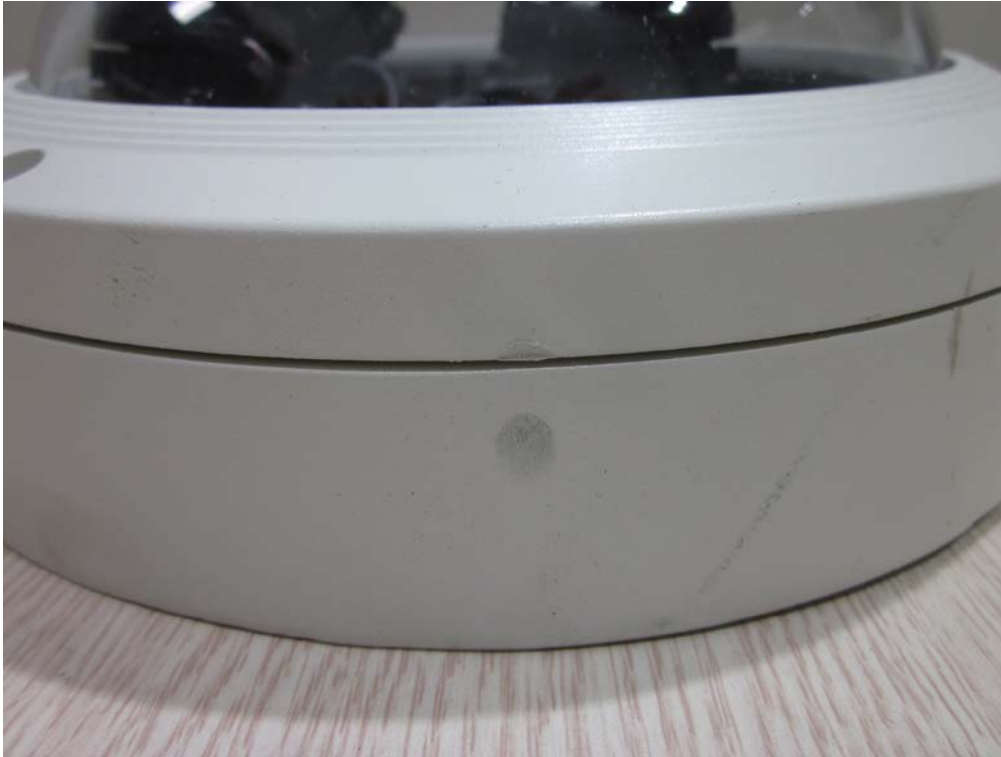
[Test result confirme\_ Enclosure 02]

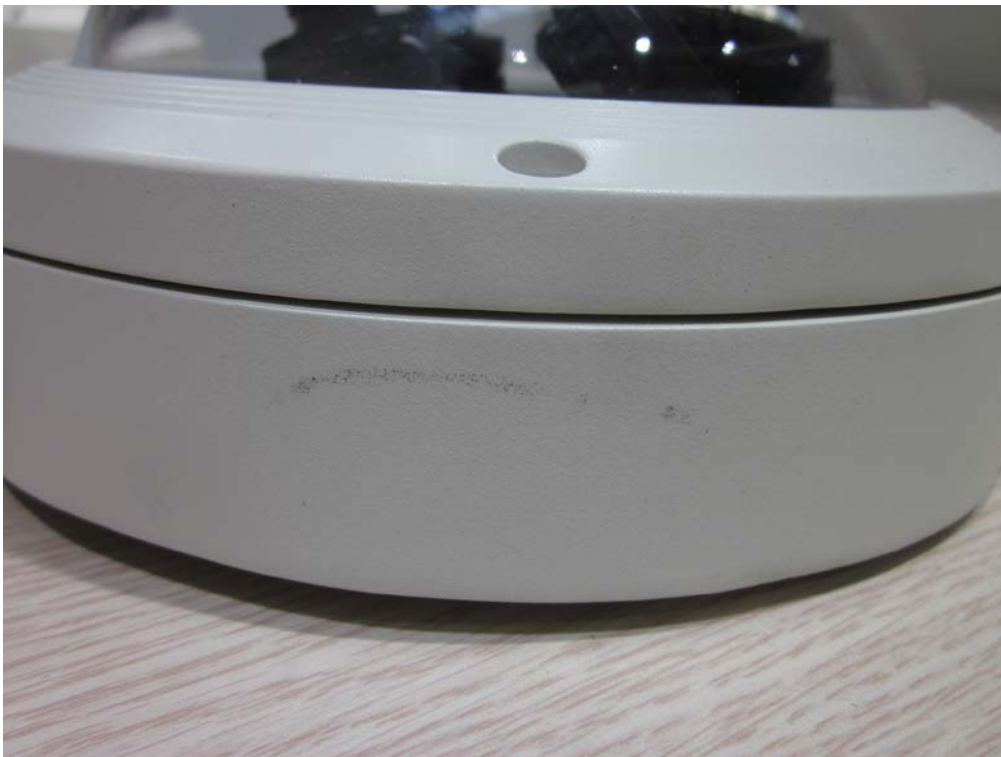
[Test result confirme\_ Enclosure 03]
