# TEST REPORT

**Report Ref. No.** 15E&S-ST-0086

○ Product Network Camera  
○ Model SNV-6085RN, SNV-6085RP, SNV-6085

Degree of protection provided by enclosure for external impacts IK10

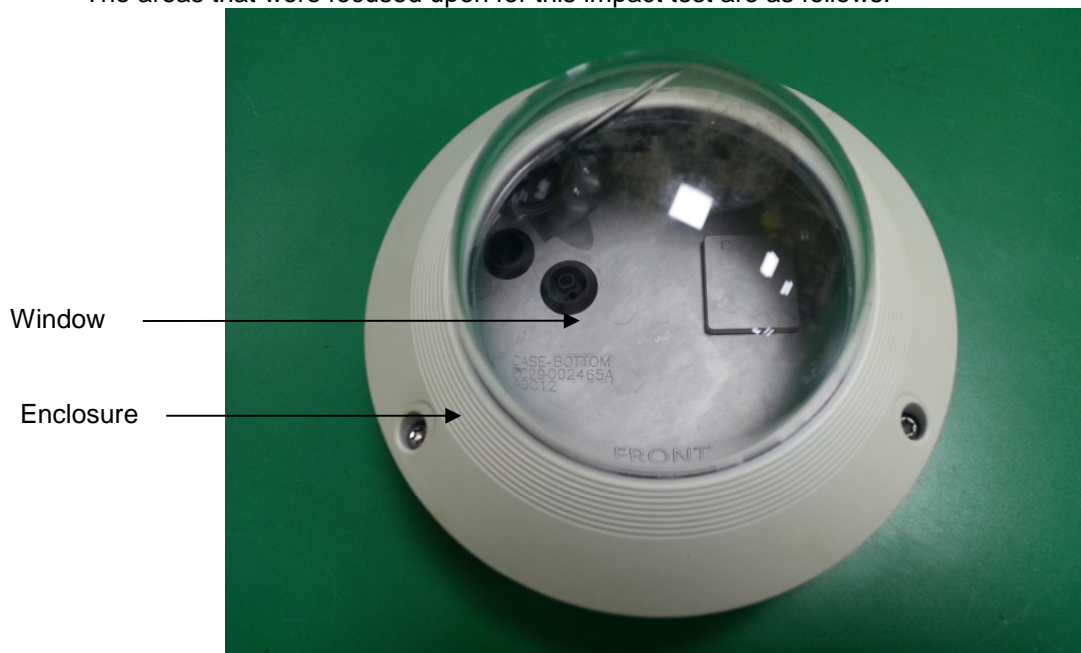
## 5. Drop Zones:

The areas that were focused upon for this impact test are as follows:

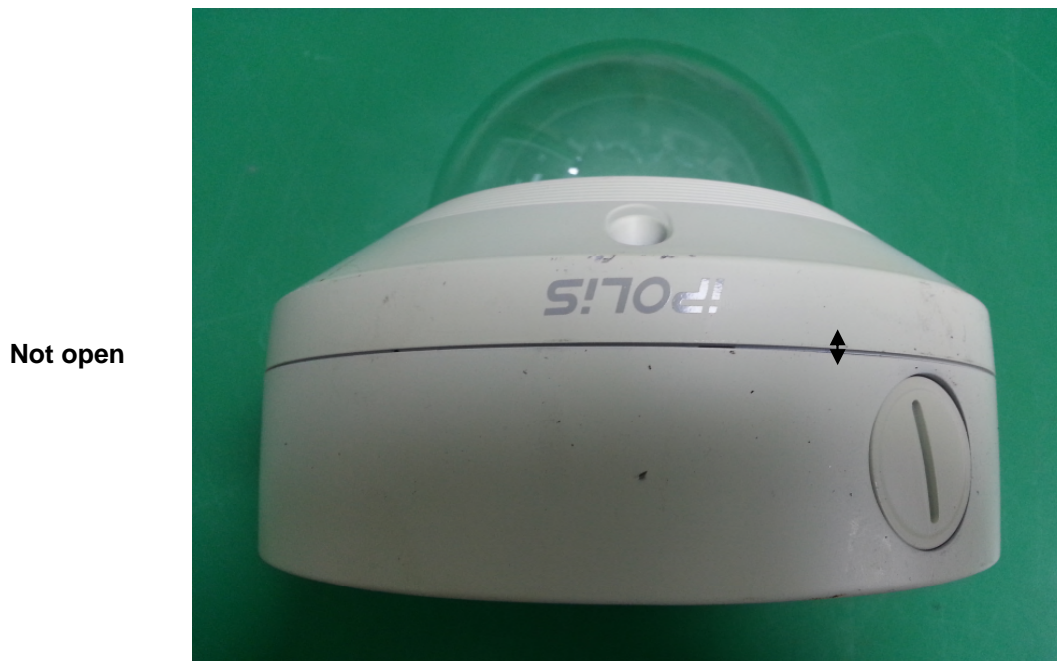
## 7. Images

| Drop Zone: Window | | |
|---|---|---|
| Drop 1 | Vertical drop onto center of Window, Scuff | Pass |

| Drop Zone: Enclosure | | |
|---|---|---|
| Drop 1 | Normal to surface of enclosure. Scuff | Pass |
| Drop 4 | Normal to surface of enclosure, about 90° circumferentially from previous drop. Crack | Pass |
| Drop 5 | Normal to surface of enclosure, about 90° circumferentially from previous drop. Crack | Pass |

After testing according to the procedure set forth by IEC 62262, model SNV-6085RN, SNV-6085RP, SNV-6085 were found to meet the criteria required for an IK10 specification.
