TEST REPORT

Report No. : SGS-R13-1065-EN
Applicant : SAMSUNG TECHWIN Co, Ltd.
Address : Samsung Techwin R&D Center, 701, Sampyeong-dong, Bundang-gu, Seongnam-si, Gyeonggi-do, Korea
Product : Mobile NVR
Model : SRM-872
Environment : Temp. (25 ± 5) °C, Humidity (60 ± 5) % R.H.
Test Date : September 9, 2013 ~ September 10, 2013
Standard : EN 61373: 2010 (Category 1 Class B)
Test Result : Refer to the attached document
Use of report : Validation

Mobile NVR / SRM-872	
TEST ITEM	TEST RESULT
Long-life Test	No abnormal was found
Shock Test	No abnormal was found
Functional Random Test	No abnormal was found

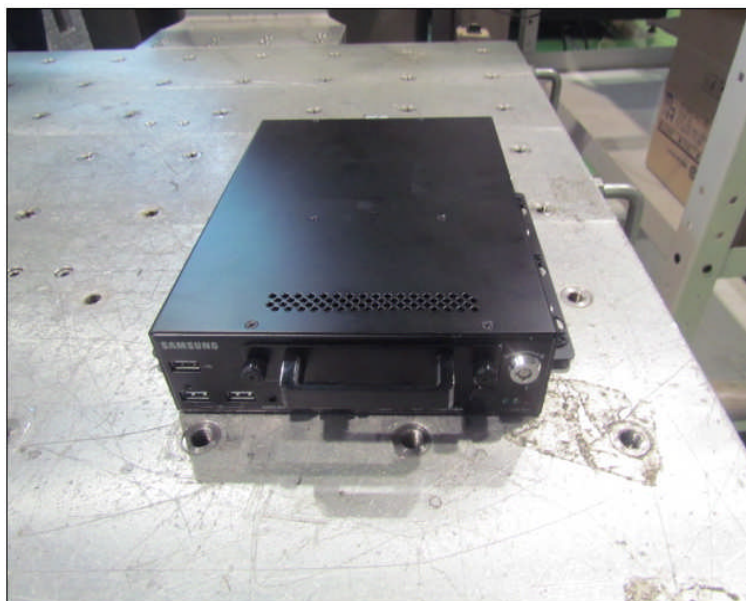
2.2 Photograph

Applicant : SAMSUNG TECHWIN Co, Ltd.
 Manufacturer : SAMSUNG TECHWIN Co, Ltd.
 Product : Mobile NVR
 Model : SRM-872
 Serial No. : N/A

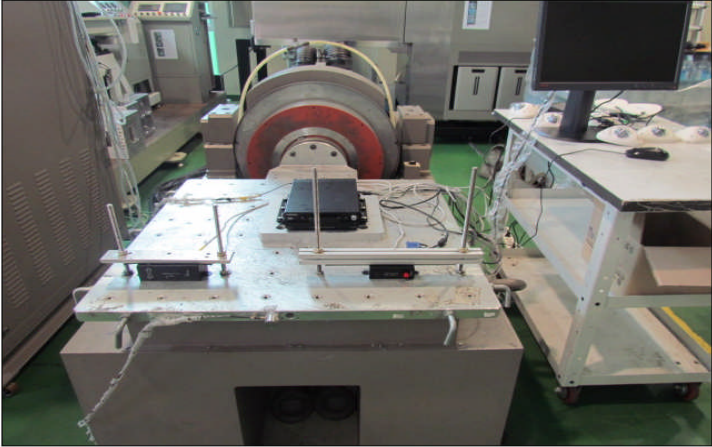
Test axis	Test photograph
Vertical (Z)

- 1) Test type : Random
- 2) Frequency : (5 ~ 150) Hz
- 3) Acceleration : Z - 5.72 m/s² r.m.s.
X - 2.55 m/s² r.m.s.
Y - 3.96 m/s² r.m.s.
- 4) Test time : Total 15 h (each axis 5 h)
- 5) Test axis : Vertical (Z), Transverse (X), Longitudinal (Y)
- 6) Check time : After the test
- 7) Sample condition : Unpackaged product / Non-operation
- 8) Sample quantity : 1 EA

- 1) Perform a visual inspection and an operational check for the specimen.
- 2) Fix the specimen on the vibration table.
- 3) Operate the vibration tester.
- 4) Repeat from steps 1) to step 3) for each required axis.
- 5) Perform a final visual inspection and an operational check for the specimen.

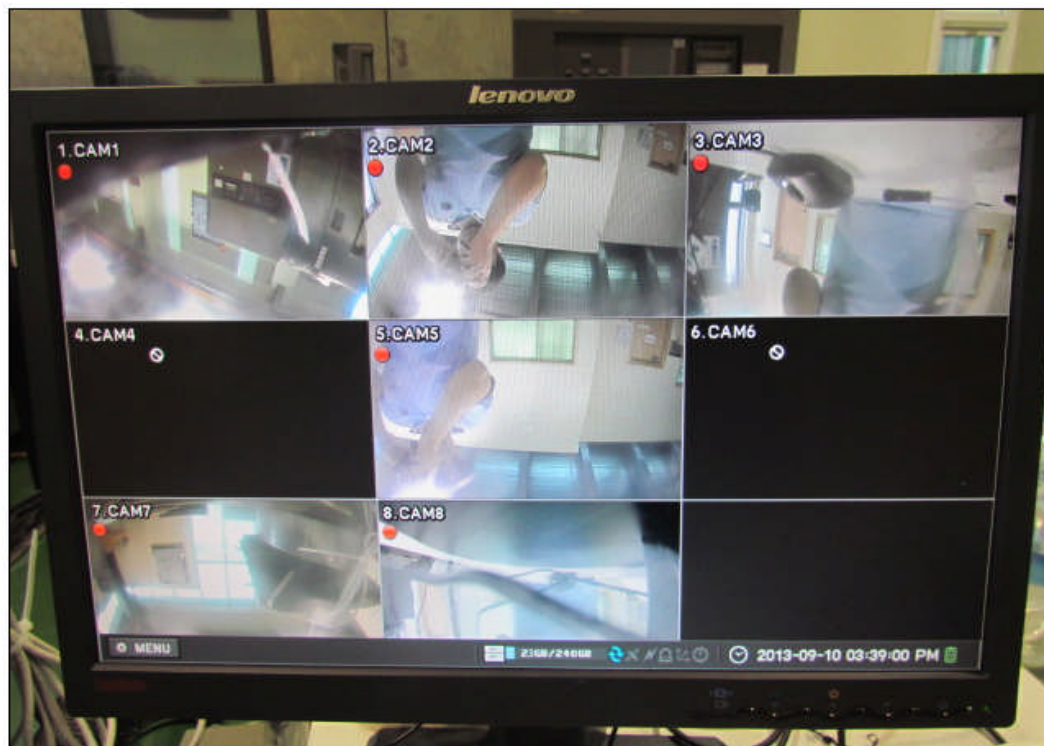
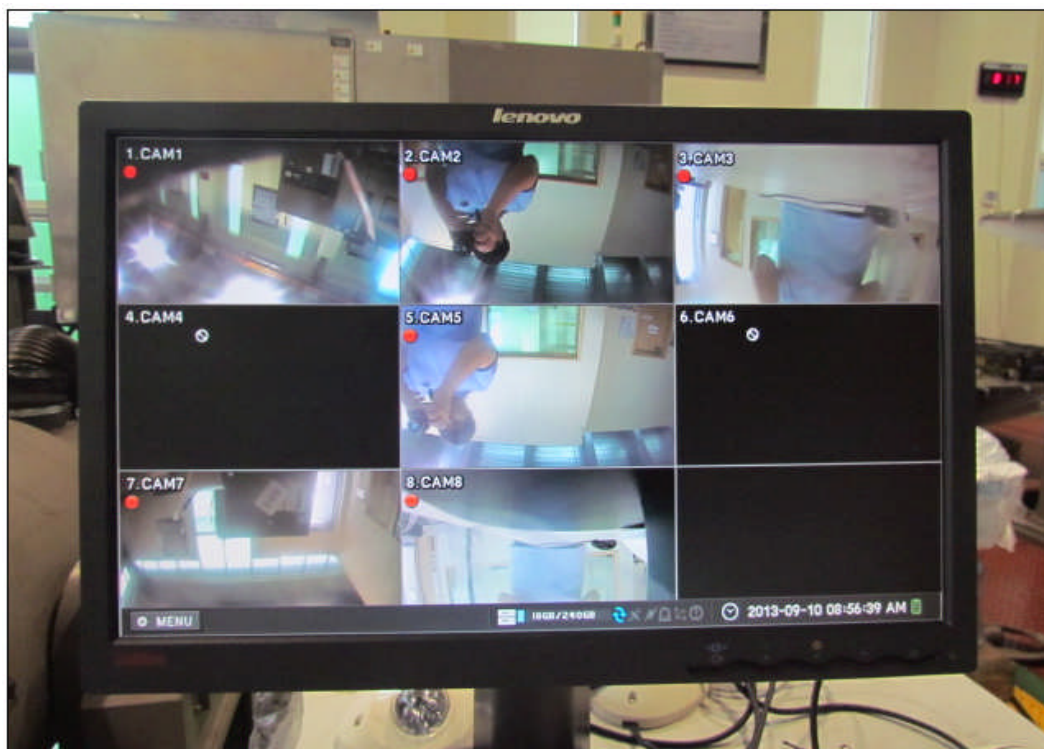
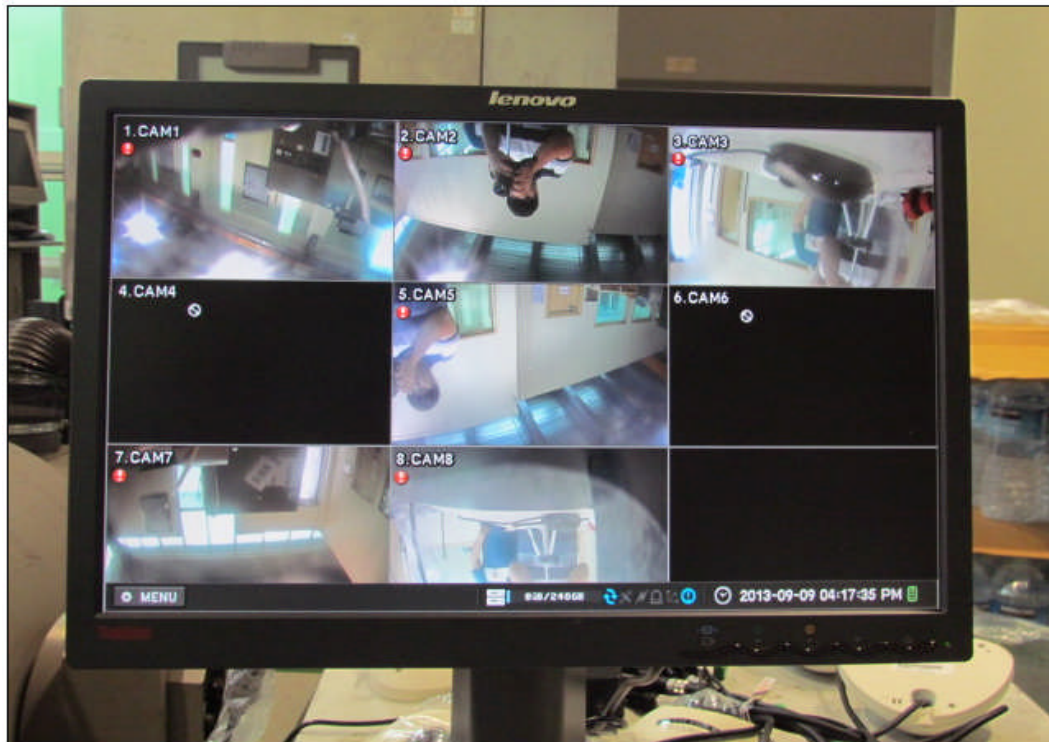
※ Appendix 1. Performance Check

Check List	Test Result
1. Visual inspection -. Mechanical damage such as deformation, crack, separating, loosening of screw, etc.	No abnormal was found
2. Performance check -. Video output	Refer to ※ Appendix 1.

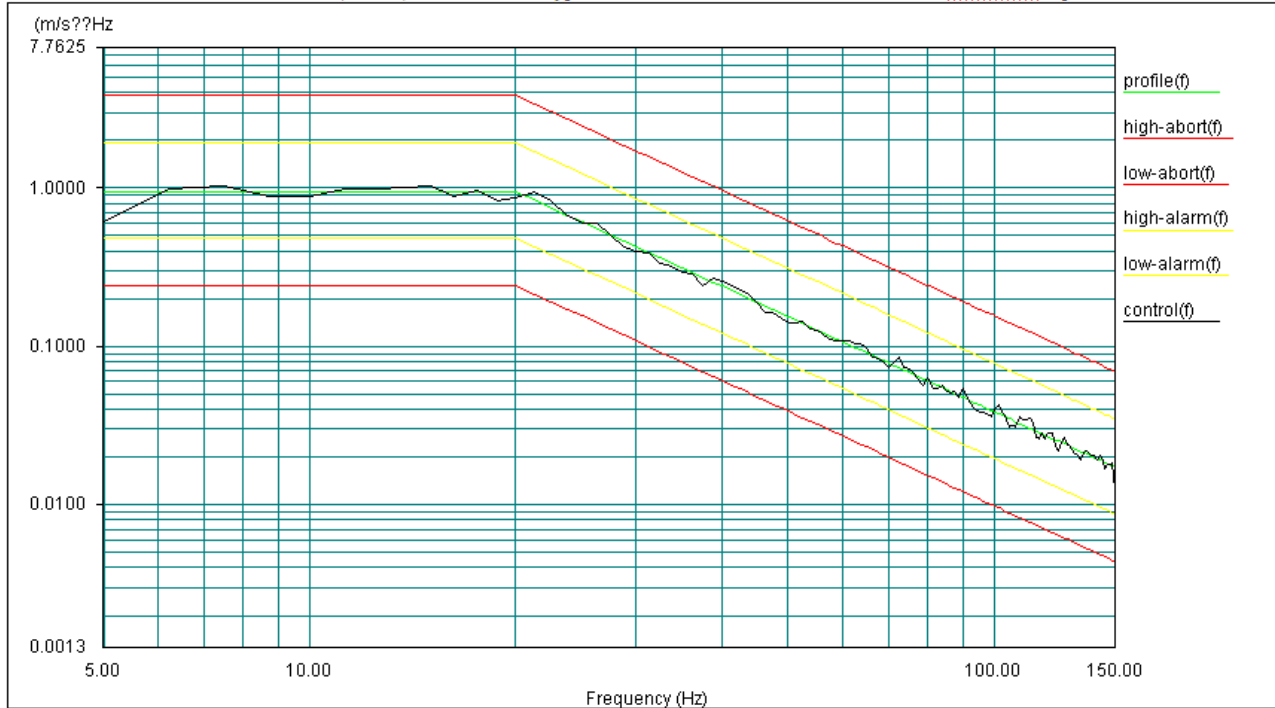
※ Appendix 1. Long-life Test Data _ Z axis

Project File Name: long-life_tgst(vertical).png
 Profile Name: Class B-Functional test (vertical) Test Type: Random Run Folder: \RunDefault Sep 10, 2013 09-53-25

Level: 0 dB
 Control RMS: 5.599784 m/s² Full Level Elapsed Time: 05:00:00 Lines: 400 Frame Time: 0.800000 Seconds
 Demand RMS: 5.613488 m/s² Remaining Time: 00:00:00 DOF: 154 dF: 1.250000 Hz
 Data saved at 03:05:49 PM, Tuesday, September 10, 2013 Report created at 03:05:50 PM, Tuesday, September 10, 2013

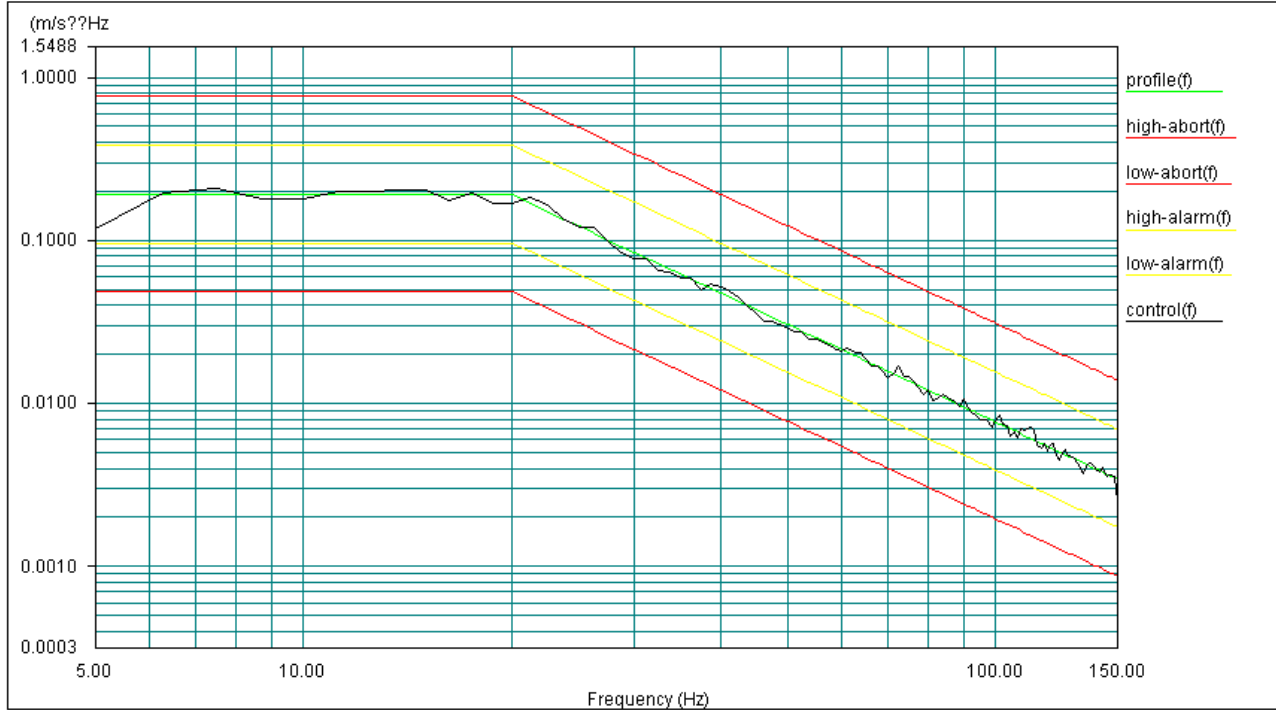
Long-life Test Data _ X axis

Project File Name: long-life test(transverse)(RANDOM).prj

ControlRMS: 2.616432 m/s²

DemandRMS: 2.505215 m/s²

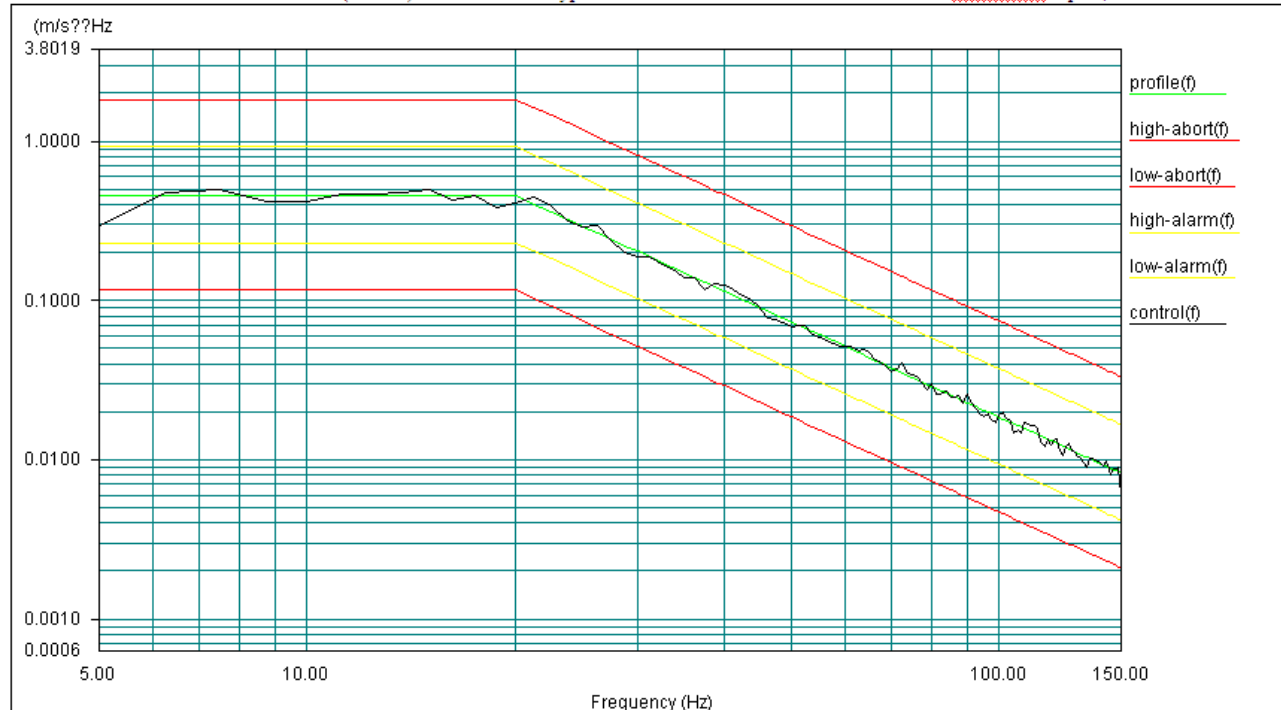
Long-life Test Data _ Y axis

Project File Name: long-life test(longitudinal)(RANDOM).prj

ControlRMS: 3.887219 m/s² Full Level Elapsed Time: 05:00:00

DemandRMS: 3.881904 m/s² Remaining Time: 00:00:00

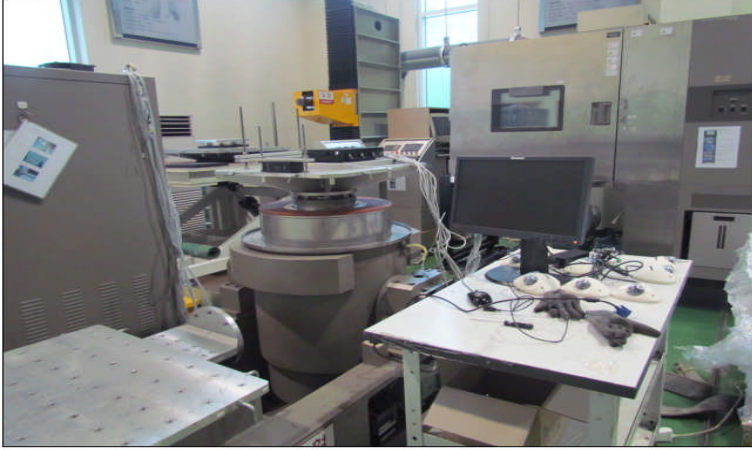
Test axis	Test photograph
Vertical (Z)

- 1) Test type : Half sine
- 2) Acceleration : Z - 30 m/s², X - 30 m/s², Y - 50 m/s²
- 3) Duration : 30 ms
- 4) Test time : 18 times in total (6 times in each axis : positive 3 / negative 3)
- 5) Test axis : Vertical (Z), Transverse (X), Longitudinal (Y)
- 6) Check time : After the test
- 7) Sample condition : Unpackaged product / Non-operation
- 8) Sample quantity : 1 EA

- 1) Perform a visual inspection and an operational check for the specimen.
- 2) Fix the specimen on the vibration table.
- 3) Operate the vibration tester.
- 4) Repeat from steps 1) to step 3) for each required axis.
- 5) Perform a final visual inspection and an operational check for the specimen.

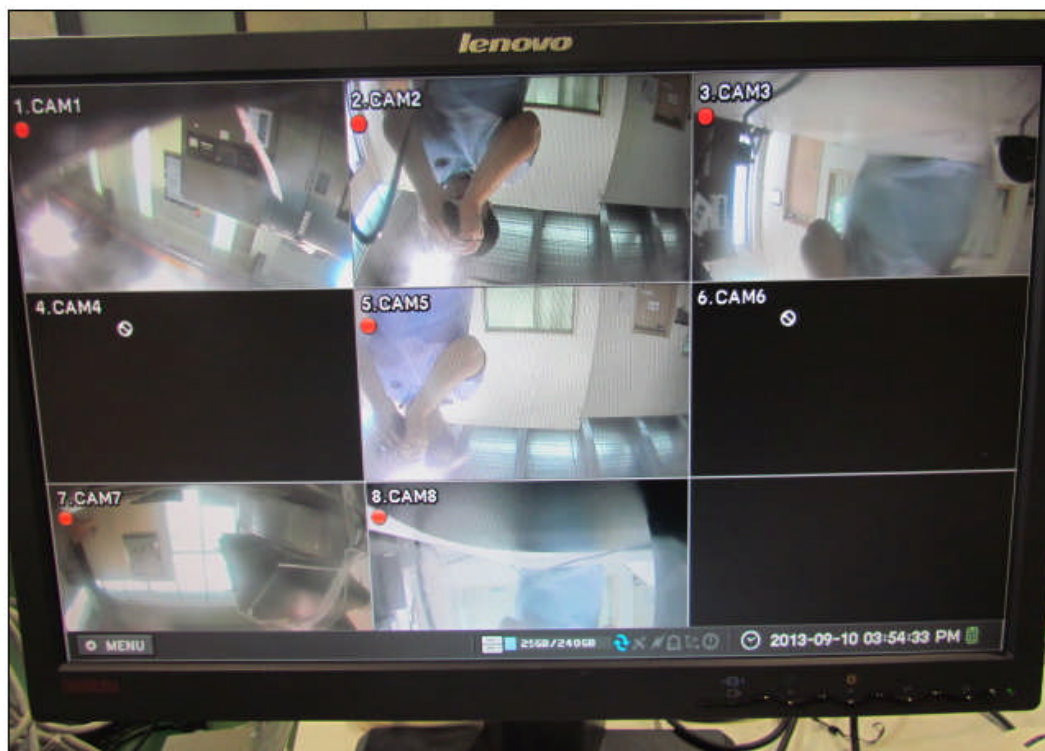
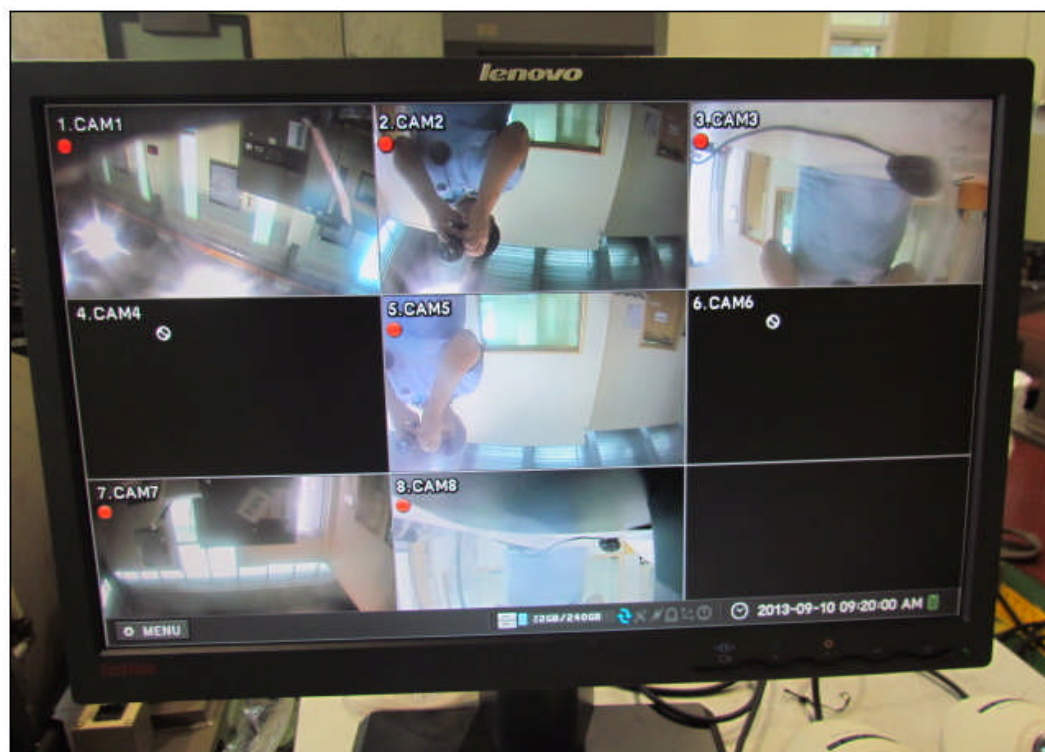
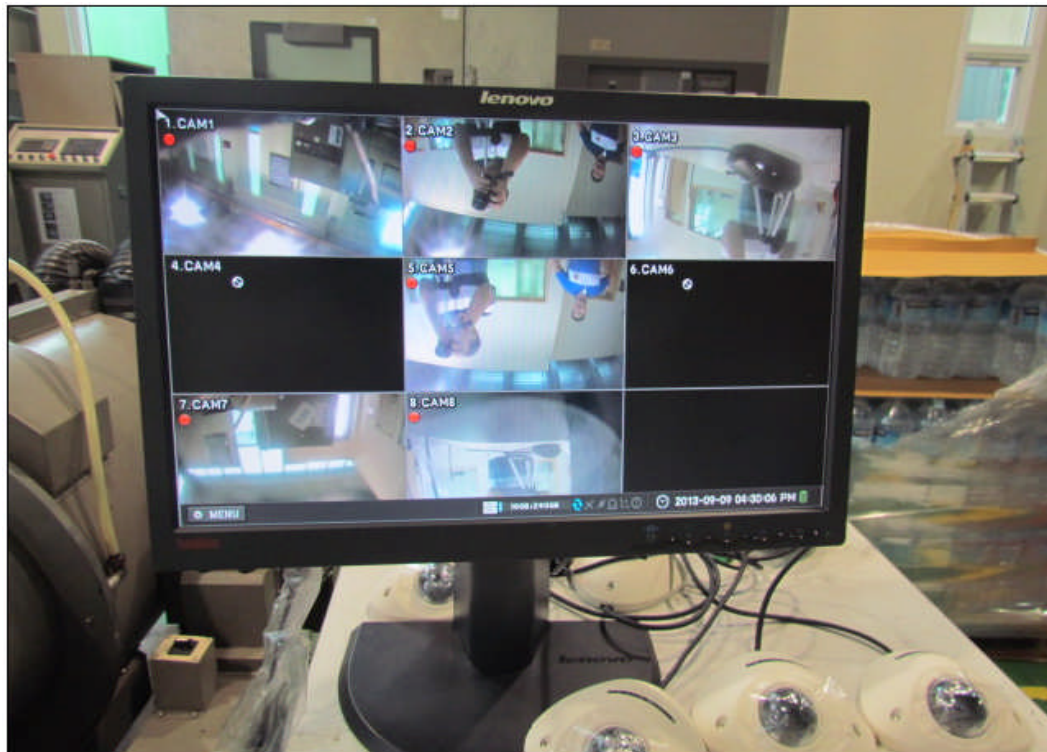
※ Appendix 1. Performance Check

Check List	Test Result
1. Visual inspection -. Mechanical damage such as deformation, crack, separating, loosening of screw, etc.	No abnormal was found
2. Performance check -. Video output	Refer to ※ Appendix 1.

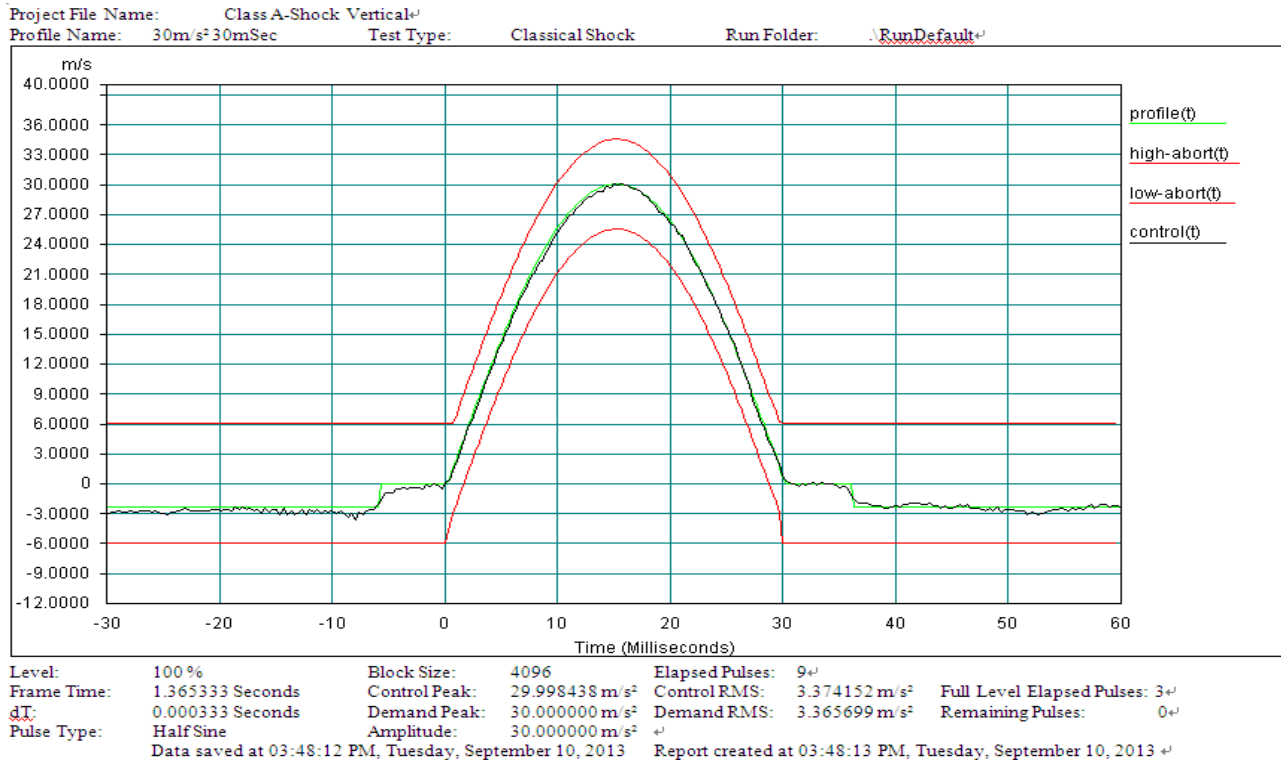
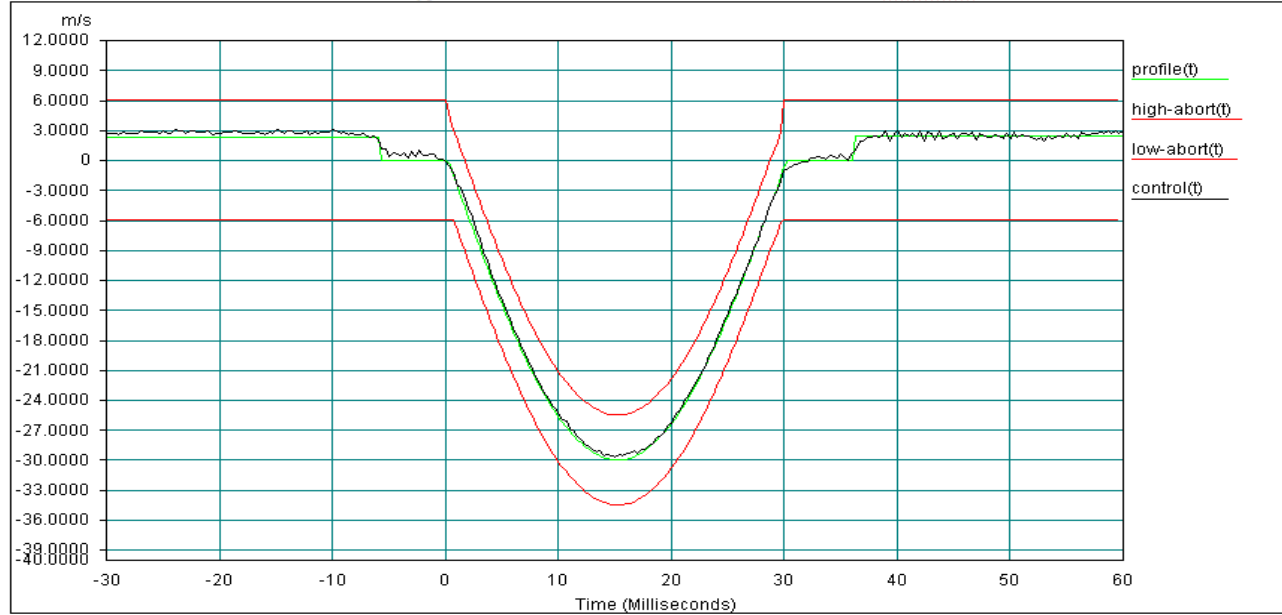
※ Appendix 1. Shock Test Data _ Z axis

Project File Name: Class A-Shock Vertical

Profile Name: 30m/s² 30mSec

Level: 100 % Block Size: 4096 Elapsed Pulses: 9
Frame Time: 1.365333 Seconds Control Peak: 29.639591 m/s² Control RMS: 3.366716 m/s² Full Level Elapsed Pulses: 3
dt: 0.000333 Seconds Demand Peak: 30.000000 m/s² Demand RMS: 3.365699 m/s² Remaining Pulses: 0
Pulse Type: Half Sine Amplitude: 30.000000 m/s²
Data saved at 03:48:47 PM, Tuesday, September 10, 2013 Report created at 03:48:48 PM, Tuesday, September 10, 2013

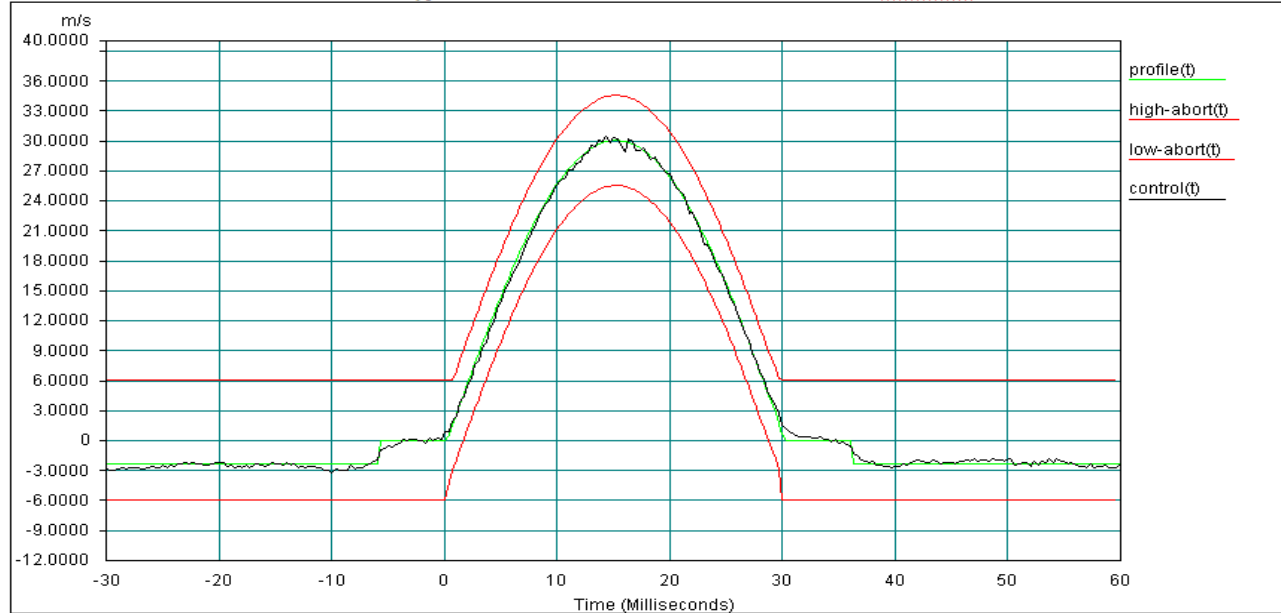
Shock Test Data _ X axis

Project File Name: Class A-Shock Transverse⁺

Level: 100 % Block Size: 4096 Elapsed Pulses: 10⁺
Frame Time: 1.365333 Seconds Control Peak: 30.373644 m/s² Control RMS: 3.365689 m/s² Full Level Elapsed Pulses: 3⁺
dT: 0.000333 Seconds Demand Peak: 30.000000 m/s² Demand RMS: 3.365699 m/s² Remaining Pulses: 0⁺
Pulse Type: Half Sine Amplitude: 30.000000 m/s²⁺
Data saved at 08:58:19 AM, Tuesday, September 10, 2013 Report created at 08:58:23 AM, Tuesday, September 10, 2013⁺

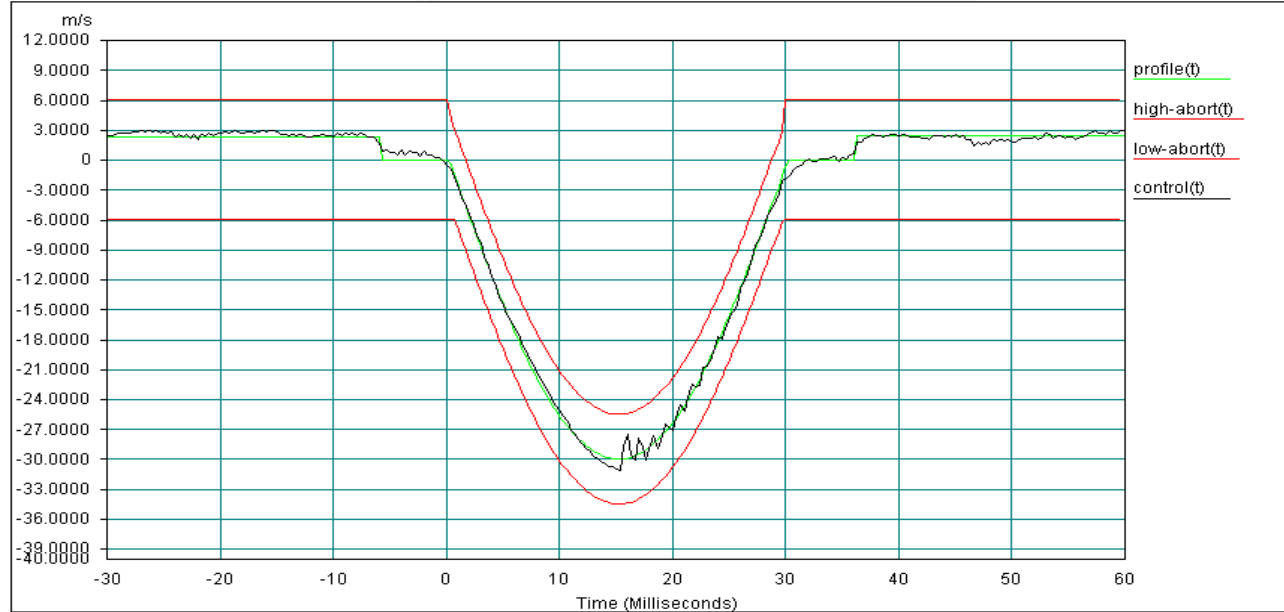
Project File Name: Class A-Shock Transverse

Level: 100 % Block Size: 4096 Elapsed Pulses: 10
Frame Time: 1.365333 Seconds Control Peak: 31.070517 m/s² Control RMS: 3.378407 m/s² Full Level Elapsed Pulses: 3
dt: 0.000333 Seconds Demand Peak: 30.000000 m/s² Demand RMS: 3.365699 m/s² Remaining Pulses: 0
Pulse Type: Half Sine Amplitude: 30.000000 m/s²
Data saved at 09:05:55 AM, Tuesday, September 10, 2013 Report created at 09:05:56 AM, Tuesday, September 10, 2013

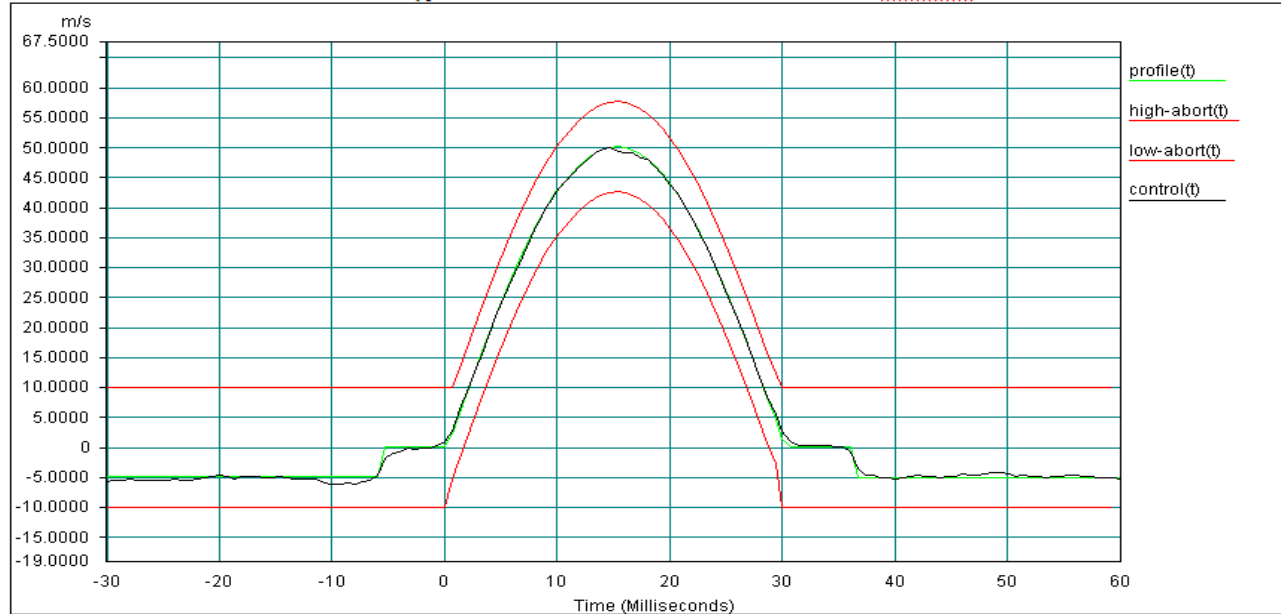
Shock Test Data _ Y axis

Project File Name: Class A-Shock Longitudinal⁺

Level:	100 %	Block Size:	2048	Elapsed Pulses:	10 ⁺	
Frame Time:	1.365333 Seconds	Control Peak:	49.959782 m/s²	Control RMS:	5.693038 m/s²	Full Level Elapsed Pulses: 3 ⁺
dt:	0.000667 Seconds	Demand Peak:	50.000000 m/s²	Demand RMS:	5.699245 m/s²	Remaining Pulses: 0 ⁺
Pulse Type:	Half Sine	Amplitude:	50.000000 m/s²

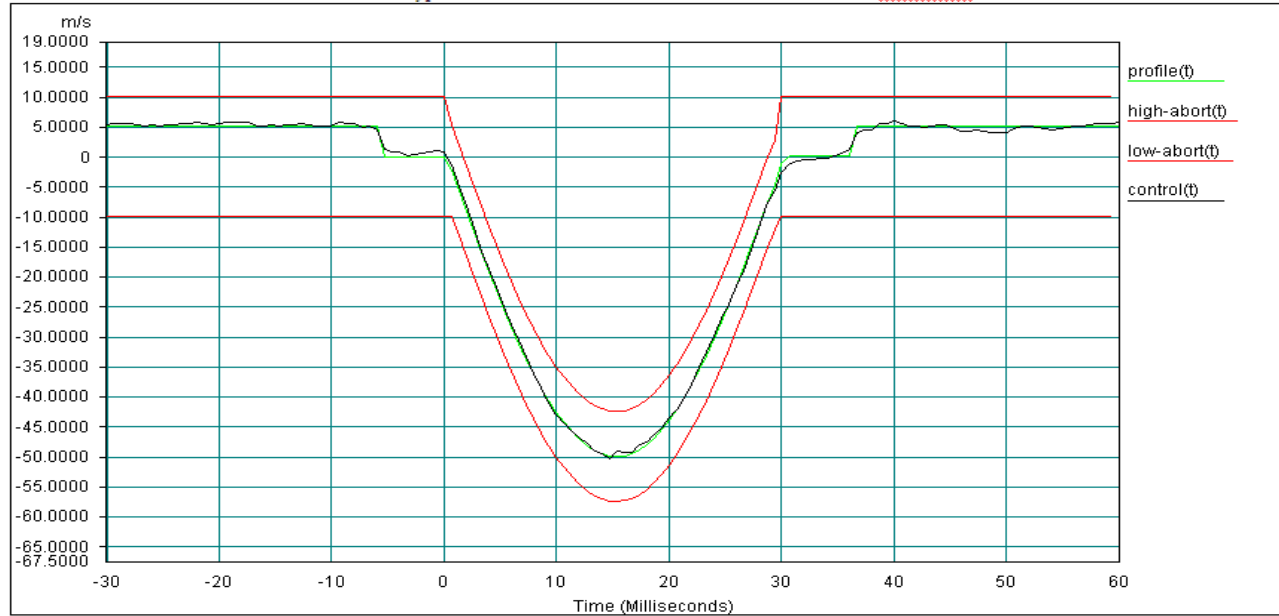
Project File Name: Class A-Shock Longitudinal

Level: 100 % Block Size: 2048 Elapsed Pulses: 10
Frame Time: 1.365333 Seconds Control Peak: 50.379955 m/s² Control RMS: 5.689444 m/s² Full Level Elapsed Pulses: 3
dT: 0.000667 Seconds Demand Peak: 50.000000 m/s² Demand RMS: 5.699245 m/s² Remaining Pulses: 0
Pulse Type: Half Sine Amplitude: 50.000000 m/s²
Data saved at 04:27:49 PM, Monday, September 09, 2013 Report created at 04:27:50 PM, Monday, September 9, 2013

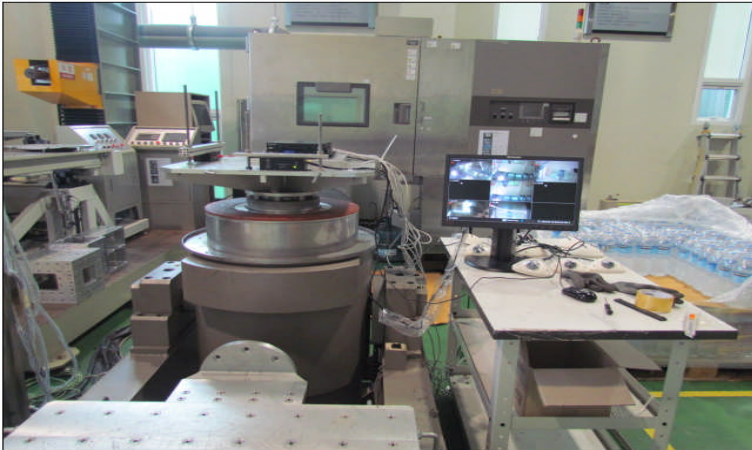
Test axis	Test photograph
Vertical (Z)

- 1) Test type : Random
- 2) Frequency : (5 ~ 150) Hz
- 3) Acceleration : Z - 1.01 m/s² r.m.s.
X - 0.45 m/s² r.m.s.
Y - 0.7 m/s² r.m.s.
- 4) Test time : Total 30 min (each axis 10 min)
- 5) Test axis : Vertical (Z), Transverse (X), Longitudinal (Y)
- 6) Check time : During the test
- 7) Sample condition : Unpackaged product / Operation
- 8) Sample quantity : 1 EA
- 9) Input voltage : AC 220 V

- 1) Perform a visual inspection and an operational check for the specimen.
- 2) Fix the specimen on the vibration table.
- 3) Operate the vibration tester.
- 4) Repeat from steps 1) to step 3) for each required axis.
- 5) Perform a final visual inspection and an operational check for the specimen.

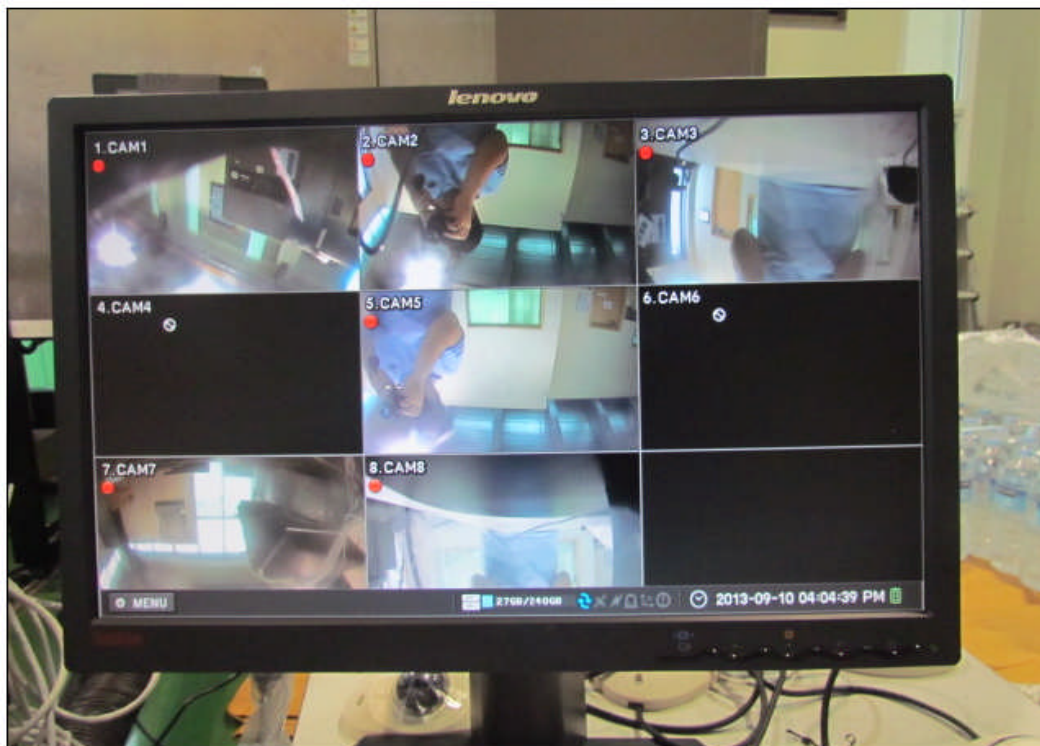
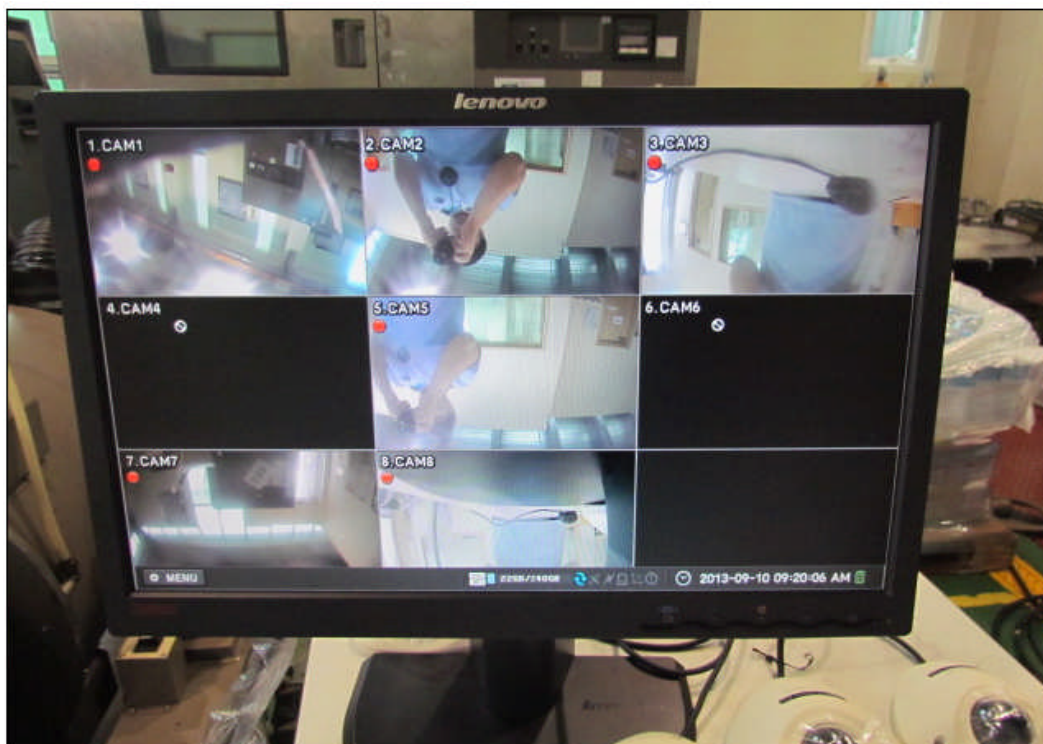
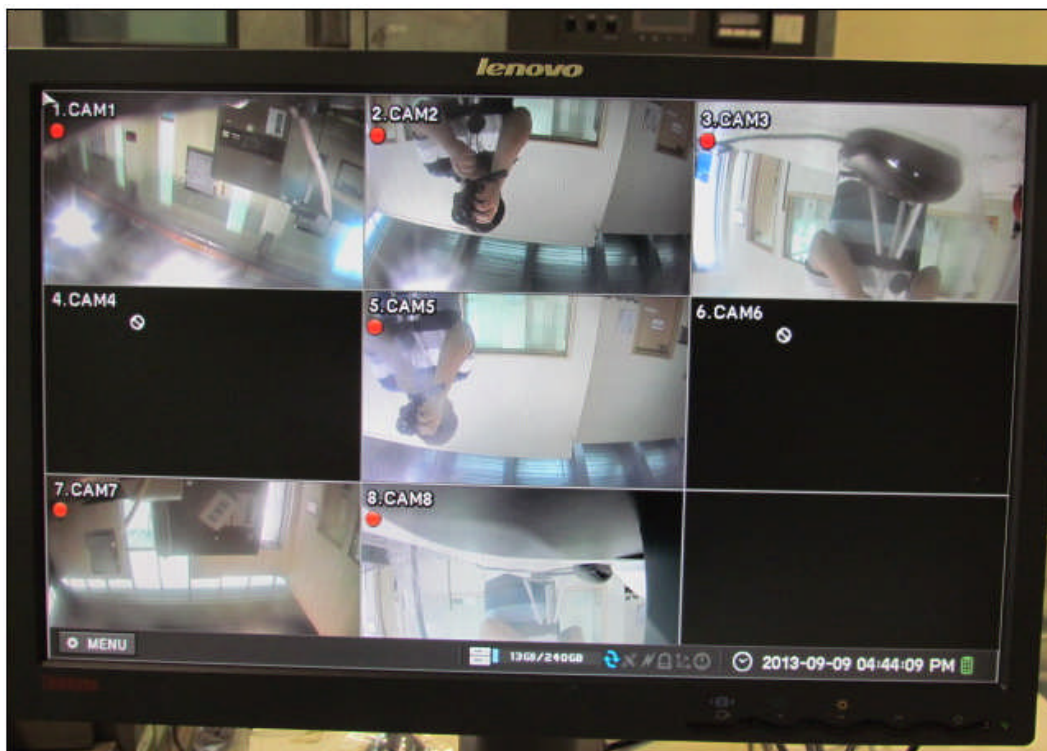
※ Appendix 1. Performance Check

Check List	Test Result
1. Visual inspection -. Mechanical damage such as deformation, crack, separating, loosening of screw, etc.	No abnormal was found
2. Performance check -. Video output	Refer to ※ Appendix 1.

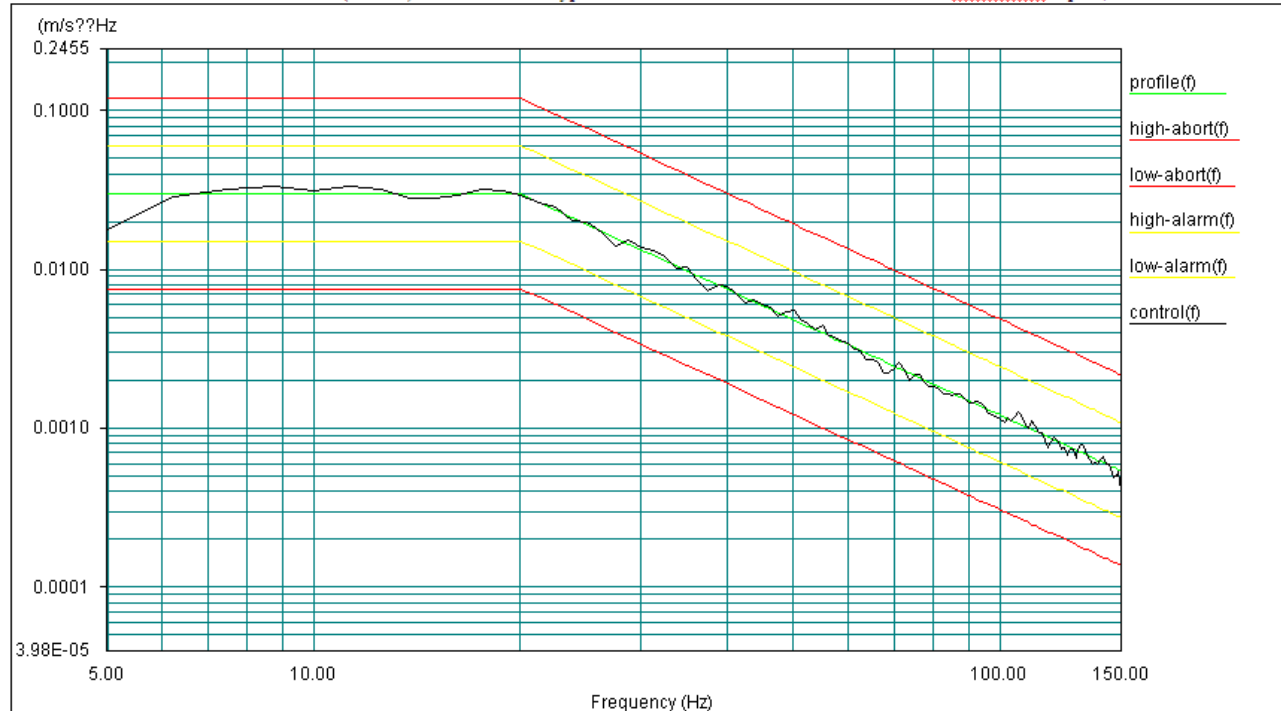
※ Appendix 1. Functional Random Test Data _ Z axis

Project File Name: functionaltest(vertical).pri

Control RMS: 1.040906 m/s² Full Level Elapsed Time: 00:10:00 Lines: 400 Frame Time: 0.800000 Seconds

Demand RMS: 0.991922 m/s² Remaining Time: 00:00:00 DOF: 154 dF: 1.250000 Hz

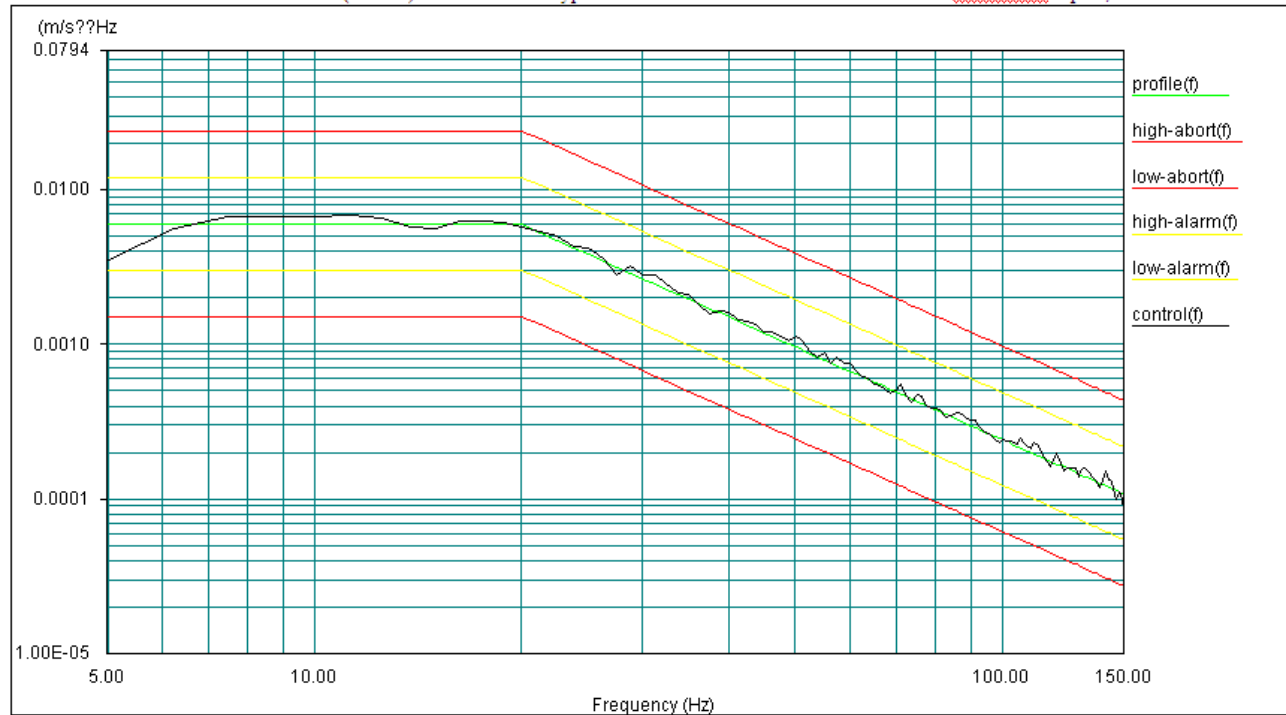
Functional Random Test Data _ X axis

Project File Name: functionaltest(transverse)(RANDOM).prj

Control RMS: 0.455054 m/s²

Demand RMS: 0.442864 m/s²

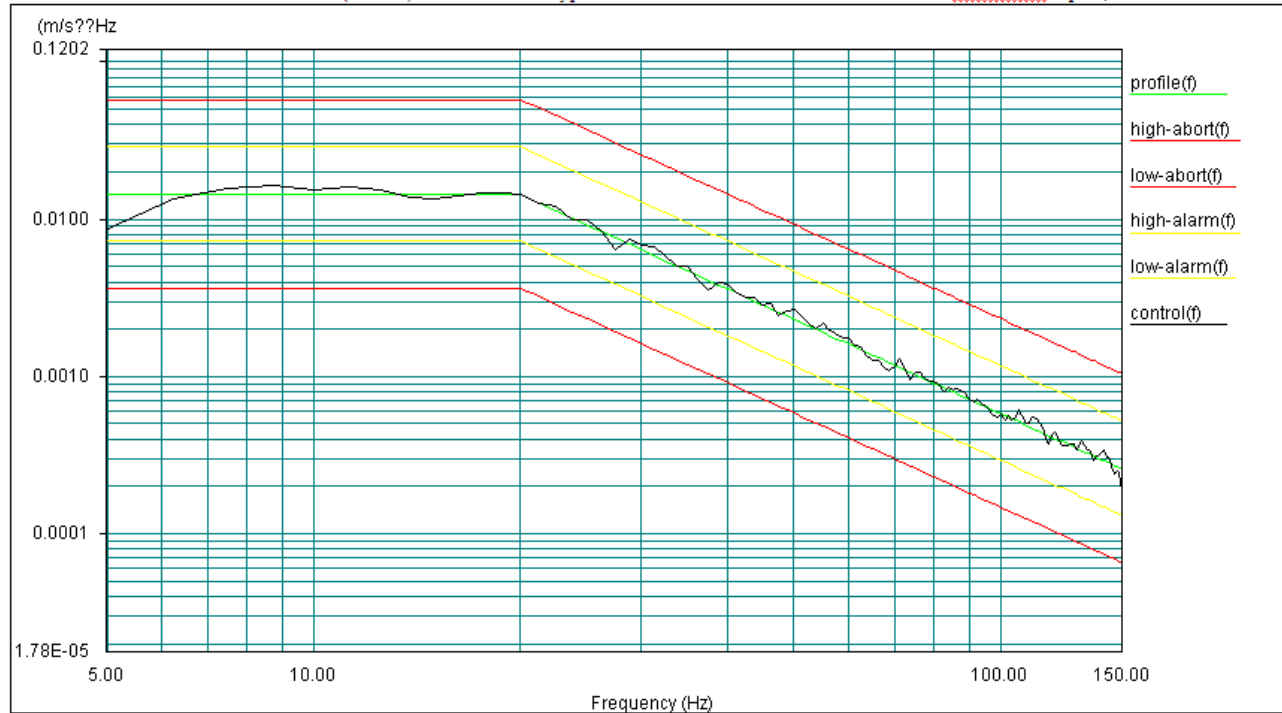
Functional Random Test Data _ Y axis

Project File Name: functionaltest(longitudinal)(RANDOM).prj

Control RMS: 0.749754 m/s²

Demand RMS: 0.686081 m/s²
