TEST REPORT

Report No. : SGS-R13-1066-EN

Product : Mobile NVR

Model : SRM-872

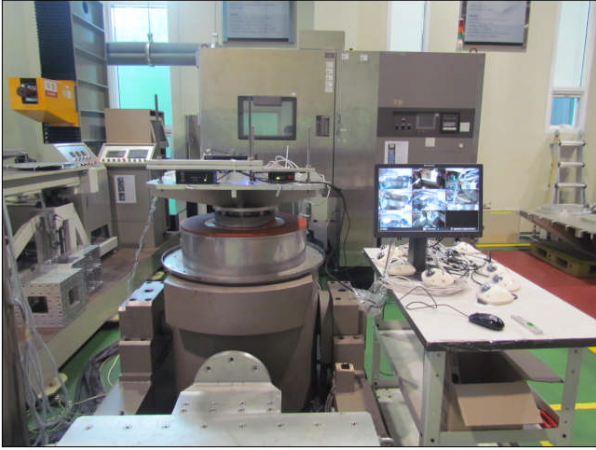
Test axis	Test photograph
Vertical (Z)

- 1) Test type : Random
- 2) Frequency : (5 ~ 500) Hz
- 3) Acceleration : Z - 2.20 m/s² r.m.s. (21.56 m/s² r.m.s.)
X - 1.62 m/s² r.m.s. (15.876 m/s² r.m.s.)
Y - 2.05 m/s² r.m.s. (20.09 m/s² r.m.s.)
- 4) Test time : Total 2 h (each axis 40 min)
- 5) Test axis : Vertical (Z), Transverse (X), Longitudinal (Y)
- 6) Check time : During the test
- 7) Sample condition : Unpackaged product / Operation
- 8) Sample quantity : 1 EA

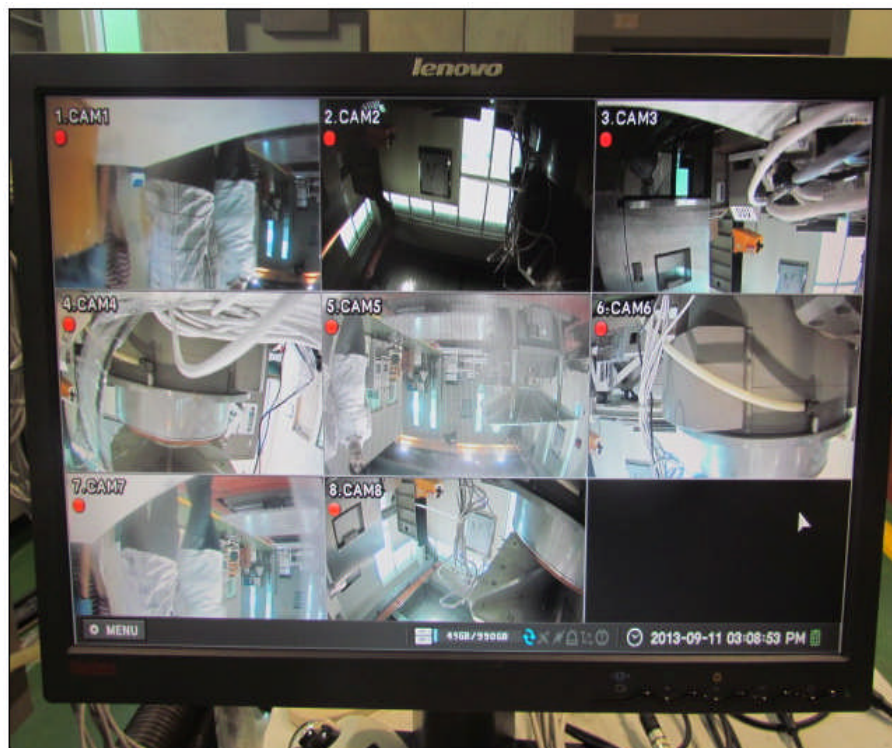
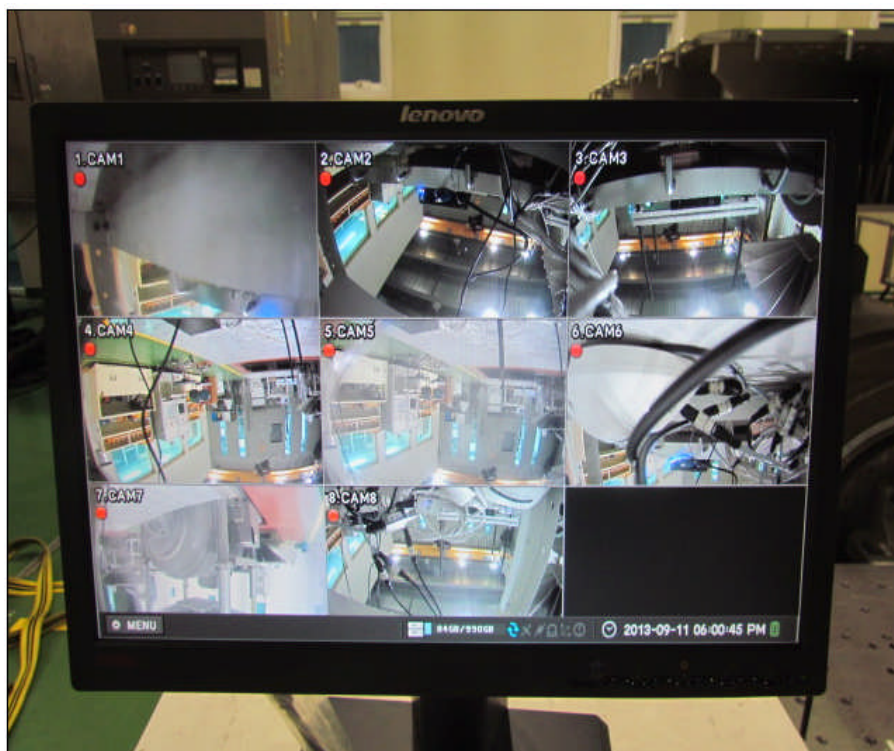
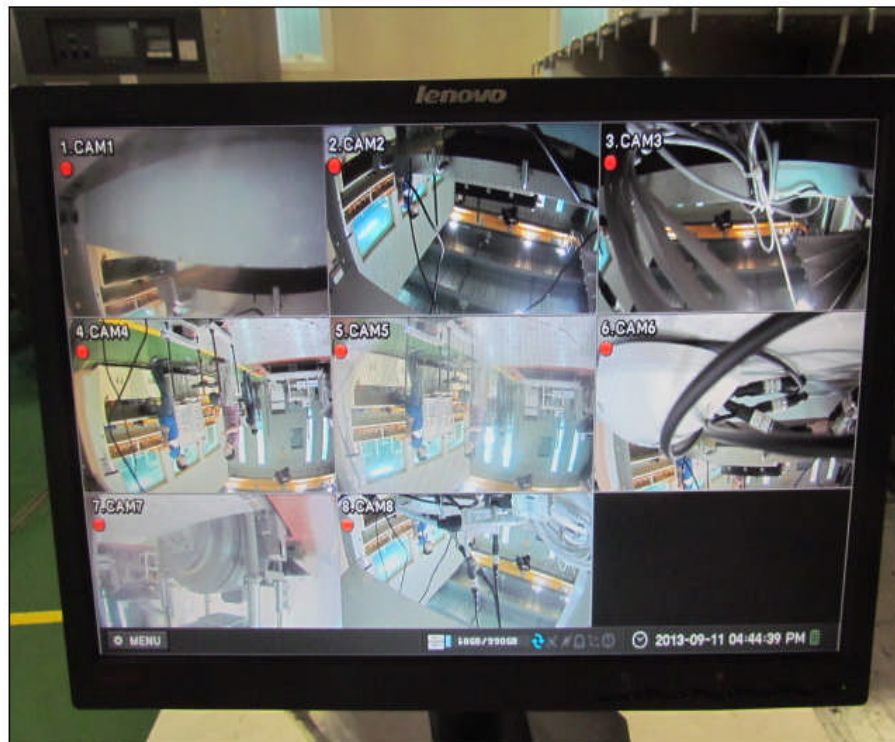
※ Appendix 1. Performance Check

Check List	Test Result
1. Visual inspection -. Mechanical damage such as deformation, crack, separating, loosening of screw, etc.	No abnormal was found
2. Performance check -. Video output	Refer to ※ Appendix 1.

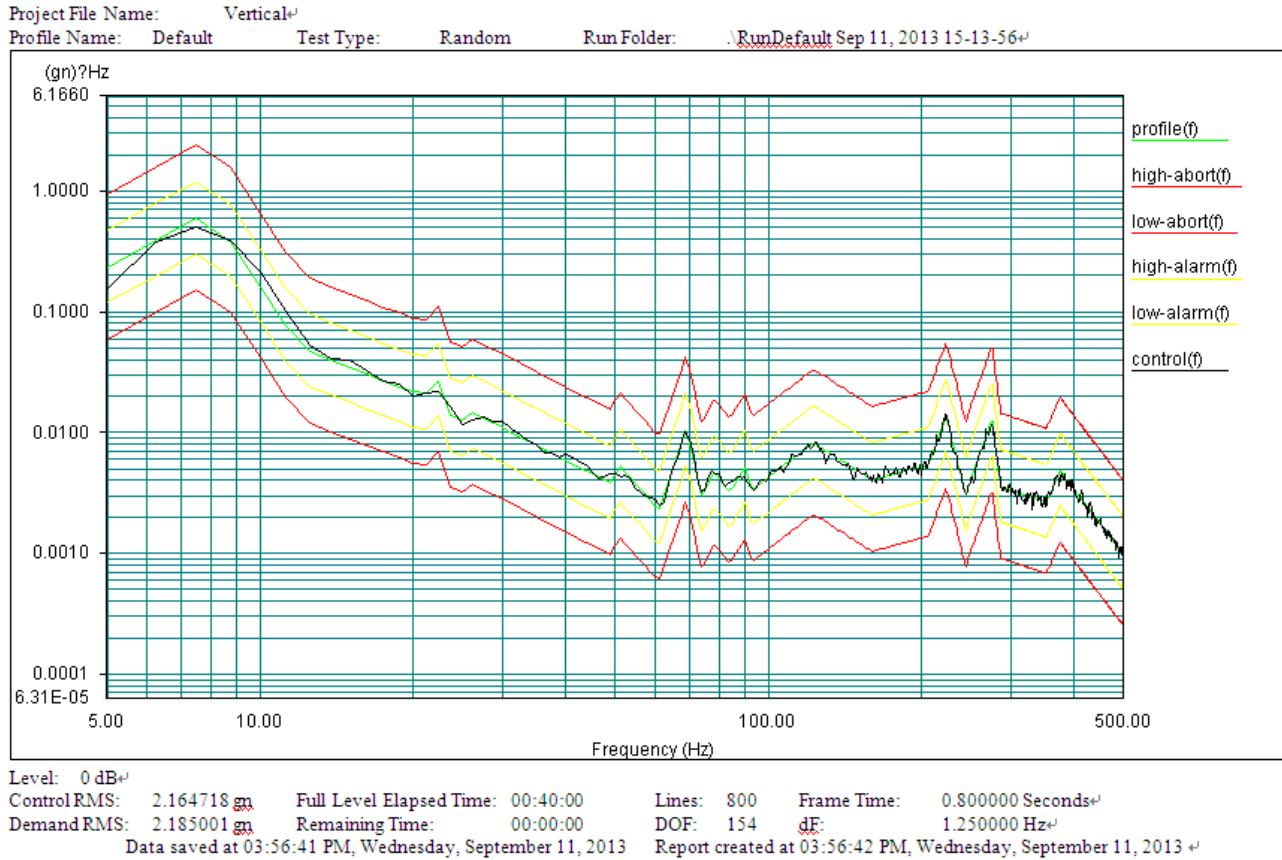
※ Appendix 1. Vibration Test Data _ Z axis

Vertical		Transverse		Longitudinal	
Frequency [Hz]	PSD Levels [g _n ² /Hz]	Frequency [Hz]	PSD Levels [g _n ² /Hz]	Frequency [Hz]	PSD Levels [g _n ² /Hz]
5	0.236 6	5	0.134 4	5	0.059 3
8	0.688 9	7	0.107 5	8	0.049 9
12	0.050 7	8	0.127 9	15	0.025 5
21	0.020 2	14	0.036 6	16	0.034 4
23	0.030 1	16	0.048 5	20	0.013 4
24	0.010 9	17	0.032 6	23	0.060 8
26	0.015 0	19	0.083 6	25	0.014 8
49	0.003 8	23	0.014 7	37	0.004 0
51	0.005 4	116	0.000 8	41	0.005 9
61	0.002 3	145	0.001 3	49	0.001 6
69	0.011 1	164	0.000 9	63	0.001 1
74	0.002 9	201	0.000 9	69	0.004 0
78	0.004 8	270	0.005 1	78	0.000 8
84	0.003 3	298	0.002 1	94	0.002 0
90	0.005 2	364	0.009 9	98	0.001 3
93	0.003 4	375	0.001 9	101	0.002 5
123	0.008 3	394	0.007 3	104	0.001 4
160	0.004 1	418	0.002 7	111	0.002 4
207	0.005 5	500	0.001 6	114	0.001 4
224	0.013 9			117	0.002 0
245	0.003 1			121	0.001 2
276	0.012 9			139	0.002 4
287	0.003 6			155	0.002 1
353	0.002 7			161	0.003 4
375	0.004 9			205	0.004 2

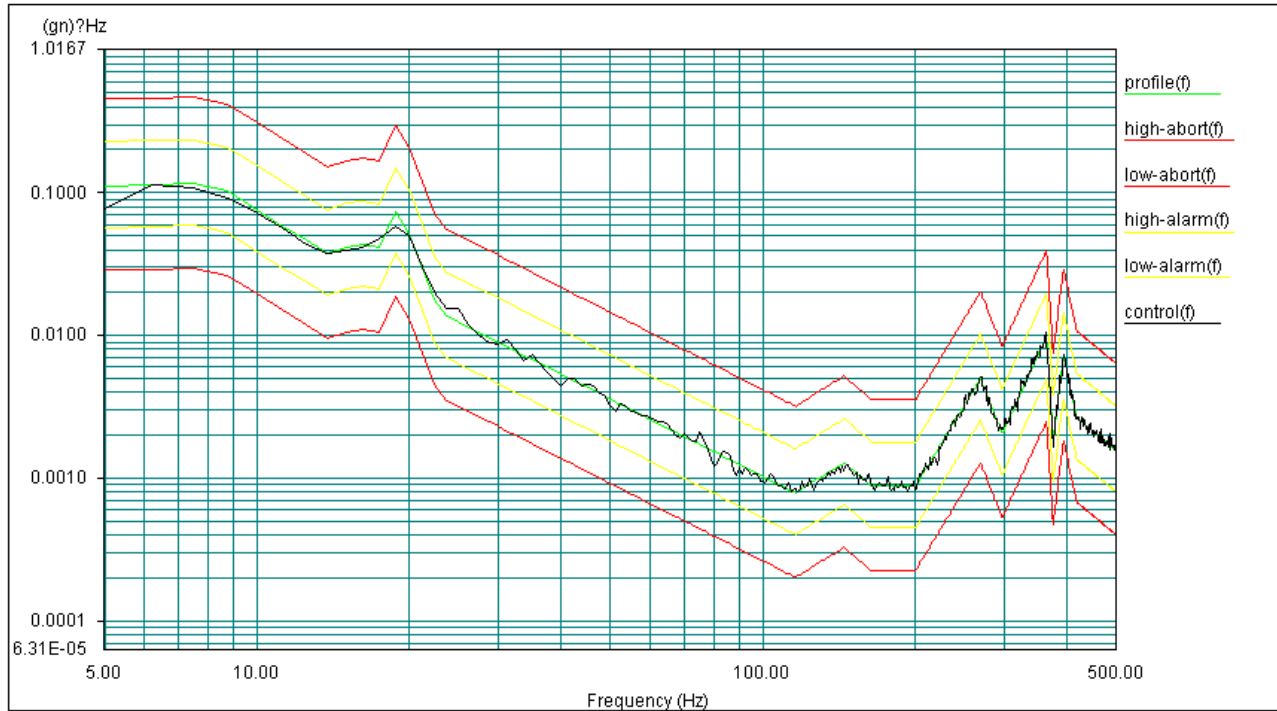
Vibration Test Data _ X axis

Control RMS: 1.587597 gn Full Level Elapsed Time: 00:40:00 Lines: 800 Frame Time: 0.800000 Seconds

Demand RMS: 1.606937 gn Remaining Time: 00:00:00 DOF: 154 dF: 1.250000 Hz

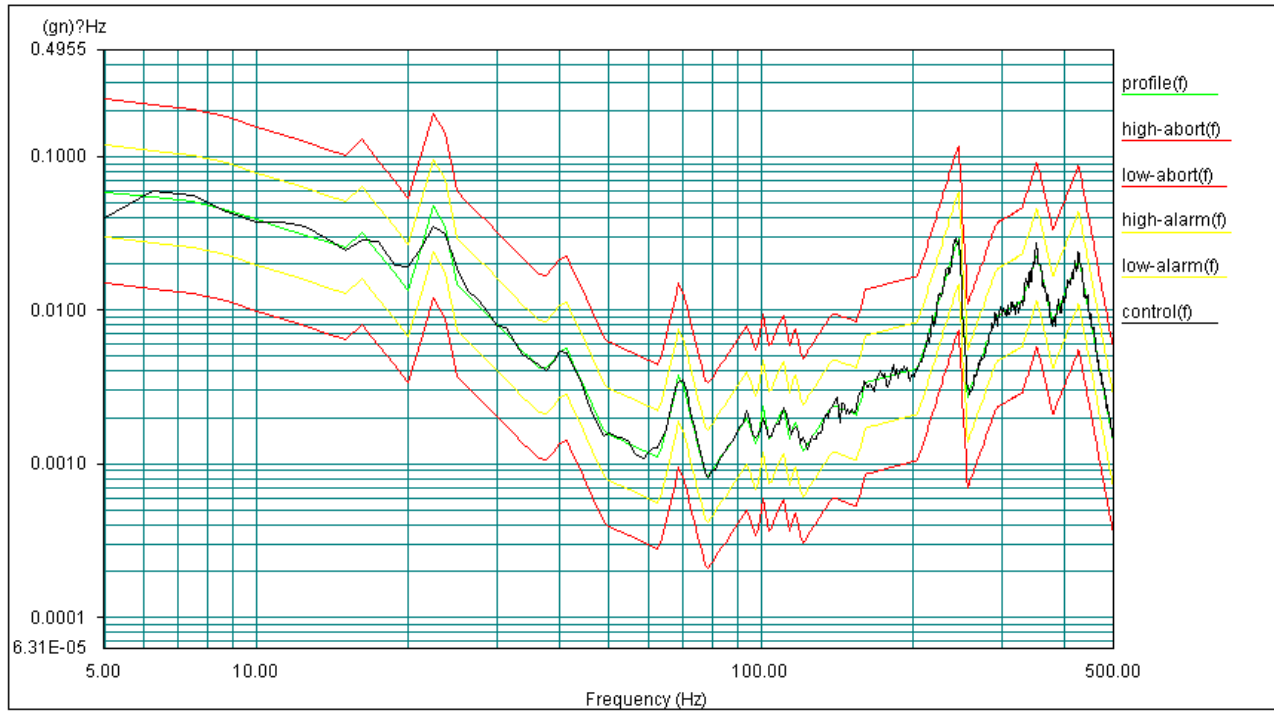
Vibration Test Data _ Y axis

Control RMS: 2.110476 gn Full Level Elapsed Time: 00:40:00 Lines: 800 Frame Time: 0.800000 Seconds

Demand RMS: 2.103446 gn Remaining Time: 00:00:00 DOF: 154 dF: 1.250000 Hz

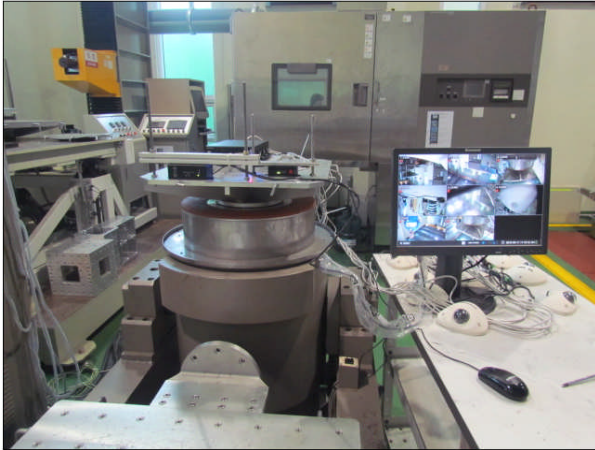
Test axis	Test photograph
Vertical (Z)

- 1) Test type : Sawtooth pulse
- 2) Acceleration : 196 m/s² (20 g_n)
- 3) Duration : 11 ms
- 4) Test time : 18 times in total (6 times in each axis : positive 3 / negative 3)
- 5) Test axis : Vertical (Z), Transverse (X), Longitudinal (Y)
- 6) Check time : During the test
- 7) Sample condition : Unpackaged product / Operation
- 8) Sample quantity : 1 EA

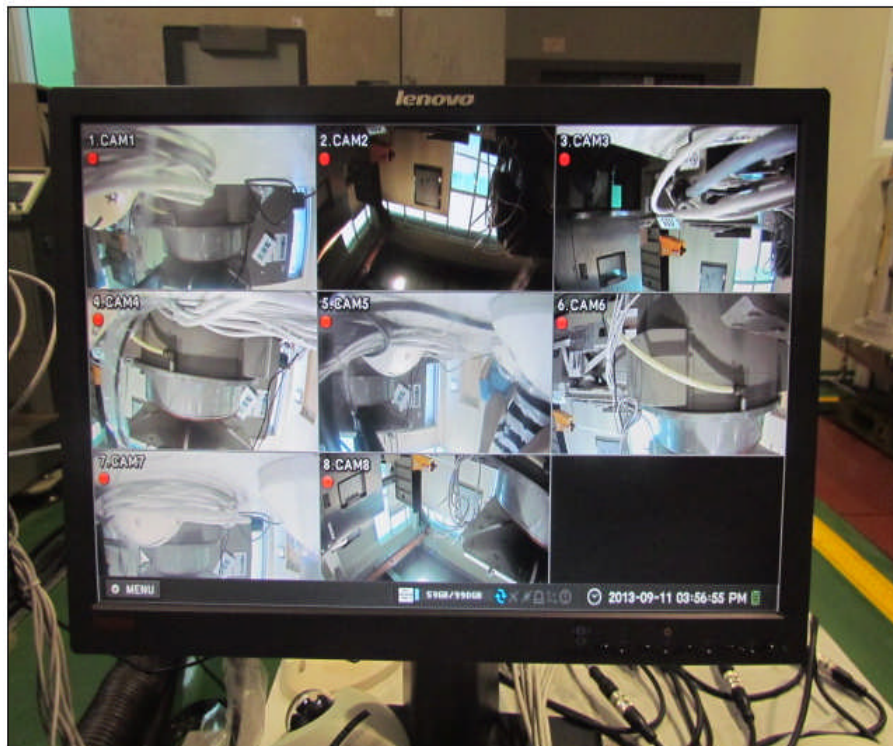
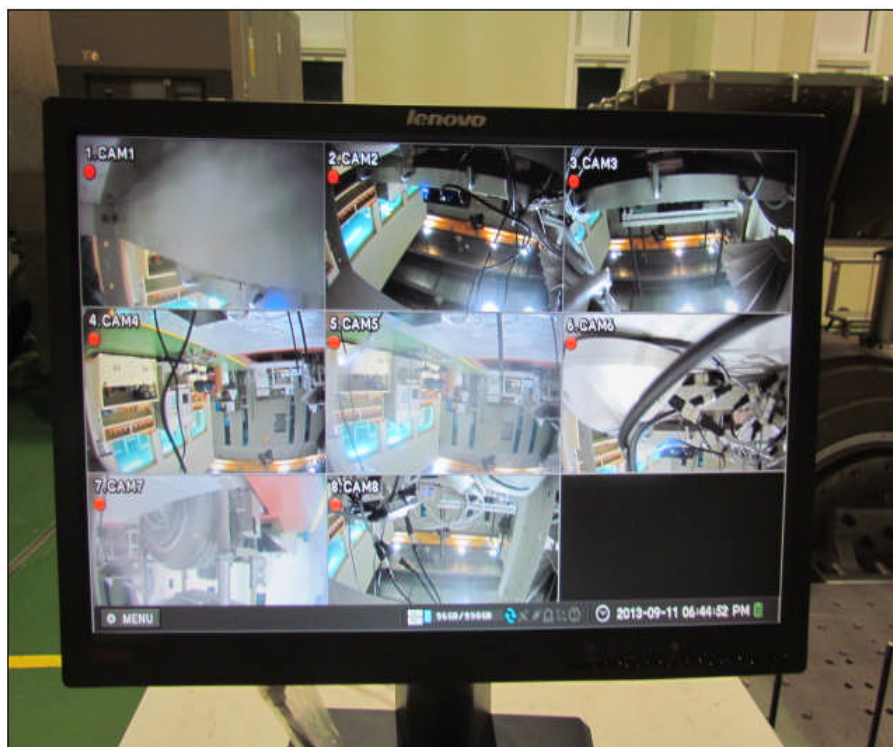
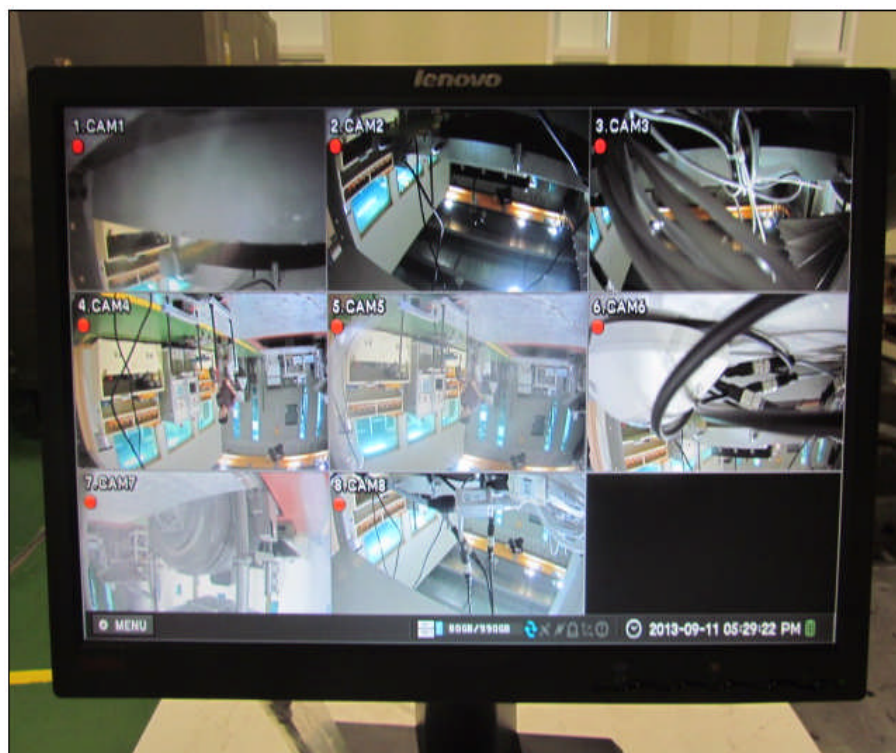
※ Appendix 1. Performance Check

Check List	Test Result
1. Visual inspection -. Mechanical damage such as deformation, crack, separating, loosening of screw, etc.	No abnormal was found
2. Performance check -. Video output	Refer to ※ Appendix 1.

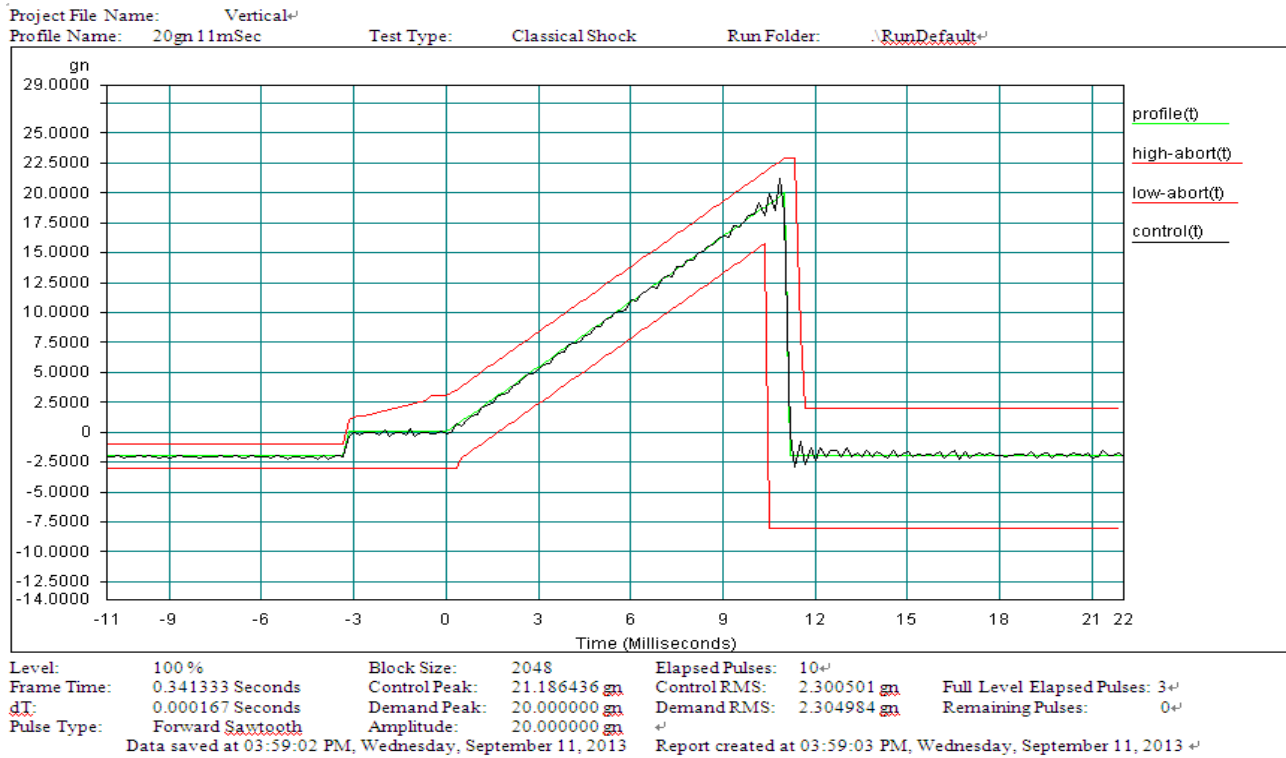
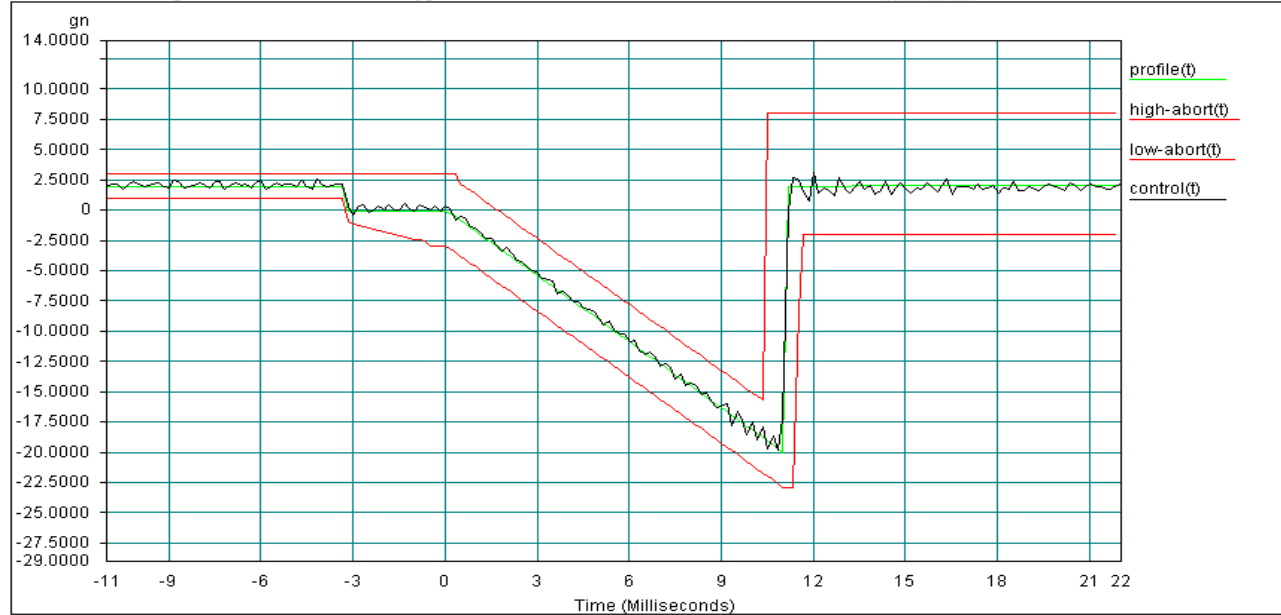
※ Appendix 1. Shock Test Data _ Z axis

Level:	100 %	Block Size:	2048	Elapsed Pulses:	10
Frame Time:	0.341333 Seconds	Control Peak:	19.831570 gn	Control RMS:	2.281741 gn
dt:	0.000167 Seconds	Demand Peak:	20.000000 gn	Demand RMS:	2.304984 gn
Pulse Type:	Forward Sawtooth	Amplitude:	20.000000 gn	Full Level Elapsed Pulses:	3
				Remaining Pulses:	0

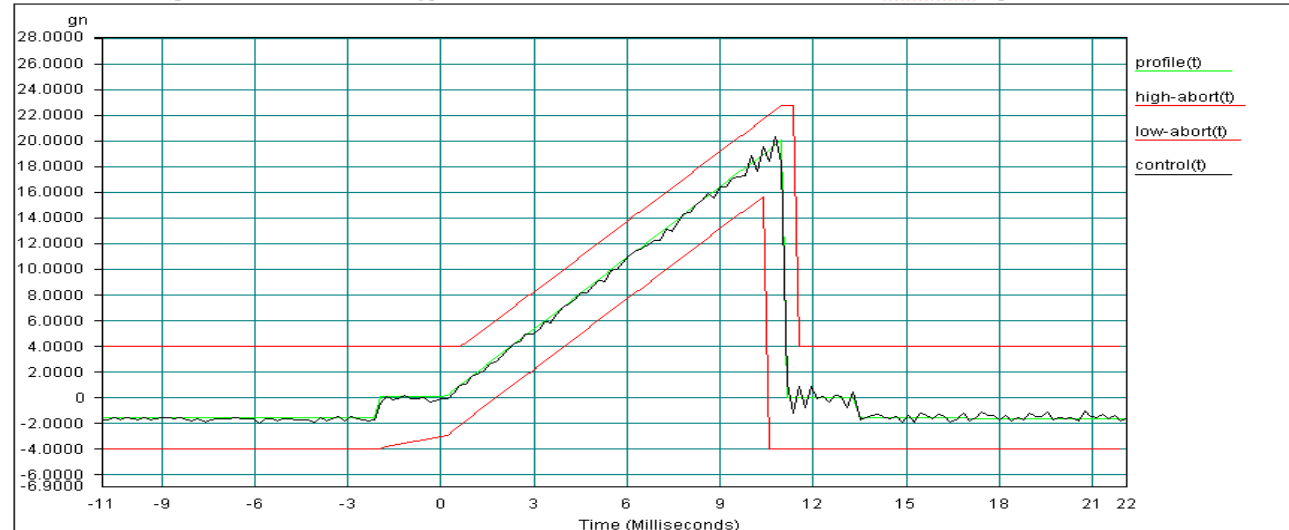
Shock Test Data _ X axis

Level: 100 % Block Size: 2048 Elapsed Pulses: 11

Frame Time: 0.400000 Seconds Control Peak: 20.316486 gn Control RMS: 2.063832 gn Full Level Elapsed Pulses: 3

dT: 0.000195 Seconds Demand Peak: 20.000000 gn Demand RMS: 2.087563 gn Remaining Pulses: 0

Pulse Type: Forward Sawtooth Amplitude: 20.000000 gn

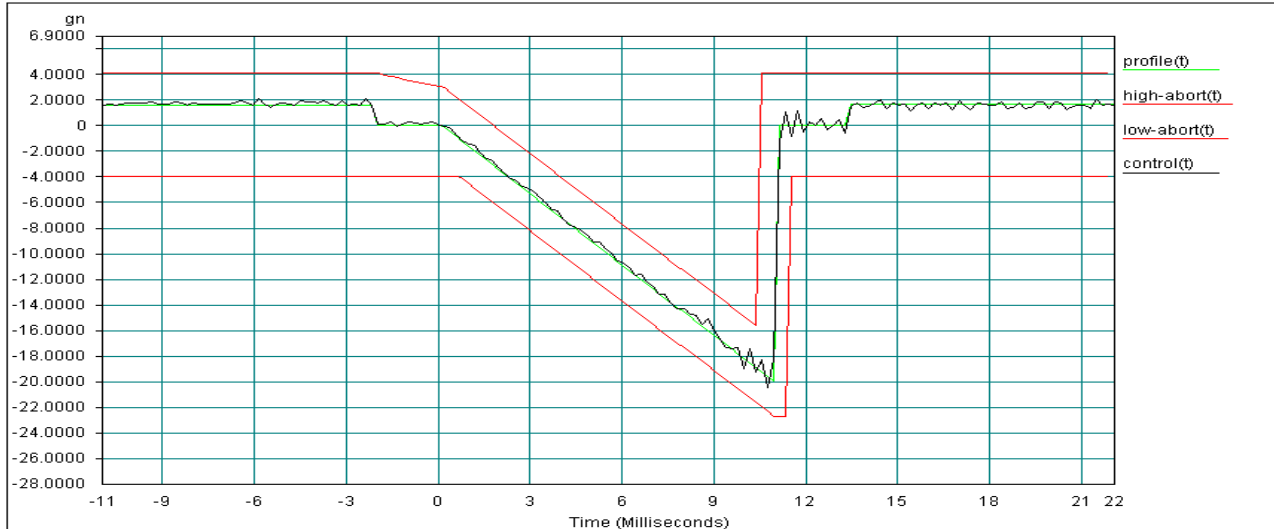
Level: 100 % Block Size: 2048 Elapsed Pulses: 11

Frame Time: 0.400000 Seconds Control Peak: 20.495964 gn Control RMS: 2.064245 gn Full Level Elapsed Pulses: 3

dT: 0.000195 Seconds Demand Peak: 20.000000 gn Demand RMS: 2.087563 gn Remaining Pulses: 0

Pulse Type: Forward Sawtooth Amplitude: 20.000000 gn

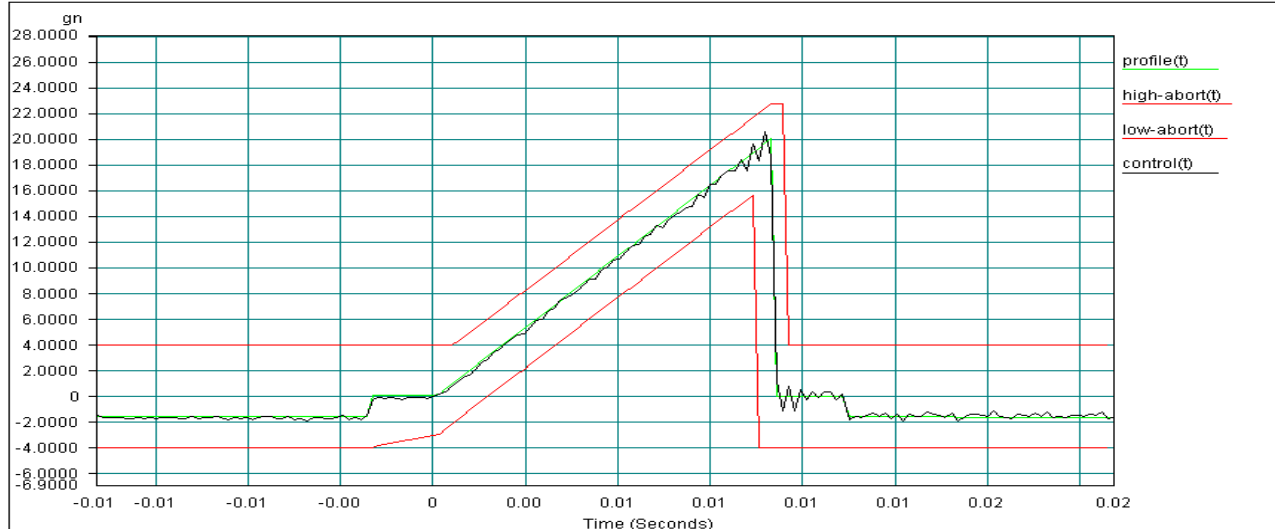
Shock Test Data _ Y axis

Level: 100 % Block Size: 2048 Elapsed Pulses: 11

Frame Time: 0.400000 Seconds Control Peak: 20.507010 gn Control RMS: 2.062366 gn Full Level Elapsed Pulses: 3

dT: 0.000195 Seconds Demand Peak: 20.000000 gn Demand RMS: 2.087563 gn Remaining Pulses: 0

Pulse Type: Forward Sawtooth Amplitude: 20.000000 gn

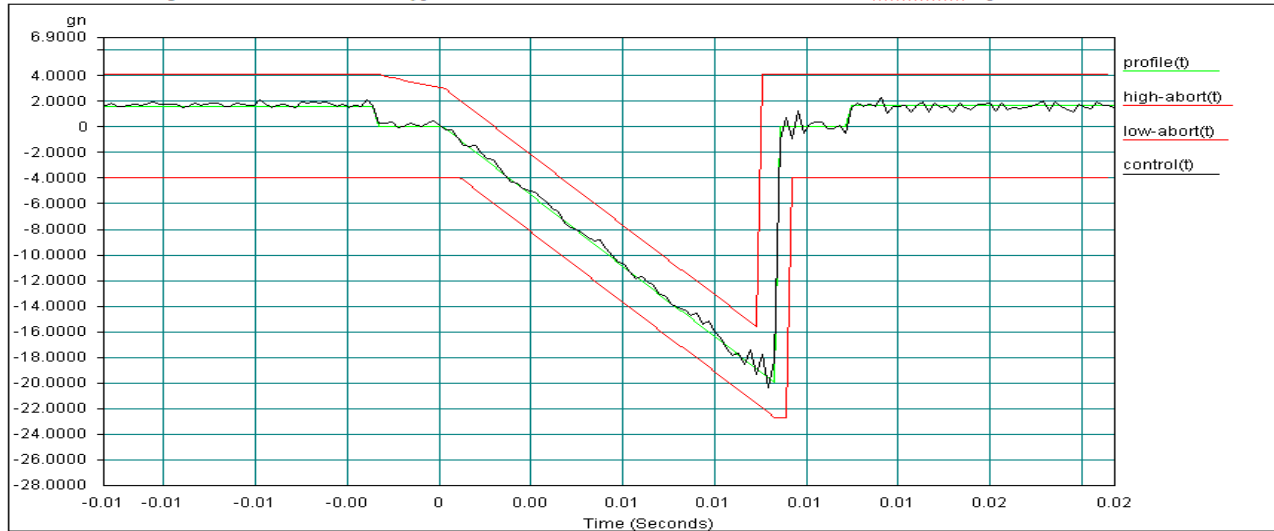
Level: 100 % Block Size: 2048 Elapsed Pulses: 11

Frame Time: 0.400000 Seconds Control Peak: 20.352678 gn Control RMS: 2.061451 gn Full Level Elapsed Pulses: 3

dT: 0.000195 Seconds Demand Peak: 20.000000 gn Demand RMS: 2.087563 gn Remaining Pulses: 0

Pulse Type: Forward Sawtooth Amplitude: 20.000000 gn
