TEST REPORT

1. **Report Number** KR16-YYP0114
2. **Applicant**
 - Name Hanwha Techwin Co.,Ltd
 - Address 1204, Changwon-daero, Seongsan-gu, Changwon-si, Gyeongsangnam-do, Korea
 - Date of Receipt October 14, 2016
3. **Manufacturer**
 - Name Hanwha Techwin Co.,Ltd
 - Address 1204, Changwon-daero, Seongsan-gu, Changwon-si, Gyeongsangnam-do, Korea
4. **Use of Report** For Quality management
5. **Test item description**
 - Product Name Network Camera
 - Model Name PNM-9020V*(*N:NTSC/P:PAL)
6. **Test method used** IEC 62262: 2002 (IK 10)
7. **Date of Test** October 18, 2016
8. **Environment**
 - Temperature (15~35) °C
 - Relative Humidity (25~75) % R.H
 - Air pressure (86~106) kPa
9. **Test Results** See of the test result

3.1 IK10 Impacts Test

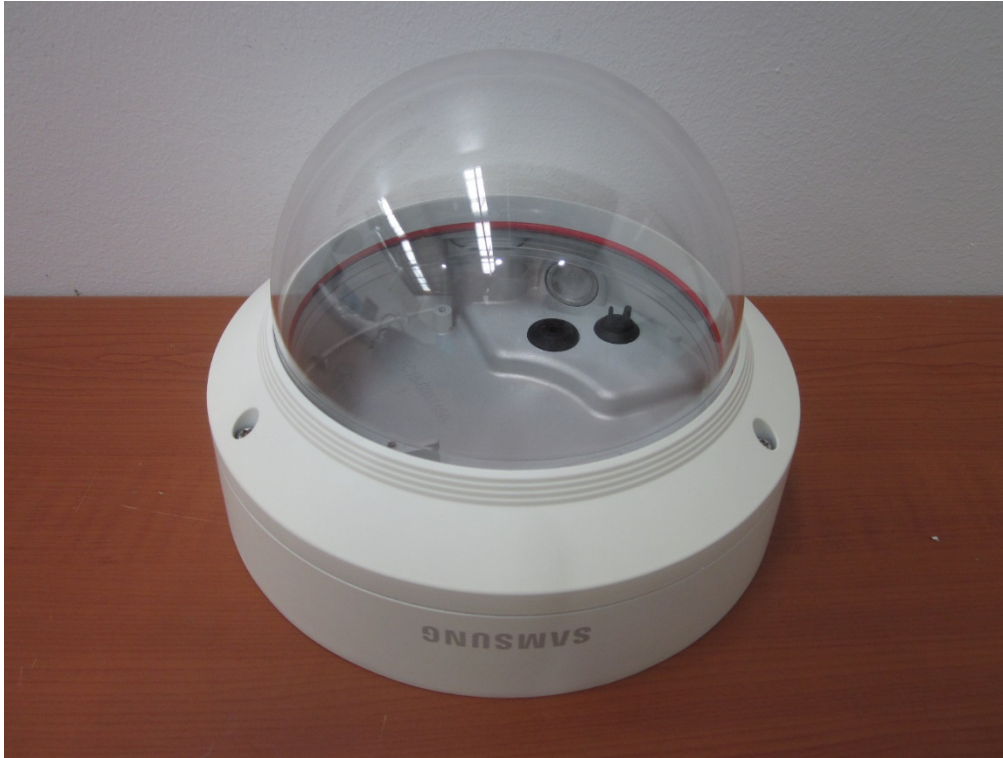
[Front]

Division	Specification
Product Name	Network Camera
Model Name	PNM-9020V*(N:NTSC/P:PAL)
