## TEST REPORT

1. **Report Number** KR16-YYP0116
2. **Applicant**
  - Name Hanwha Techwin Co.,Ltd
  - Address 1204, Changwon-daero, Seongsan-gu, Changwon-si, Gyeongsangnam-do, Korea
  - Date of Receipt October 14, 2016
3. **Manufacturer**
  - Name Hanwha Techwin Co.,Ltd
  - Address 1204, Changwon-daero, Seongsan-gu, Changwon-si, Gyeongsangnam-do, Korea
4. **Use of Report** For Quality management
5. **Test item description**
  - Product Name Network Camera
  - Model Name PNM-9020V\*(\*N:NTSC/P:PAL)
6. **Test method used** IEC 60529: 2013 / IP66
7. **Date of Test** October 18, 2016 ~ October 19, 2016
8. **Environment**
  - Temperature (15~35) °C
  - Relative Humidity (25~75) % R.H
  - Air pressure (86~106) kPa
9. **Test Results** See of the test result

Division	Specification
Product Name	Network Camera
Model Name	PNM-9020V*(*N:NTSC/P:PAL)

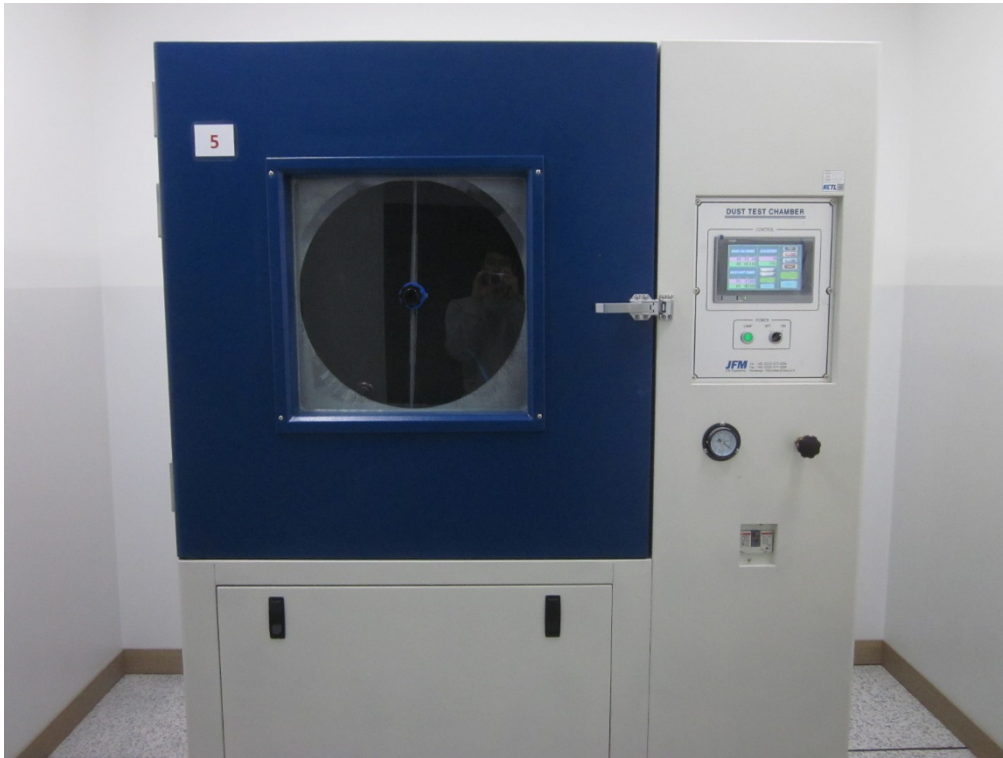
### 3.2.5 TEST Photograph

Item	Description
First characteristic numeral	IP6X (Dust-tight)
Enclosures	Category 1
Test condition	The talcum powder used shall be able to pass through a square-meshed sieve the nominal wire diameter of which is 50 µm and the nominal width of a gap between wires 75 µm. The amount of talcum powder to be used is 2 kg per cubic metre of the test chamber volume
Test time	8 h
Definition	No ingress of dust

- 1) The enclosure under test is supported inside the test chamber and the pressure inside the enclosure is maintained below the surrounding atmospheric pressure by a vacuum pump
- 2) The suction connection shall be made to a hole specially provided for this test
- 3) The object of the test is to draw into the enclosure, by means of depression, a volume of air 80 times the volume of the sample enclosure tested without exceeding the extraction rate of 60 volumes per hour. In no event shall the depression exceed 2 kPa (20 mbar) on the manometer
- 4) If an extraction rate of 40 to 60 volumes per hour is obtained the duration of the test is 2 h.
- 5) If, with a maximum depression of 2 kPa (20 mbar), the extraction rate is less than 40 volumes per hour, the test is continued until 80 volumes have been drawn through, or a period of 8 h has elapsed.

[During the test]

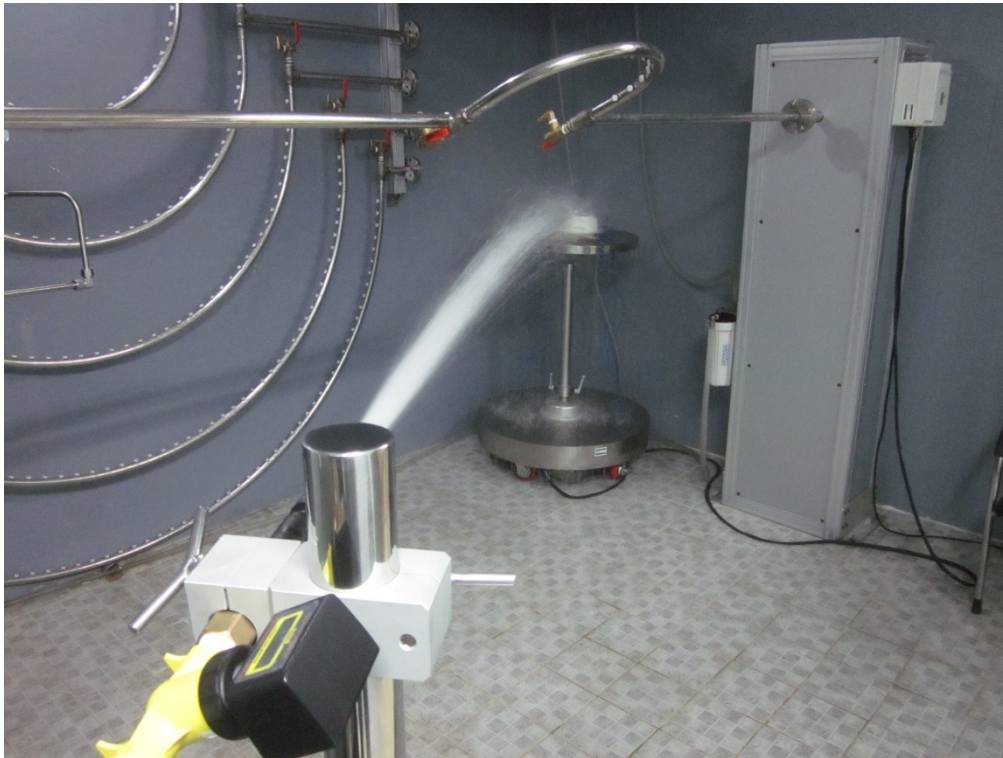
### 3.3.5 TEST Photograph

Item	Description
Second characteristic numeral	IPX6 (Protected against powerful water jets)
Test condition	1. Water jet hose nozzle diameter: 12.5 mm 2. Water flow rate: 100 L/min±5% 3. Distance: 2.5~3.0 m
Test time	1 min/m <sup>2</sup> , at least 3 min
Definition	Water projected in powerful jets against the enclosure from any direction shall have no harmful effects

- 1) The tests are conducted with fresh water
- 2) The water pressure is adjusted to give the specified delivery rate
- 3) The test is made by spraying the enclosure from all practicable directions with a stream of water from a standard test nozzle

[During the test]]

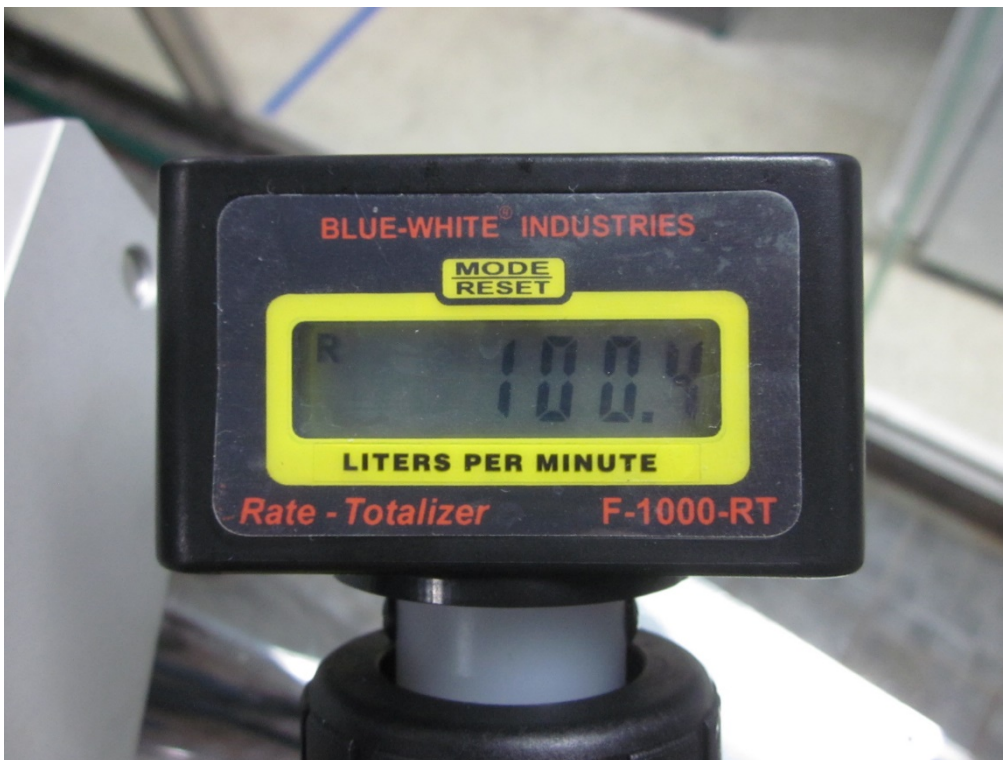
[During the test\_Water flow rate]

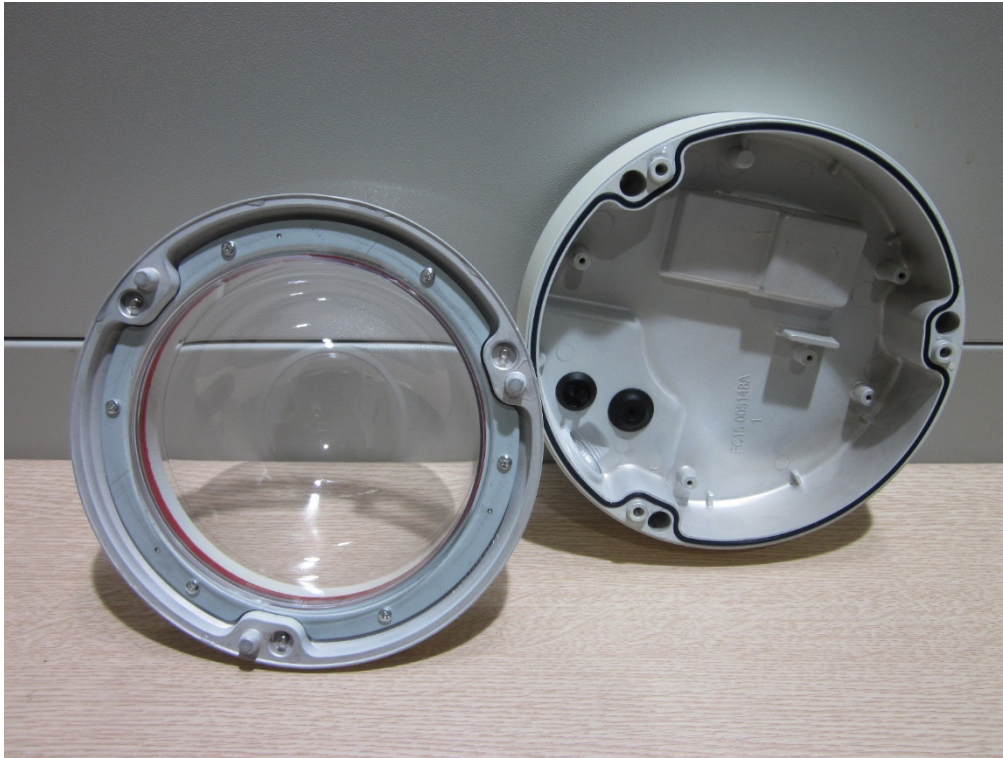
Check List	Test Result
Protected against powerful water jets	No abnormal was found

[Test result confirme]
