TEST REPORT

Report No.:
CTK-2023-00300
Page (1) / (16) pages

: NETWORK CAMERA / QNO-C9083R

: IEC 60529:1989 +A1:1999+A2:2013

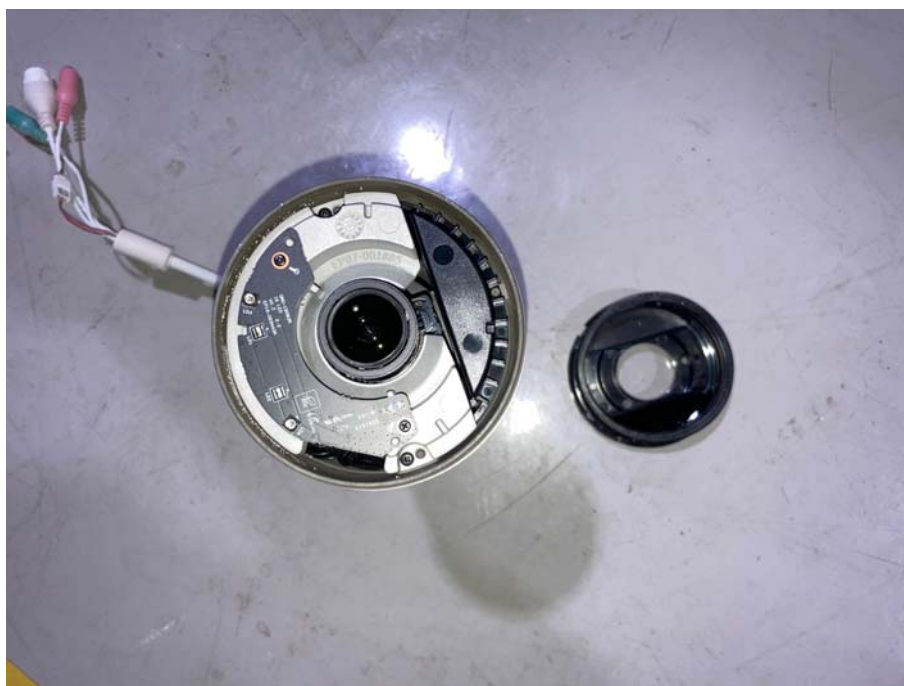
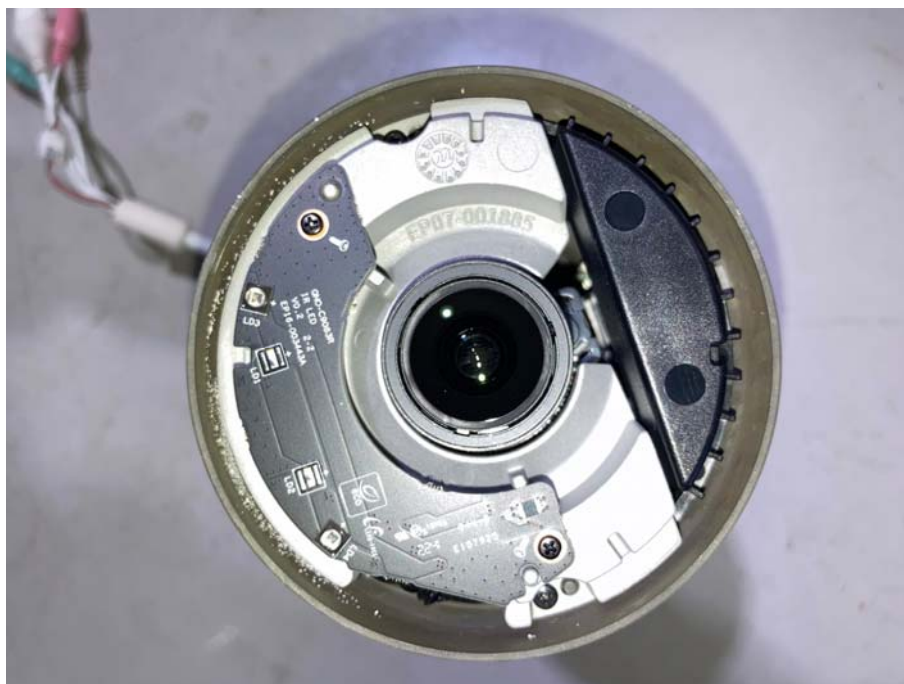
< Photo 5 > The First Characteristic Test

2.3 Product internal photographs after test

IP Code	Remark
IP 6X	No penetration of probe No ingress of dust
IP X6	No ingress of water.
