TEST REPORT

REPORT No.:
CTK-2024-00666
Page (1) / (13) pages

NETWORK CAMERA / QNO-6083R

KS C IEC 62262: 2005

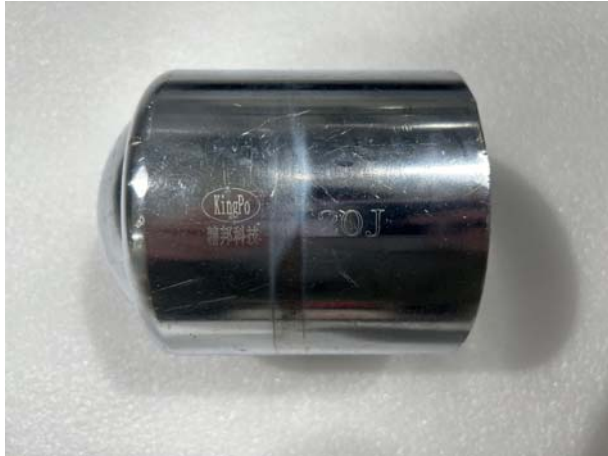
Testing equipment	Model Name	Manufacturer	Manufacturing Number	Calibration Date
Vertical Hammer Tester	Vertical Hammer	Kingpo	0190605A01002	-
Vertical Hammer	20J	Kingpo	TX028-3	-
Steel measuring meter	5.5 m	KOMELON	225851	2023-03-14

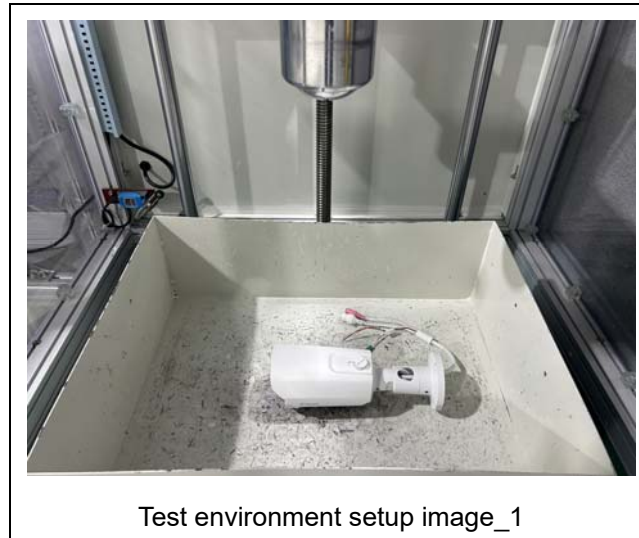
3.3.1 Test environment setup image

IK code	Impact Energy (J)	Equivalent mass (kg)	Drop height (mm ± 1%)	Application
00	Non-protected	-	-	<input type="checkbox"/>
01	0.14	0.25	56	<input type="checkbox"/>
02	0.20	0.25	80	<input type="checkbox"/>
03	0.35	0.25	140	<input type="checkbox"/>
04	0.50	0.25	200	<input type="checkbox"/>
05	0.70	0.25	280	<input type="checkbox"/>
06	1.00	0.25	400	<input type="checkbox"/>
07	2.00	0.50	400	<input type="checkbox"/>
08	5.00	1.70	300	<input type="checkbox"/>
09	10.00	5.00	200	<input type="checkbox"/>
10	20.00	5.00	400	<input checked="" type="checkbox"/>
- Impact times: five times for each of the exposed surface. (Do not impact more than 3 times in the same spot)

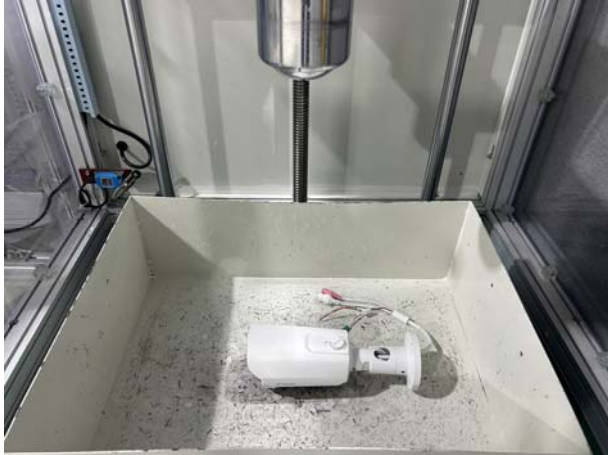
Check the hit area the test _1

Evaluation Criteria		Test Results	Comment
Visual Inspection	Pre-test	No problem with the product	-
	Post-test	Some scratches were generated on the outside of the product.	-
