# TEST REPORT

REPORT No.:  
CTK-2024-00687  
Page (1) / (12) pages

NETWORK CAMERA / QNO-C6083R

IEC 60529:1989 +A1:1999+A2:2013

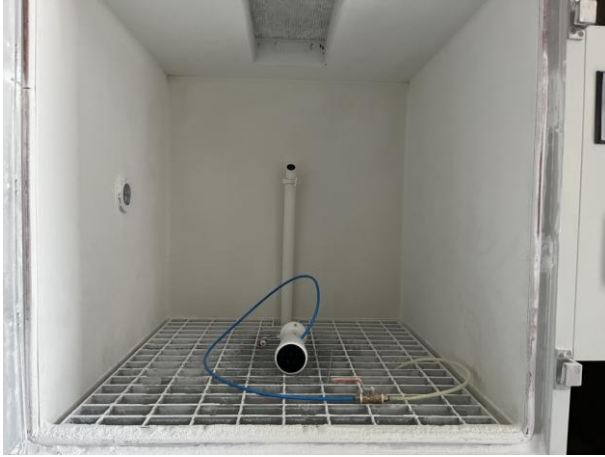
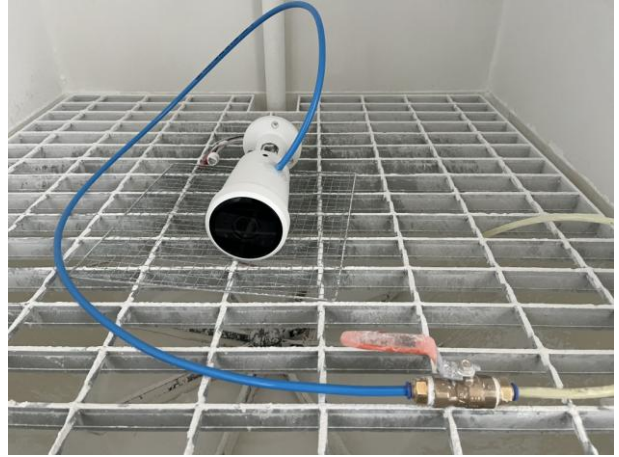
First characteristic numeral	Degree of protection	Application
6	<p>In Dust Testing Equipment, the test sample has to have no ingress of dust after testing atmospheric pressure present condition for 8 hr.</p> <p>(Talcum powder have to go through the measured sieve by <math>\Phi</math> 50 <math>\mu</math>m wire that are spacing 75 <math>\mu</math>m in squared, per volume and union Talcum powder have to be 2 kg/m<sup>3</sup>)</p> <p>Products in volume .....: <b>2 622.97 cm<sup>3</sup> → 2.62 L</b></p> <p>Target intake volume (Products in volume 80) .....: <b>209.83 L</b></p> <p>Suction volume (Max product in volume 60) .....: <b>157.37 LPH → 2.62 LPM</b></p> <p>Actual Suction volume .....: <b>2.62 L</b></p> <p>Suction pressure (Up to 2 kPa) .....: <b>1.06 kPa</b></p> <p>Test time (Up to 8 time) .....: <b>8 hr</b></p>	<input checked="" type="checkbox"/>
<sup>1)</sup> The full diameter of the object probe shall not pass through an opening of the enclosure. Due to the simultaneous requirement specified in table 2, the definition “shall not penetrate” is given in table 1.

Dust test\_1

Dust test\_2

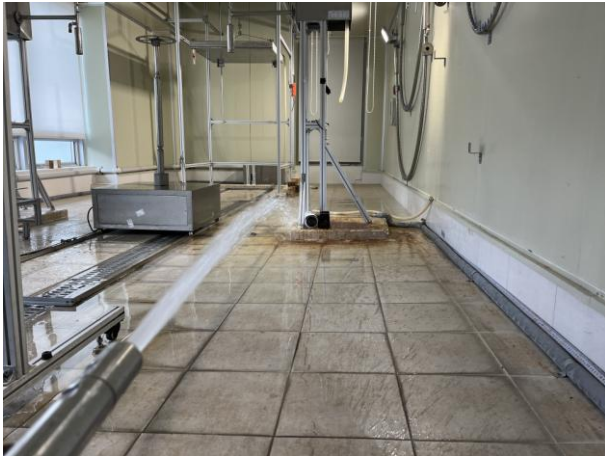
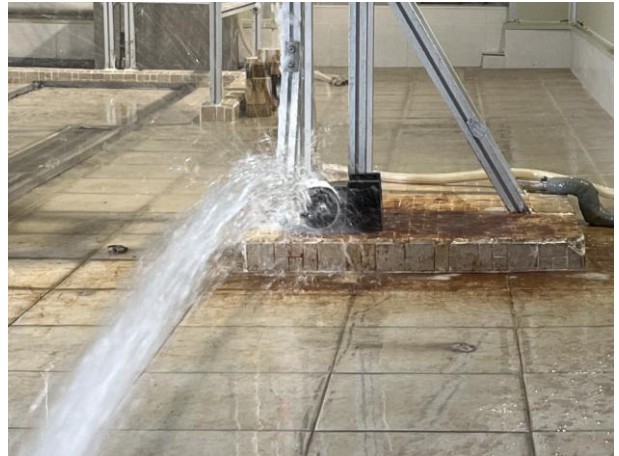
Second characteristic numeral	Degrees of protection	Application
6	<p>The product must not be harmed in any direction even strong jet water.</p> <p>Water jet hose nozzle Fig.6, Nozzle 12.5 mm diameter</p> <p>Water flow rate: 100 l/min <math>\pm</math> 5 % : <b>100 LPM</b></p> <p>Distance: 2.5 m to 3 m: <b>3 m</b></p> <p>Duration of test: 1 min/m<sup>2</sup> at least 3 min: <b>3 min</b></p>	<input checked="" type="checkbox"/>

Water test\_1

Water test\_2

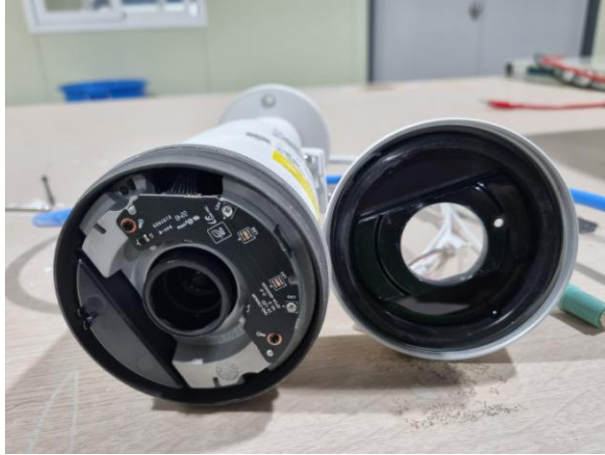
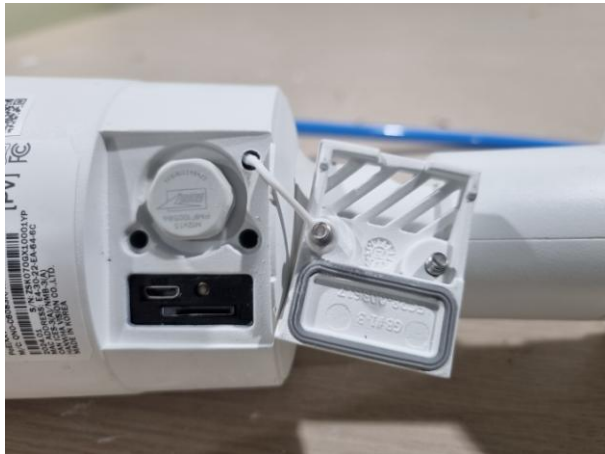
### 4.2.1 Product internal images after test [The First characteristic Numeral Test]

IP code	Evaluation Criteria	Test Results	Remark
IP 6X	No penetration of probe.	<b>No penetration of probe</b>	-
	No ingress of dust.	<b>No ingress of dust</b>	-
IP X6	No ingress of water.	<b>No ingress of water</b>	-
