# TEST REPORT

REPORT No.:  
CTK-2023-02239  
Page (1) / (16) pages

: NETWORK CAMERA / XNP-C9253R

: Specifications presented by the sponsor  
(reference NEMA TS 2.2.8)

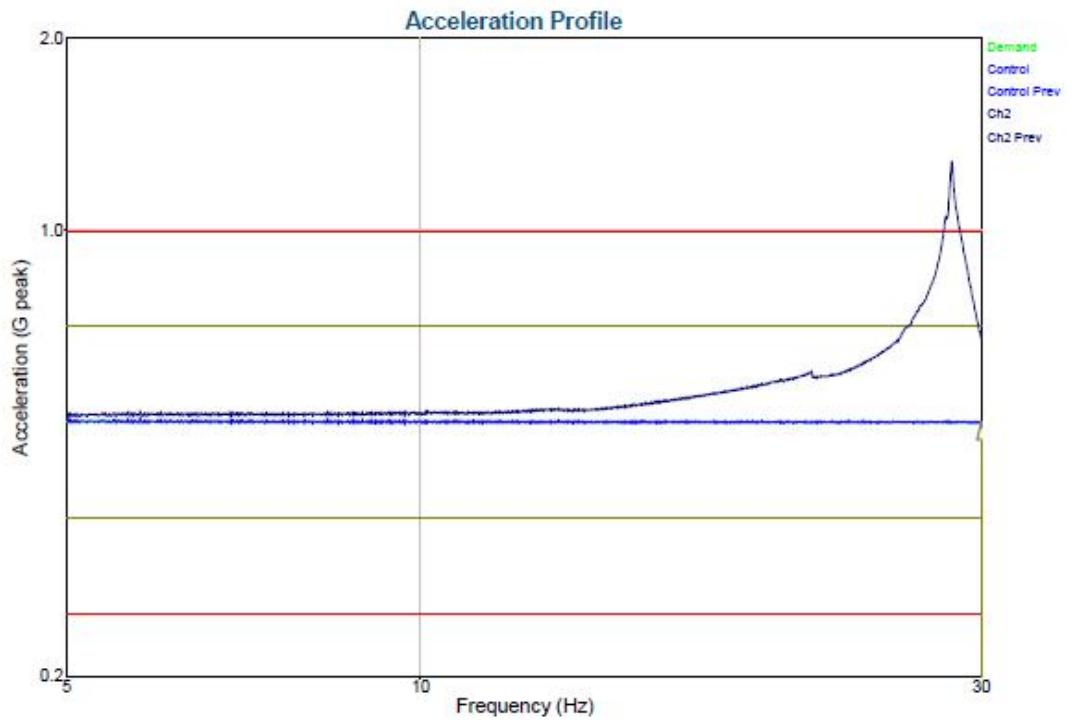
**[X axis]**

10 13, 2023 14:08:56 Level 1) 100 %

Output: 0.05821 Volts peak NEMA TS-2 2.2.8

Demand: 0.5 G

Level Time: 0:12:31

Frequency: 30 Hz

Control: 0.5004 G

Total Time: 0:12:42

End of Sweep Test

Axis	Resonance check	Recorded
X	1 Point	28.33 Hz
Y	1 Point	14.39 Hz
Z	2 Point	26.71 / 29 Hz

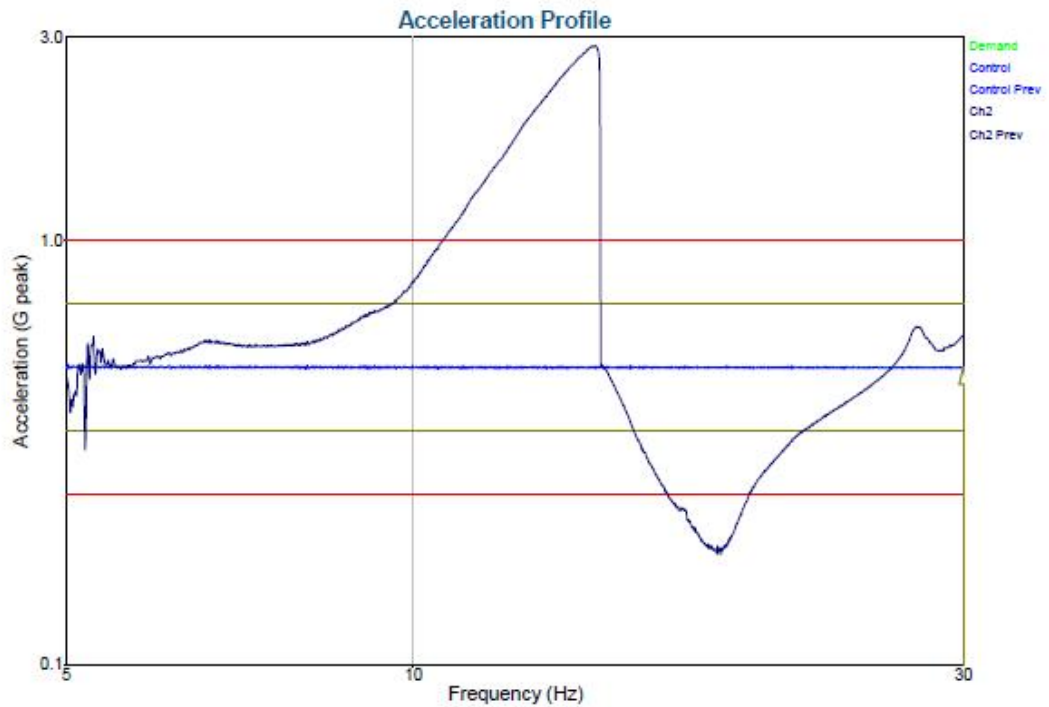
[Y axis]

10 14, 2023 17:13:59 Level 1) 100 %

Output: 0.06323 Volts peak NEMA TS-2 2.2.8

Demand: 0.5 G

Level Time: 0:12:30

Frequency: 30 Hz

Control: 0.5019 G

Total Time: 0:12:42

End of Sweep Test

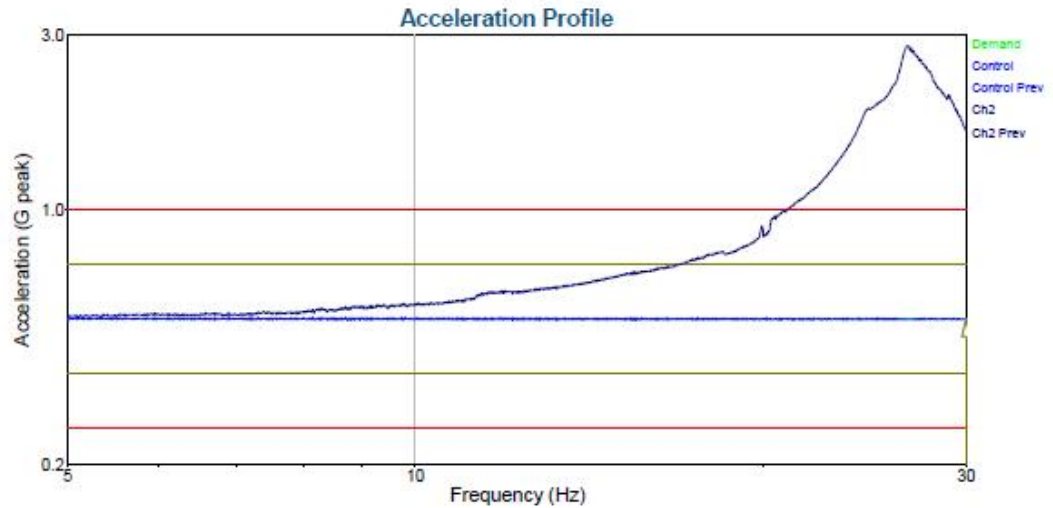
**[Z axis]**

10 15, 2023 14:52:41 Level 1) 100 %

Output: 0.03454 Volts peak NEMA TS-2 2.2.8

Demand: 0.5 G

Level Time: 0:12:30

Frequency: 30 Hz

Control: 0.4991 G

Total Time: 0:12:41

End of Sweep Test

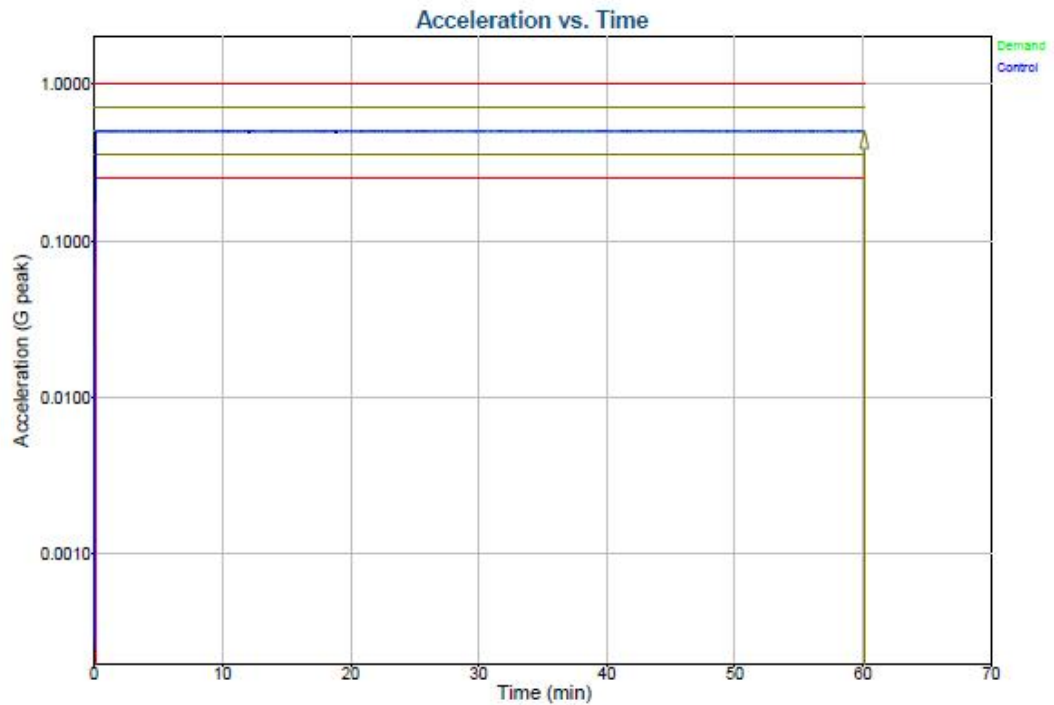
**[X axis]**

10 13, 2023 15:10:25 Level 1) 100 % at previous frequency: 0.06211 Volts peak NEMA TS-2 2.2.8 규정

Demand: 0.5 G Level Time: 1:00:00 Frequency: 28.33 Hz

Control: 0.5007 G Total Time: 1:00:08 End of Timed Test

- Pass

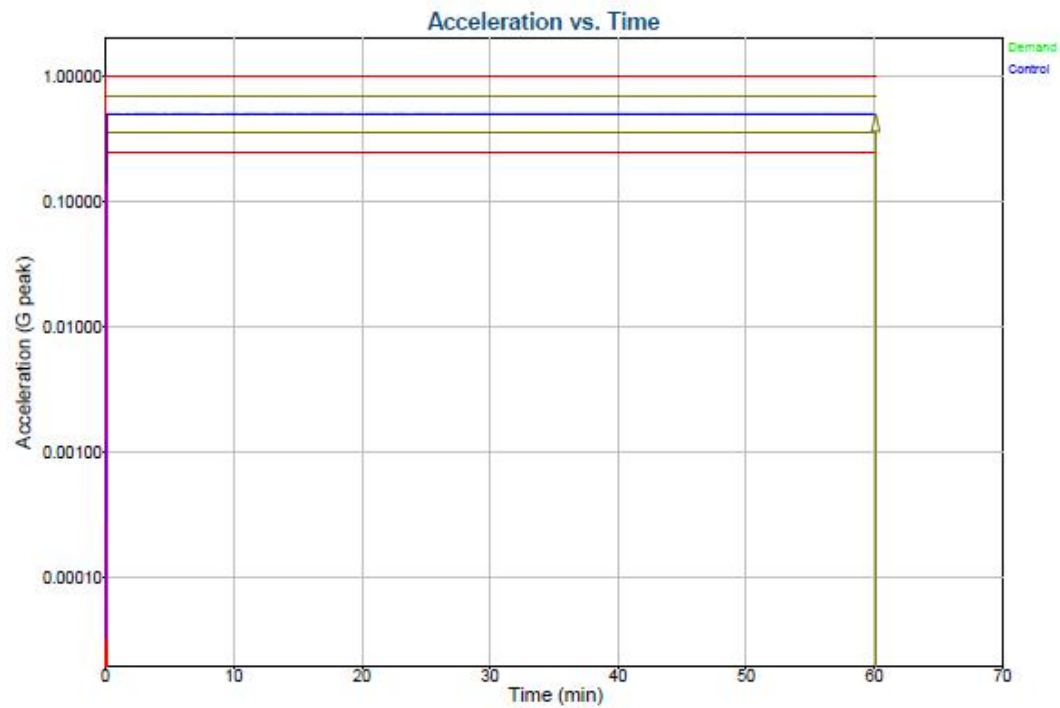
[Y axis]

10 12, 2023 17:34:39    Level 1) 100 % at previous frequency    Demand: 0.06419 Volts peak    NEMA TS-2 2.2.8 ㄱ구

Demand: 0.5 G    Level Time: 1:00:00    Frequency: 30 Hz

Control: 0.4997 G    Total Time: 1:00:08    End of Timed Test

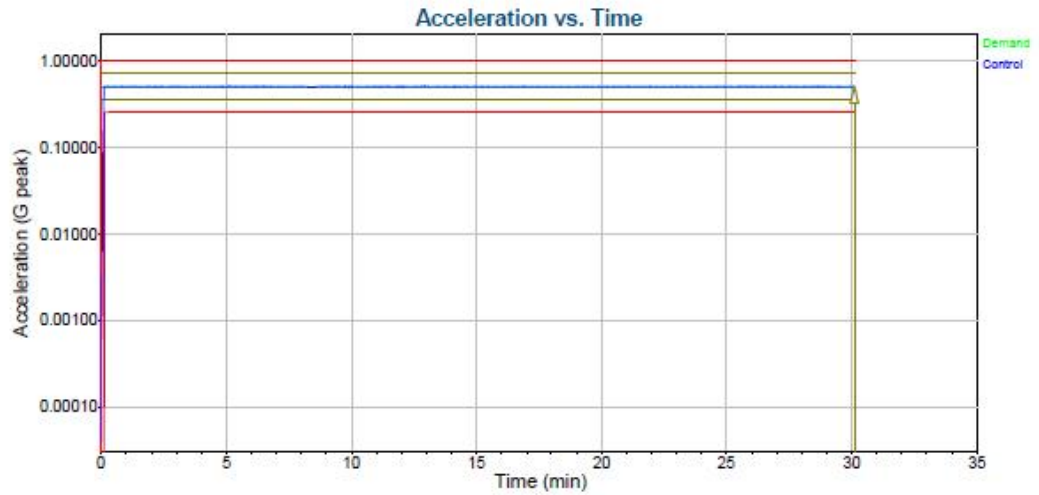
[Z axis]

10 15, 2023 15:23:57

Level 1) 100 %

Output: 0.03909 Volts peak

NEMA TS-2 2.2.8 내구

Demand: 0.5 G

Level Time: 0:30:00

Frequency: 26.71 Hz

Control: 0.5028 G

Total Time: 0:30:06

End of Timed Test
