TEST REPORT

Report No.:
KR18-YYP0216

3. Name of Product and Model : Network Camera / QNO-7080R*(*N:NTSC / P:PAL)

6. Test method used : IEC 60529: 2013 (IP66)

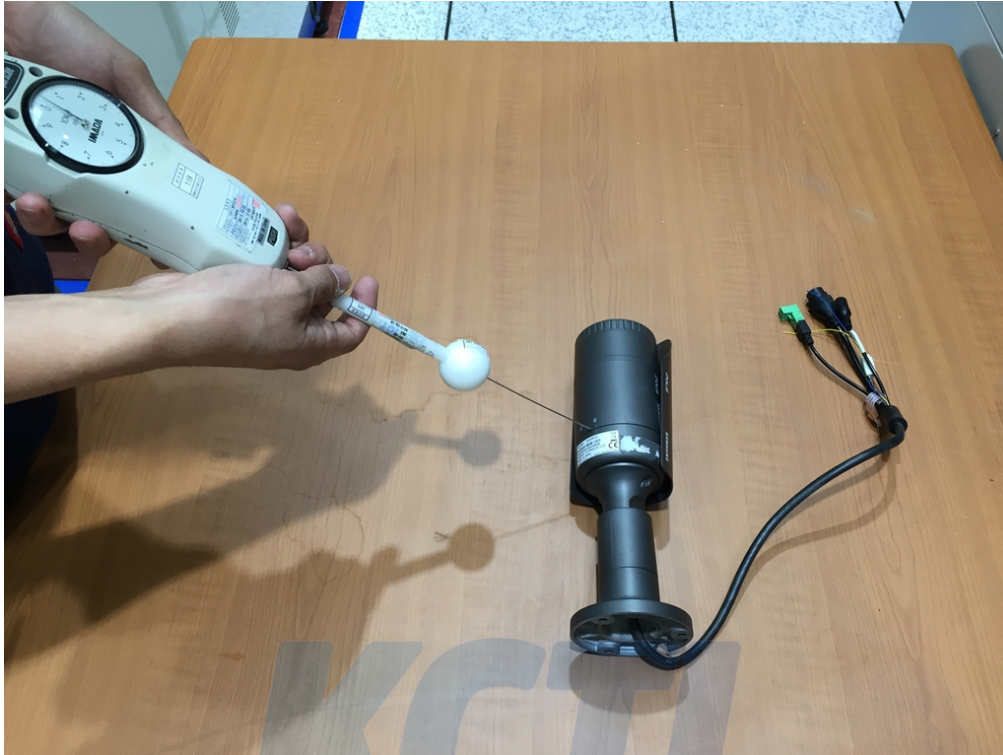
3.1.6 Test Photograph

- 1) Insert or push the access probe through gap of outward with specified force.

[During the test]

Item	Description
First characteristic numeral	IP6X (Protected against access to hazardous parts with a wire)
Definition	The access probe of 1.0 mm ø shall not penetrate
Test condition	1. Access probe: 1.0 mm ø, 100 mm length 2. Test force: 1 N ± 10 %
Test location	All of the outside openings

Check List	Test Result
Protected against access to hazardous parts with a wire	No abnormal was found

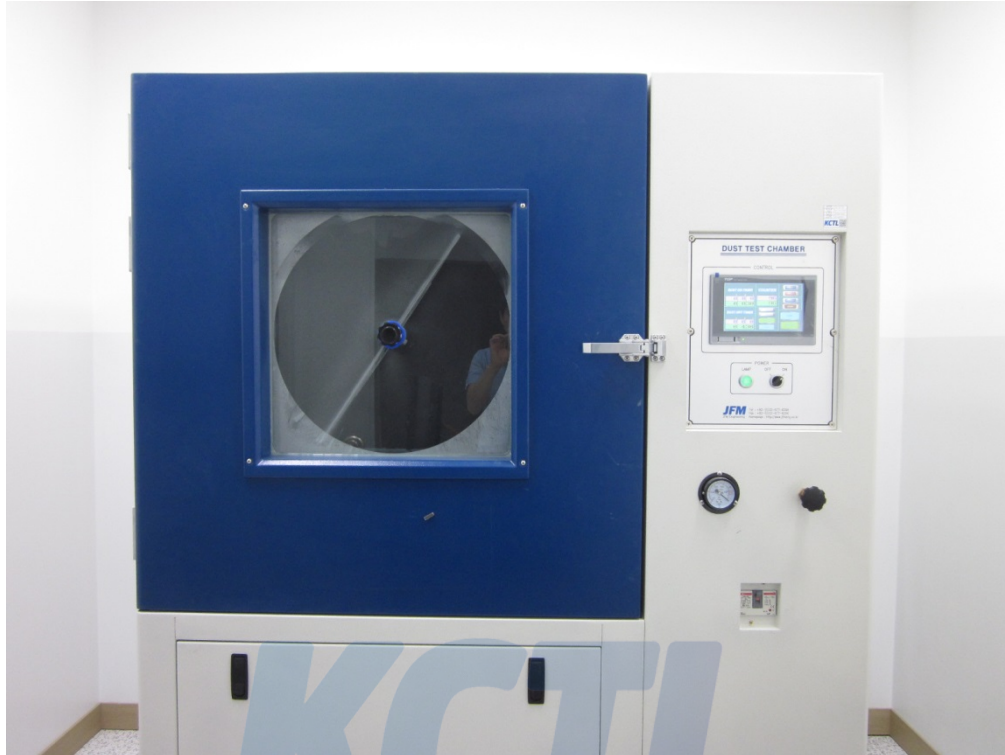
3.2.6 Test Photograph

- 1) The enclosure under test is supported inside the test chamber and the pressure inside the enclosure is maintained below the surrounding atmospheric pressure by a vacuum pump.
- 2) The suction connection shall be made to a hole specially provided for this test.
- 3) The object of the test is to draw into the enclosure, by means of depression, a volume of air 80 times the volume of the sample enclosure tested without exceeding the extraction rate of 60 volumes per hour. In no event shall the depression exceed 2 kPa (20 mbar) on the manometer.
- 4) If an extraction rate of 40 to 60 volumes per hour is obtained the duration of the test is 2 h.
- 5) If, with a maximum depression of 2 kPa (20 mbar), the extraction rate is less than 40 volumes per hour, the test is continued until 80 volumes have been drawn through, or a period of 8 h has elapsed.

[During the test]

Item	Description
First characteristic numeral	IP6X (Dust-tight)
Definition	No ingress of dust
Enclosures	Category 1
Test condition	The talcum powder used shall be able to pass through a square-meshed sieve the nominal wire diameter of which is 50 µm and the nominal width of a gap between wires 75 µm. The amount of talcum powder to be used is 2 kg per cubic meter of the test chamber volume
Test time	8 h

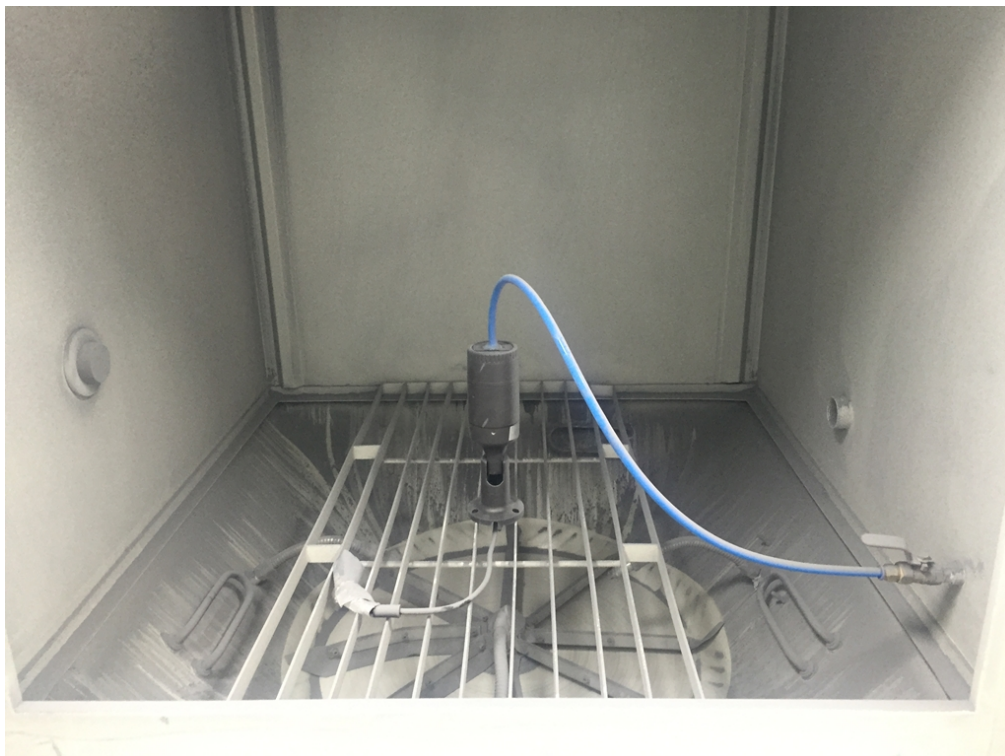
[After the test]

Check List	Test Result
No ingress of dust	No abnormal was found

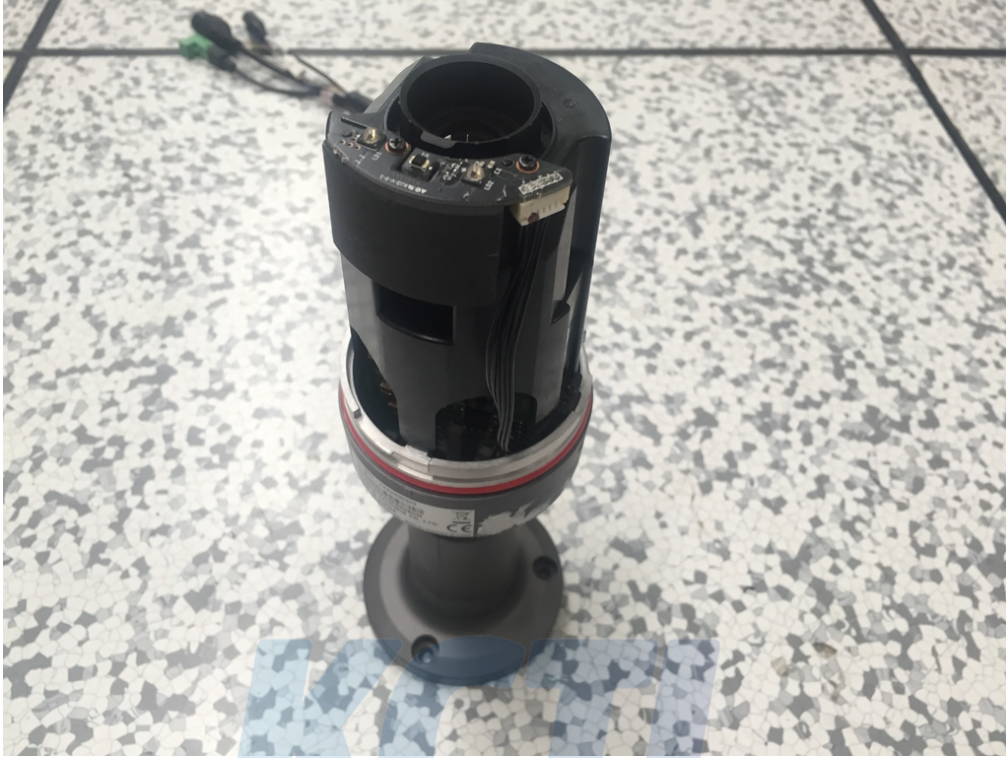
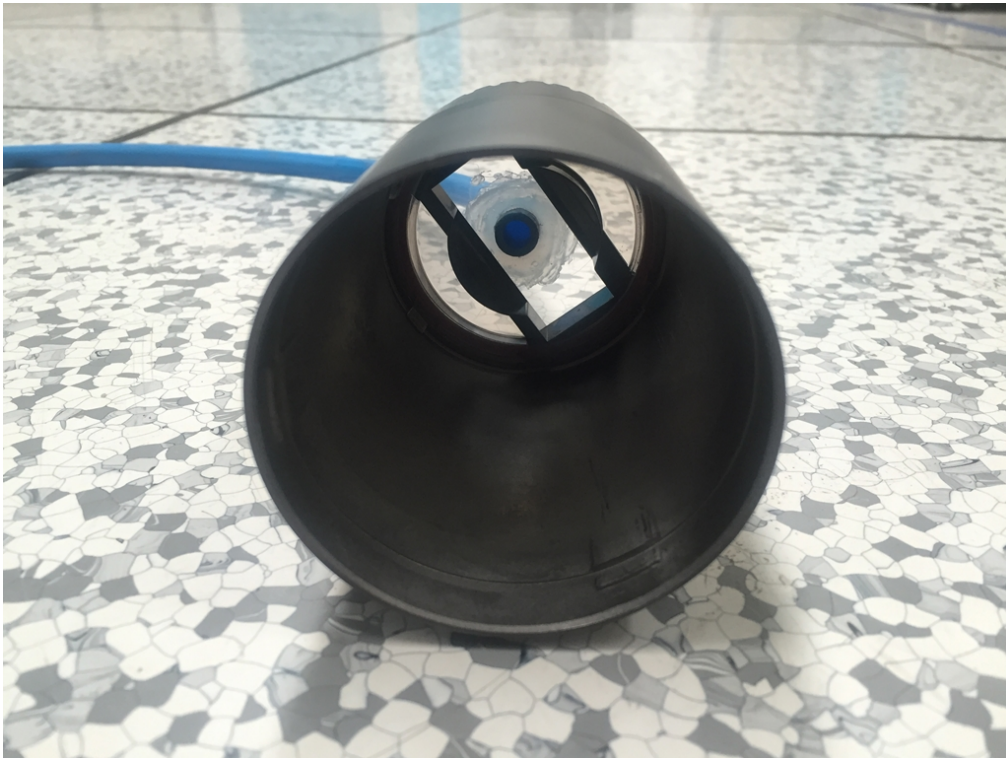
3.2.7 Test Result Photograph

[Test result confirmation 01]

[Test result confirmation 02]

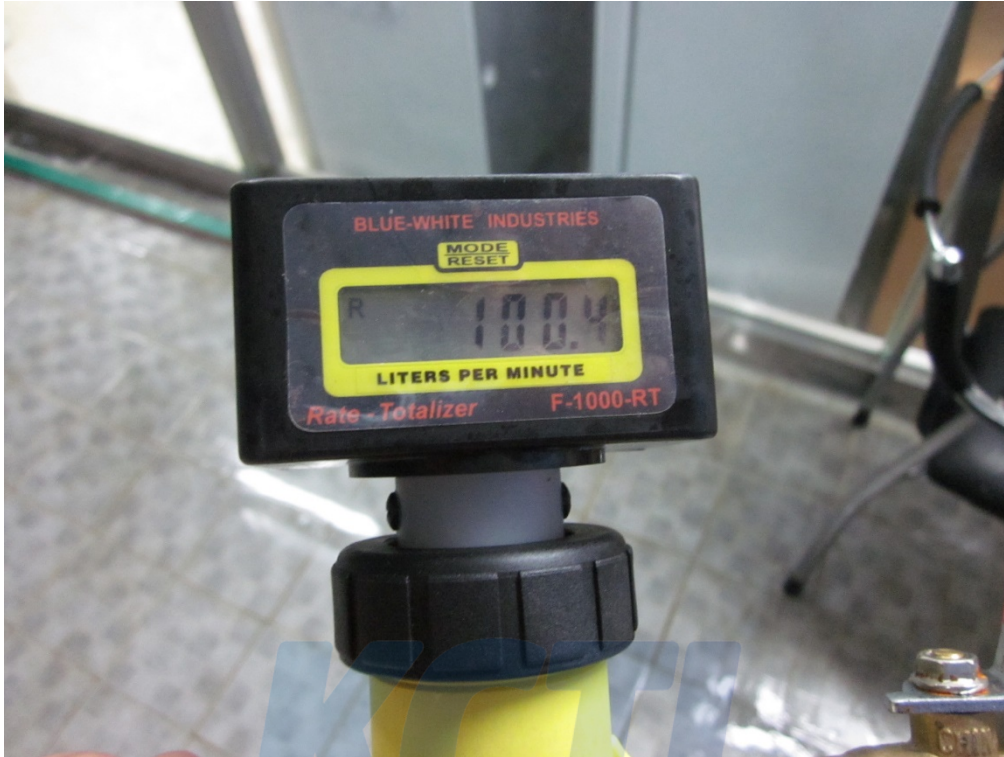
3.3.6 Test Photograph

Item	Description
Second characteristic numeral	IPX6 (Protected against powerful water jets)
Definition	Water projected in powerful jets against the enclosure from any direction shall have no harmful effects.
Test condition	1. Water jet hose nozzle Figure 6, Nozzle 12.5 mm diameter 2. Water flow rate: 12.5 l/min ± 5 % 3. Distance: 2.5 to 3.0 m
Definition	Water projected in jets against the enclosure from any direction shall have no harmful effects
Test time	1 min/m ² , at least 3 min

[During the test_Water flow rate]

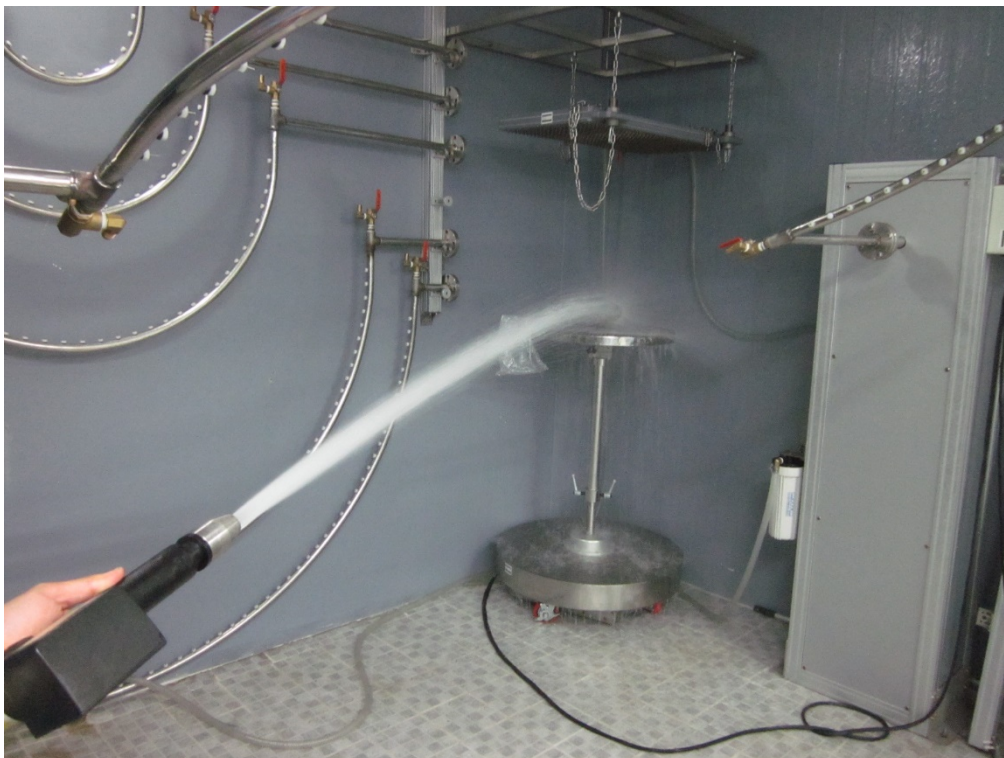
- 1) The tests associated with second characteristic numeral are conducted with fresh water.
- 2) The water pressure is adjusted to give the specified waterproof rate.
- 3) The test is made by spraying the enclosure from all practicable directions with a standard test nozzle.

[During the test]

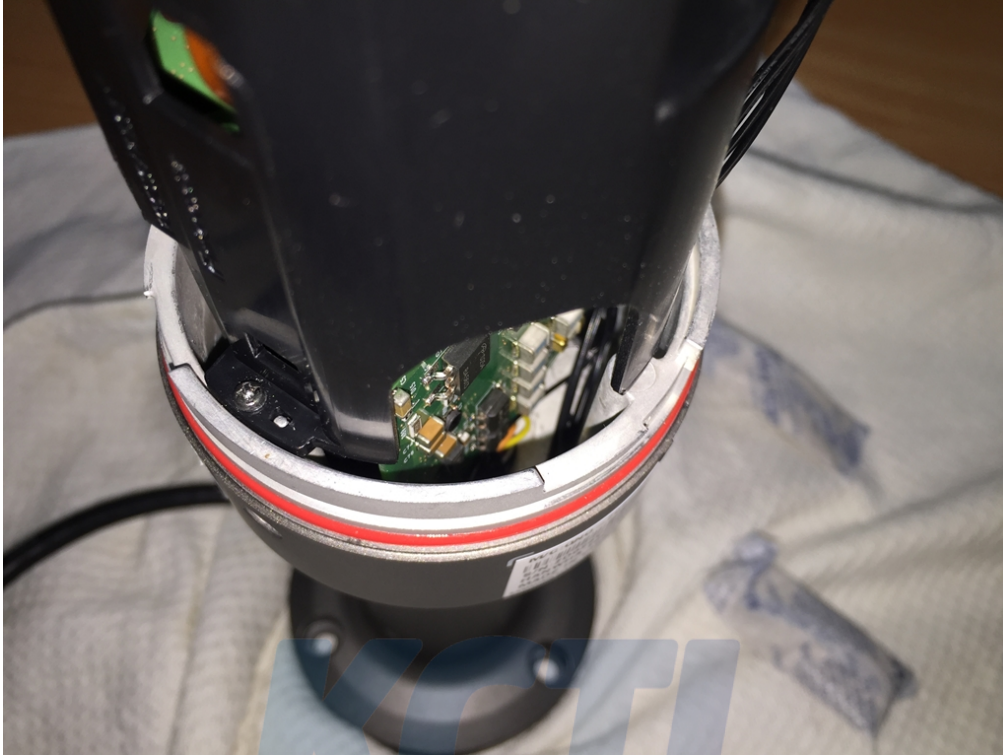
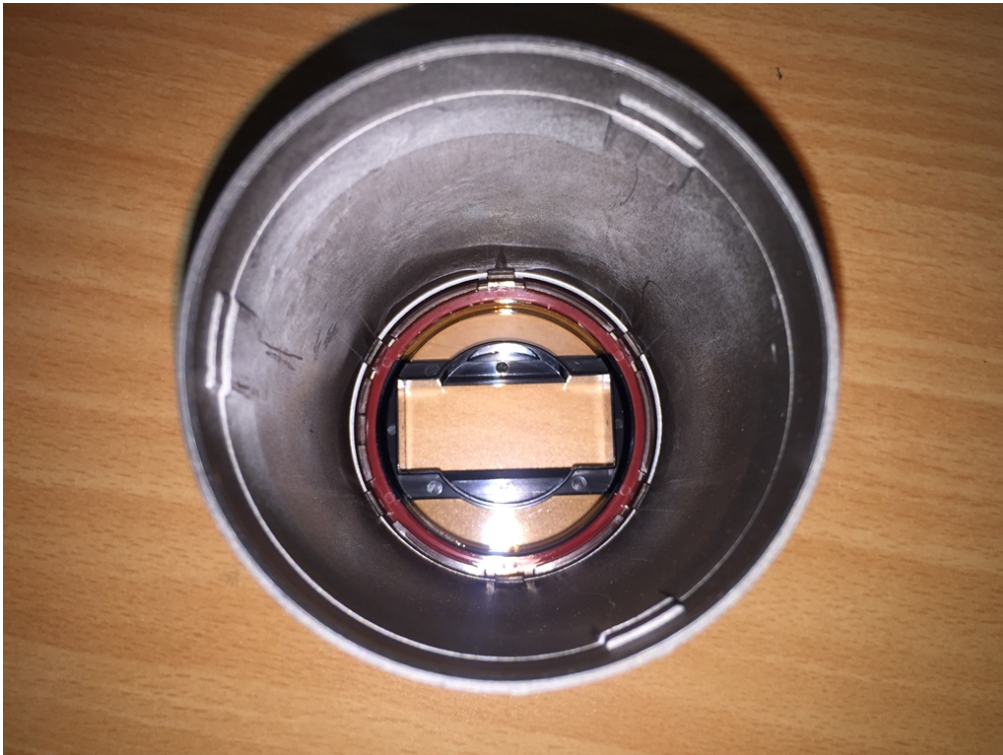
3.3.7 Test Result Photograph

Check List	Test Result
Protected against powerful water jets	No abnormal was found

[Test result confirmation 01]

[Test result confirmation 02]
