## TEST REPORT

1. **Report Number** KR16-YYP0022-A
2. **Applicant**
  - Name Hanwha Techwin Co.,Ltd
  - Address 1204, Changwon-daero, Seongsan-gu, Changwon-si, Gyeongsangnam-do, Korea
  - Date of Receipt July 13, 2016
3. **Manufacturer**
  - Name Hanwha Techwin Co.,Ltd
  - Address 1204, Changwon-daero, Seongsan-gu, Changwon-si, Gyeongsangnam-do, Korea
4. **Use of Report** For Quality management
5. **Test item description**
  - Product Name Network Camera
  - Model Name QNV-7080R>(\*N: NTSC / P: PAL)
6. **Test method used** IEC 60529: 2006 / IP66
7. **Date of Test** July 27, 2016 ~ July 29, 2016
8. **Environment**
  - Temperature (15~35) °C
  - Relative Humidity (25~75) % R.H
  - Air pressure (86~106) kPa
9. **Test Results** No abnormal was found

Division	Specification
Product Name	Network Camera
Model Name	QNV-7080R*(*N: NTSC / P: PAL)

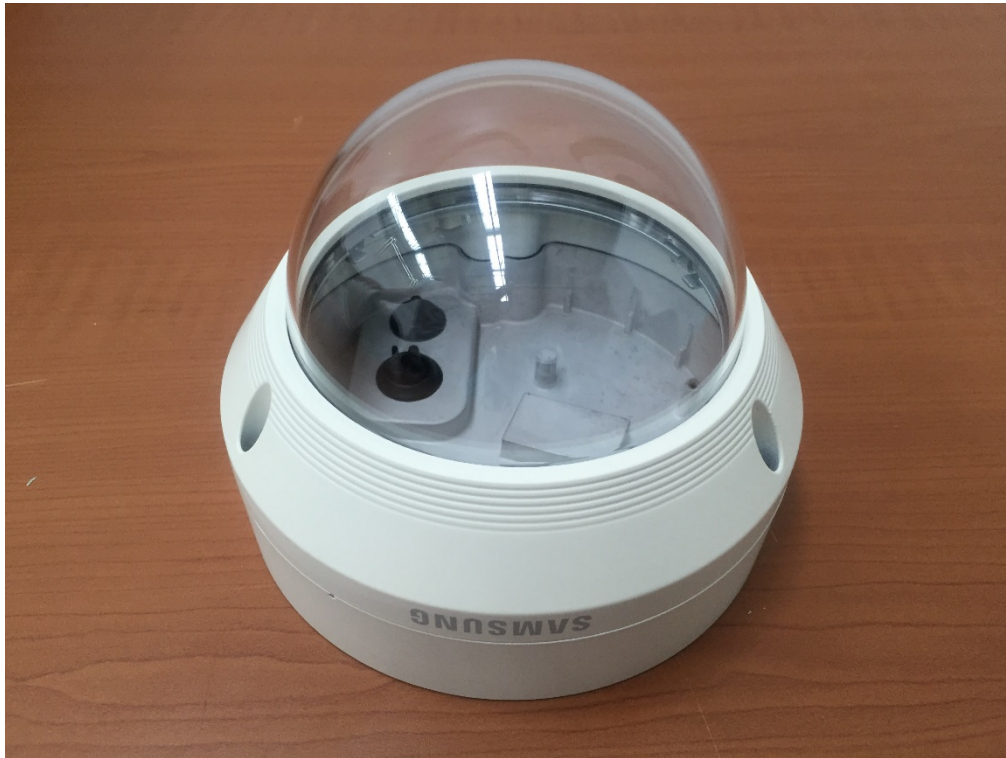
## 2.2 Product Photograph

[Sample]

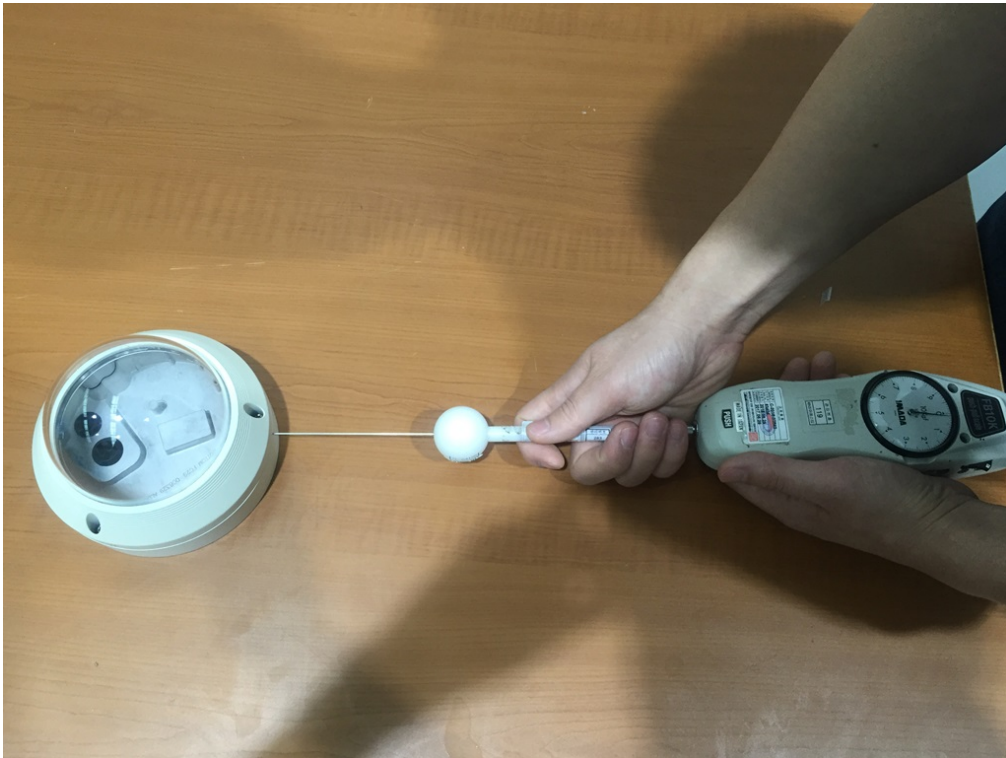
### 3.1.5 TEST Photograph

[During the test]

Item	Description
First characteristic numeral	IP6X (Protected against access to hazardous parts with a wire)
Test condition	1. Access probe: 1.0 mm $\varnothing$ , 100 mm length, 2. Test force: 1 N $\pm$ 10 %
Test location	All of the outside openings
Definition	The access probe of 1.0 mm $\varnothing$ shall not penetrate

Check List	Test Result
Protected against access to hazardous parts with a wire	No abnormal was found

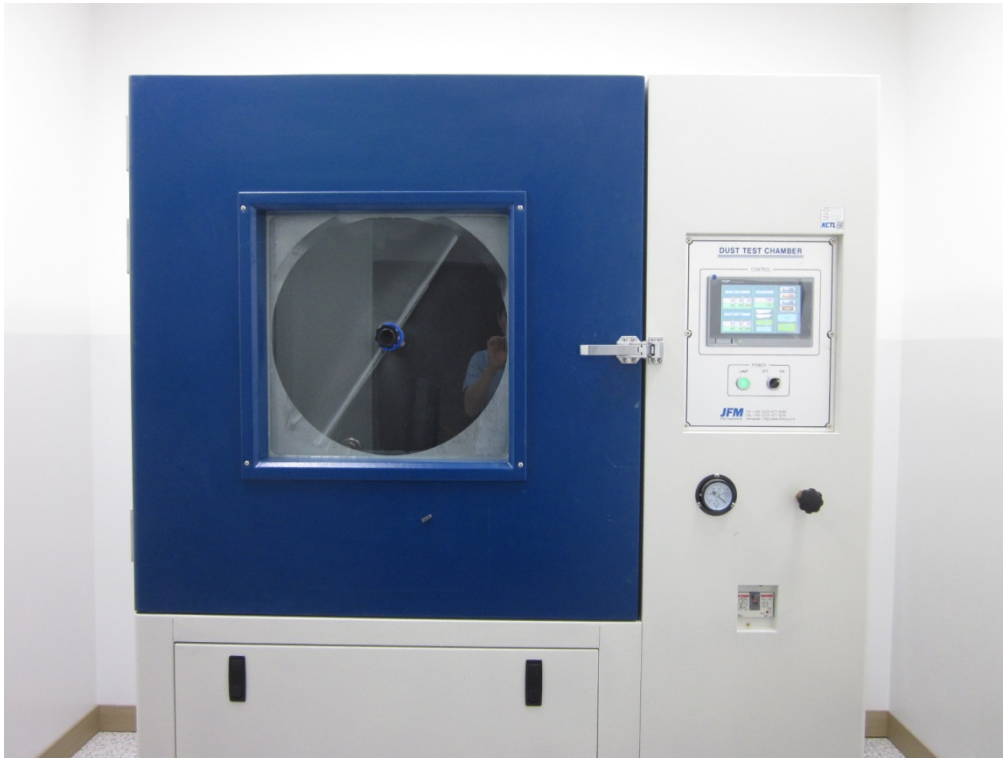
### 3.2.5 TEST Photograph

[During the test]

Item	Description
First characteristic numeral	IP6X (Dust-tight)
Enclosures	Category 1
Test condition	The talcum powder used shall be able to pass through a square-meshed sieve the nominal wire diameter of which is 50 µm and the nominal width of a gap between wires 75 µm. The amount of talcum powder to be used is 2 kg per cubic metre of the test chamber volume
Test time	8 h
Definition	No ingress of dust

- 1) The enclosure under test is supported inside the test chamber and the pressure inside the enclosure is maintained below the surrounding atmospheric pressure by a vacuum pump
- 2) The suction connection shall be made to a hole specially provided for this test
- 3) The object of the test is to draw into the enclosure, by means of depression, a volume of air 80 times the volume of the sample enclosure tested without exceeding the extraction rate of 60 volumes per hour. In no event shall the depression exceed 2 kPa (20 mbar) on the manometer
- 4) If an extraction rate of 40 to 60 volumes per hour is obtained the duration of the test is 2 h.
- 5) If, with a maximum depression of 2 kPa (20 mbar), the extraction rate is less than 40 volumes per hour, the test is continued until 80 volumes have been drawn through, or a period of 8 h has elapsed.

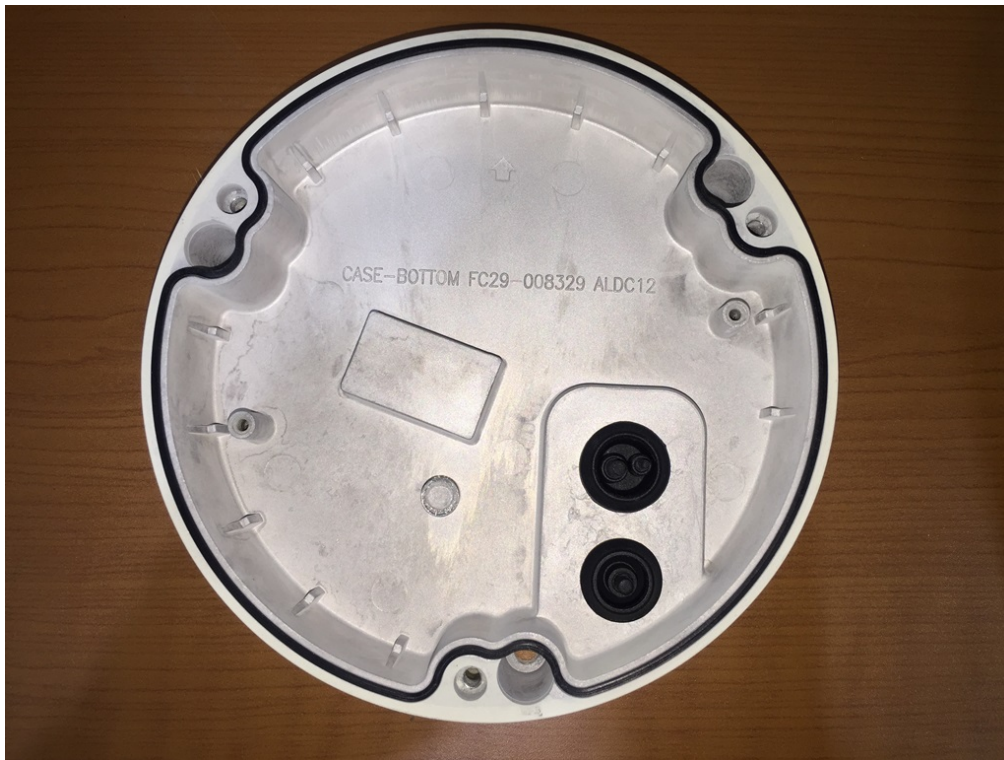
[Test result confirme]

Check List	Test Result
Dust-tight	No abnormal was found

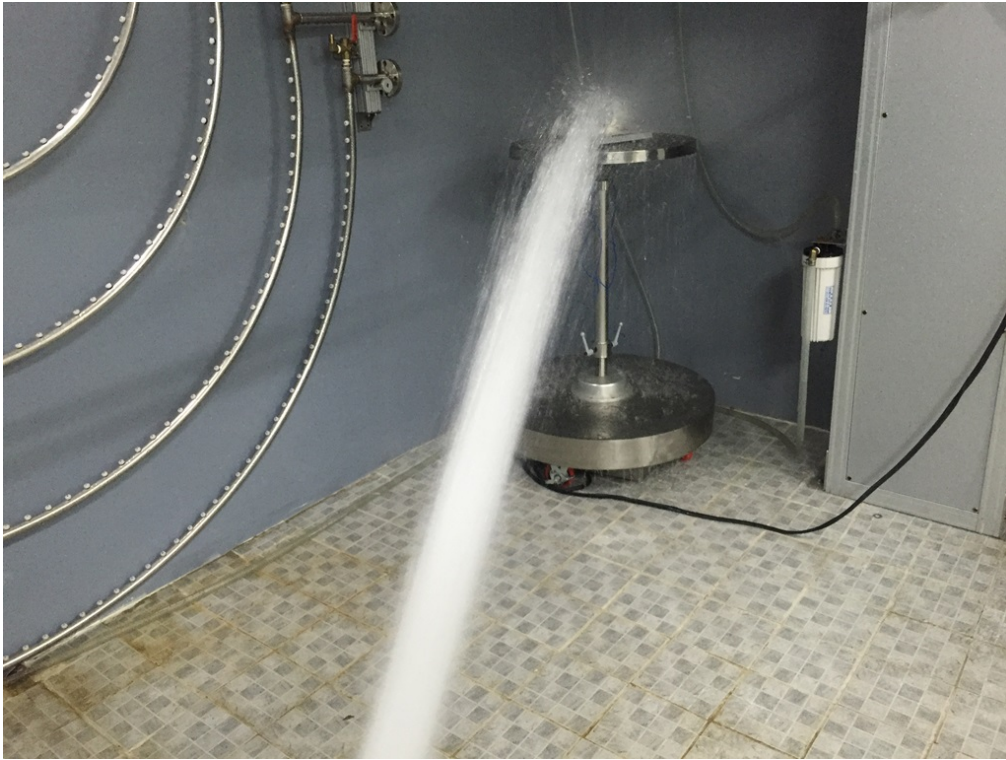
### 3.3.5 TEST Photograph

[During the test]]

Item	Description
Second characteristic numeral	IPX6 (Protected against powerful water jets)
Test condition	1. Water jet hose nozzle diameter: 12.5 mm 2. Water flow rate: 100 L/min±5% 3. Distance: 2.5~3.0 m
Test time	1 min/m <sup>2</sup> , at least 3 min
Definition	Water projected in powerful jets against the enclosure from any direction shall have no harmful effects

- 1) The tests are conducted with fresh water
- 2) The water pressure is adjusted to give the specified delivery rate
- 3) The test is made by spraying the enclosure from all practicable directions with a stream of water from a standard test nozzle

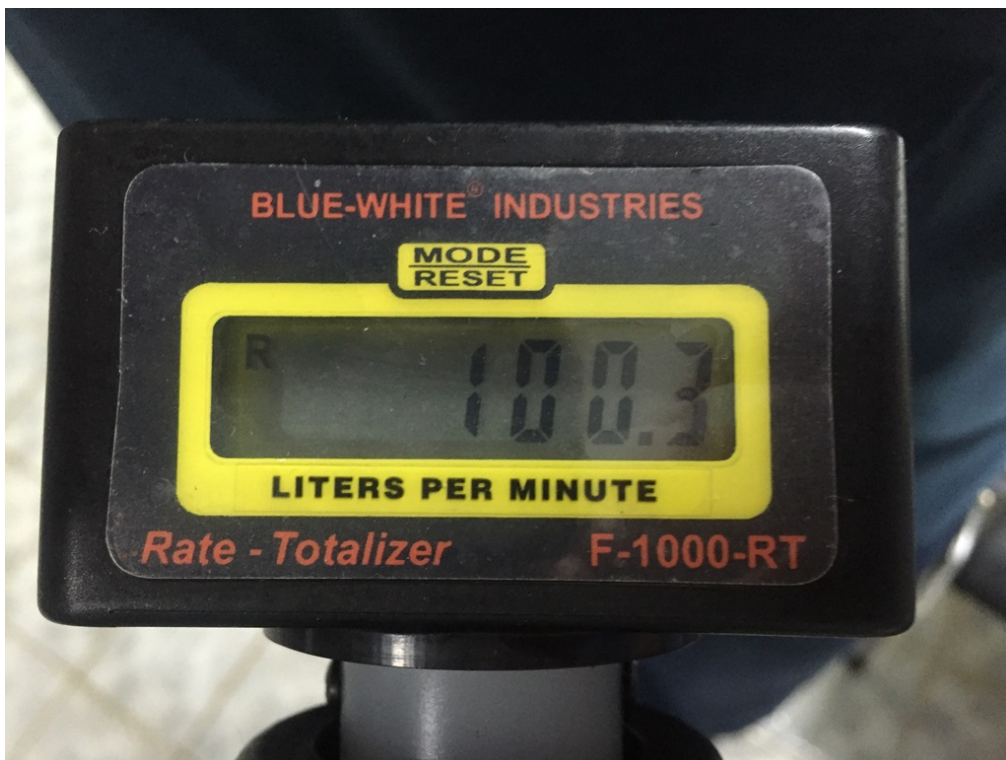
[During the test\_Water flow rate]

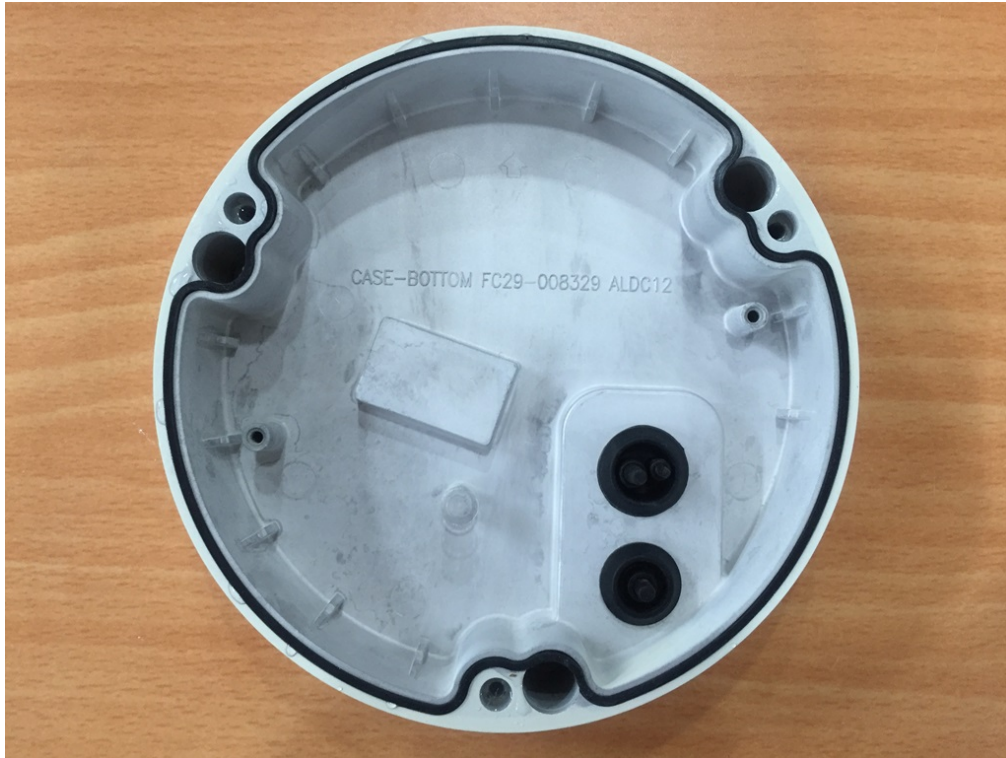
[Test result confirme]

Check List	Test Result
Protected against powerful water jets	No abnormal was found
