TEST REPORT

Report No. : STC-B13-127

3. Product : Anti-Vandal Dome Camera

5. Test Method/Item : IEC 60529:2001 / IP66

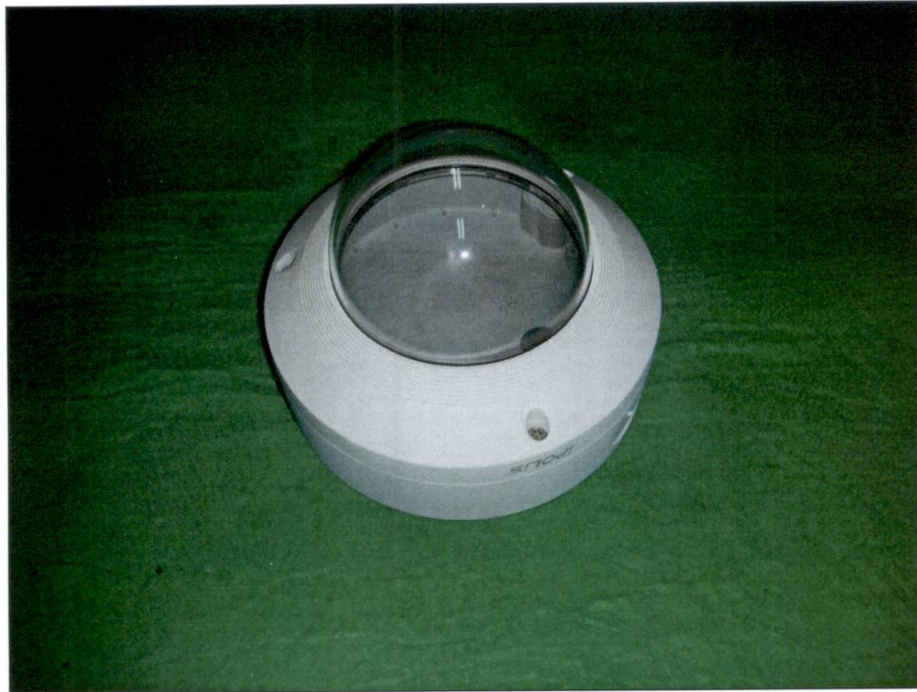
[Specimen]

- 1) Dust test for first characteristic numeral 6
 - Depression: 2 kPa
 - Duration of time: 8 h
- 2) Water test for second characteristic numeral 6
 - Internal diameter of the nozzle: 12.5 mm
 - Delivery rate: 100 L/min
 - Duration of time: 3 min

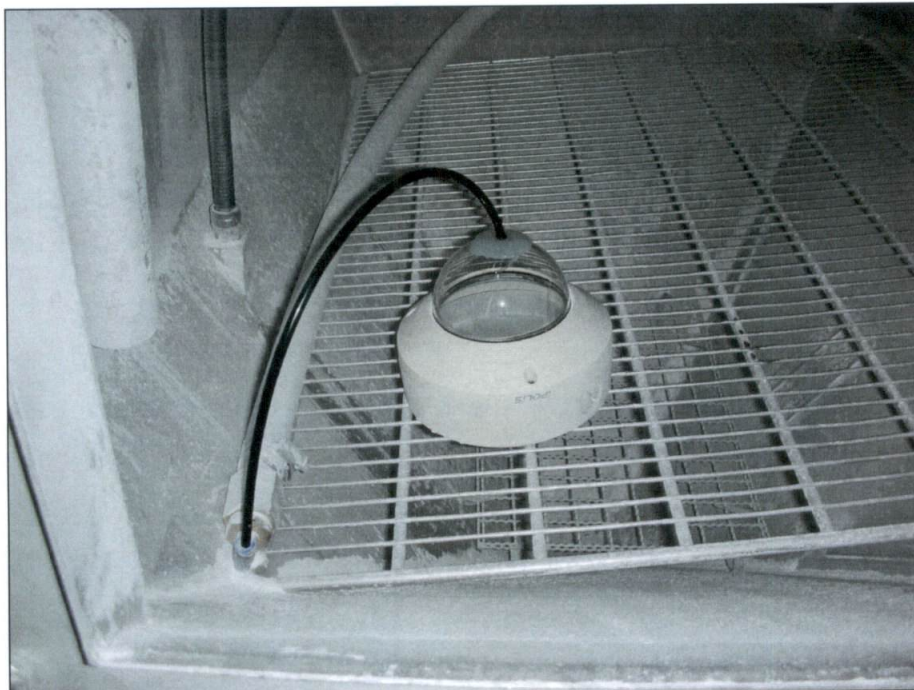
[Before Test]

1) Dust Test

- The talcum powder used shall be able to pass through a square-meshed sieve the nominal wire diameter of which is $50 \mu\text{m}$ and the nominal width between wires was $75 \mu\text{m}$
- The amount of talcum powder was 2 kg per cubic meter of the chamber volume.
- The amount of talcum powder to be used is 2 kg per cubic metre of the test chamber volume.

☒ If, with a maximum depression of 2 kPa (20 mbar), the extraction rate is less than 40 volumes per hour, the test is continued until 80 volumes have been drawn through, or

The protection is satisfactory if no deposit of dust is observable inside the enclosure at the end of the test.

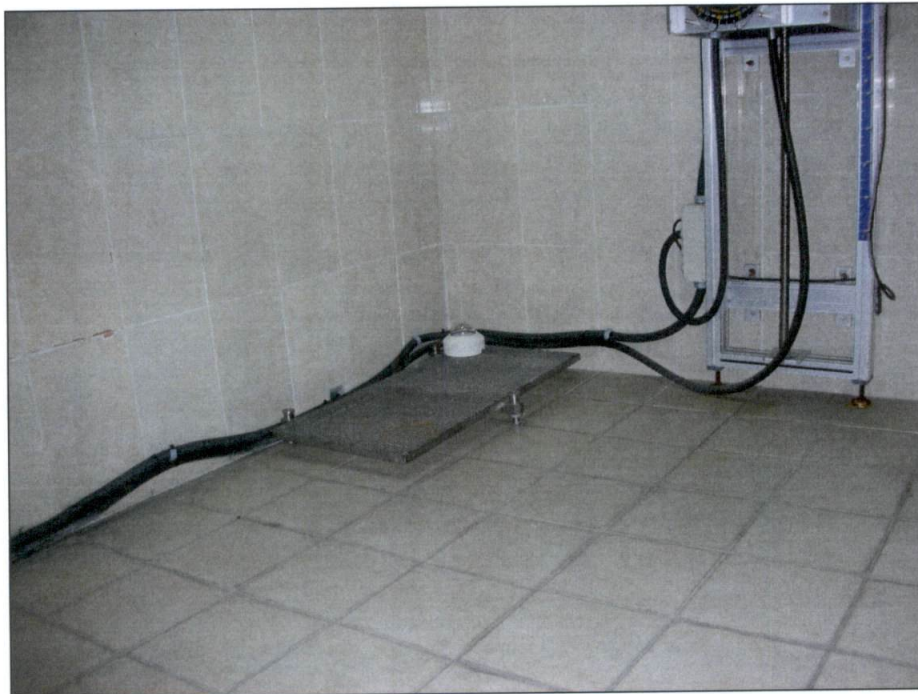
[Before Test]

2) Water Test

- The test was made by spraying the enclosure from all practicable directions with a stream of water from a standard test nozzle
- Nozzle internal diameter: 12.5 mm
- Delivery rate: 100 L/min \pm 5 %
- Water pressure: to be adjusted to achieve the specified delivery rate
- Test duration per square metre of enclosure surface area likely to be sprayed: 1 min
- Minimum test duration: 3 min
- Distance from the nozzle to the enclosure surface: between 2.5 m and 3 m
