ENVIRONMENTAL TEST REPORT

Product: NETWORK CAMERA

“MODEL NAME(S): SNP-6321H”

Report No : R14OR-042

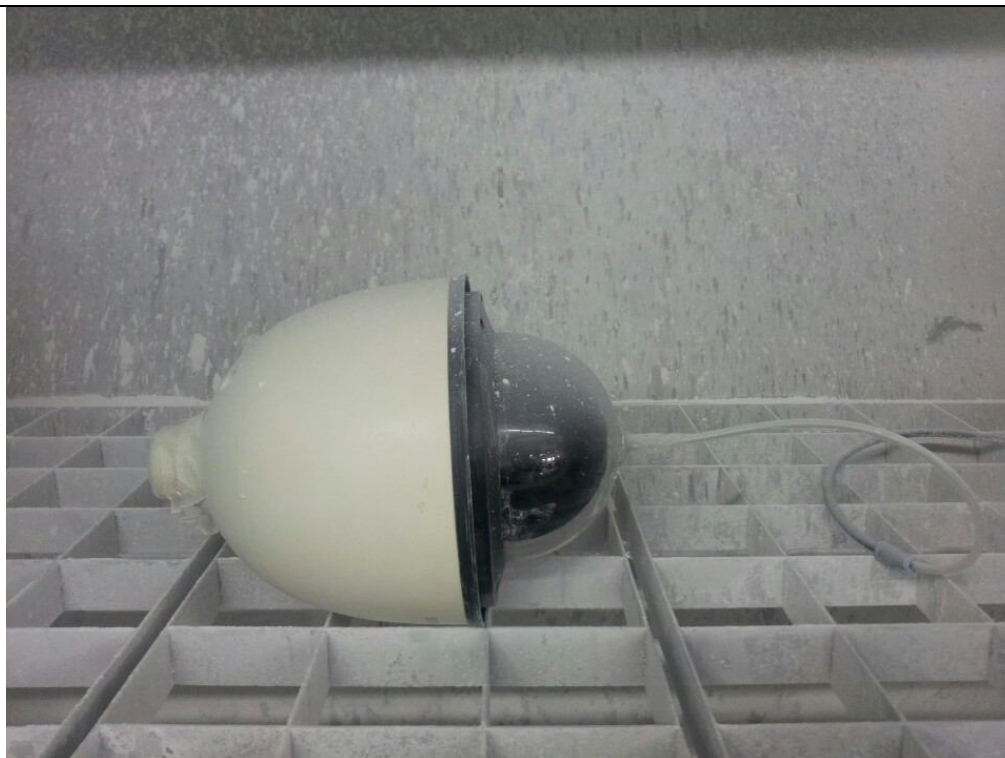
DUST

4.3.1 Dust Test

Items		Descriptions
1st Characteristic Numbers		IP6X
Enclosures Category		<input checked="" type="checkbox"/> Category 1 <input type="checkbox"/> Category 2 <input type="checkbox"/> Category 1 and Category 2
Test Condition		-Wire diameter: 50 μm -Width between wires: 75 μm -Amount of talcum powder of the test chamber: 2 kg/m^3
Method	Category 1	<input type="checkbox"/> If an extraction rate of 40 to 60 volumes per hour is obtained the duration of the test is 2 h. <input checked="" type="checkbox"/> If, with a maximum depression of 2 kPa(20 mbar), the extraction rate is less than 40 volumes per hour, the test is continued until 80 volumes have been drawn, or a period of 8 h has elapsed.
	Category 2	<input type="checkbox"/> The enclosure under test is supported in its normal operating position inside the test chamber, but is not connected to a vacuum pump. Any drain-hole normally open shall be left open for the duration of the test. The test shall be continued for a period of 8 h.

Acceptance Conditions		The protection is satisfactory if no deposit of dust is observable inside the enclosure at the end of the test.

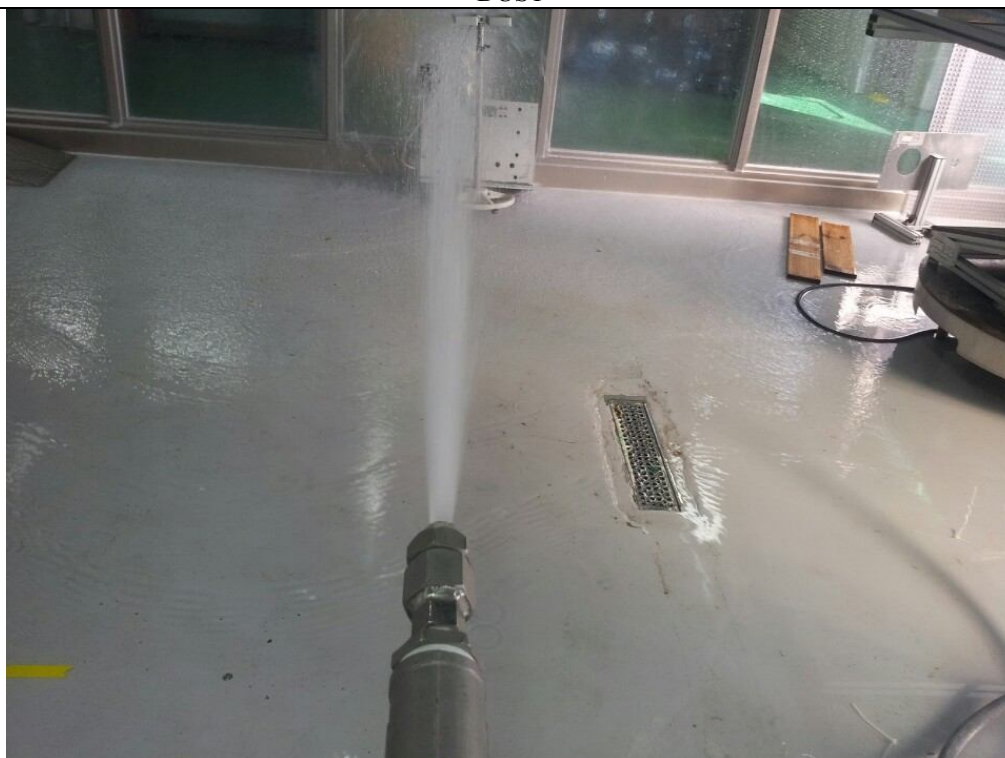
WATER

4.3.2 Water Test

Items	Descriptions
2nd Characteristic Numbers	IPX6
Test Condition	<ul style="list-style-type: none"> -Internal diameter of the nozzle: 12.5 mm -Delivery rate: 100 l/min \pm 5 % -Distance from nozzle to enclosure surface: Between 2.5 m & 3 m -The duration of the test: 3 min
Acceptance Conditions	<ul style="list-style-type: none"> -In general, if any water has entered, it shall not; -Be sufficient to interfere with the correct operation of the equipment or impair safety. -Deposit on insulation parts where it could lead to tracking along the creepage distances. -Reach live parts or windings not designed to operate when wet. -Accumulate near the cable end or enter the cable if any.

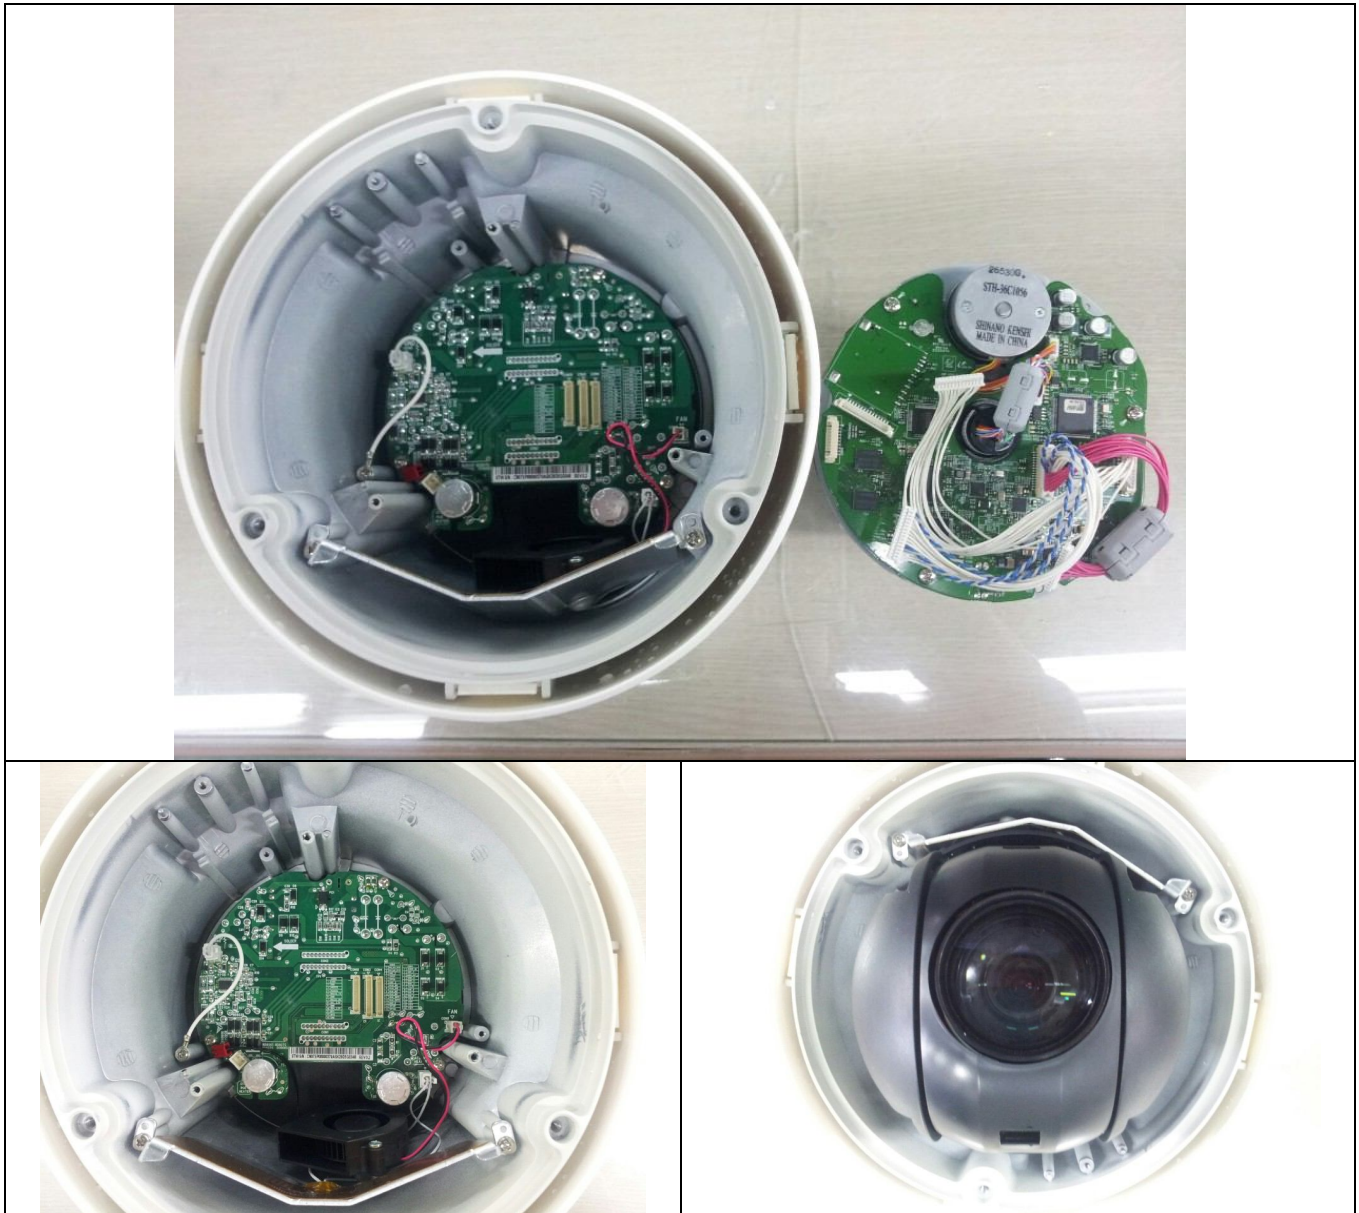
APPENDIX II - PHOTO OF INSIDE AFTER IP66 TEST

Item	IP Code	Result
SNP-6321H	IP66	Pass
