TEST REPORT

: NETWORK CAMERA / XNP-C9253R

7. Test Standard (Method) used : KS C IEC 62262: 2005

1. Degrees of protection provided by enclosures for electrical equipment against external mechanical impacts (IK code)

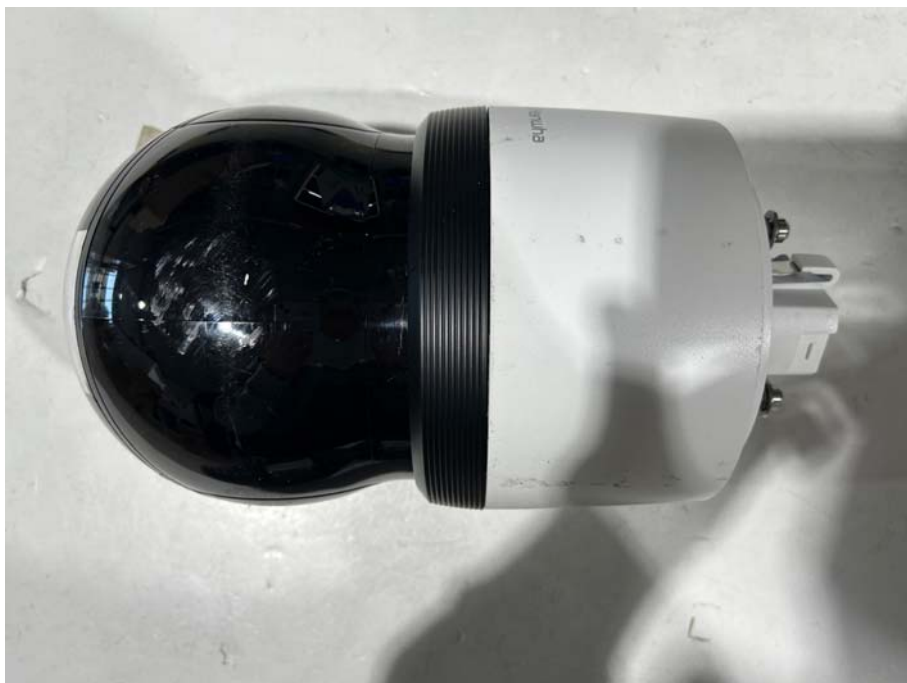
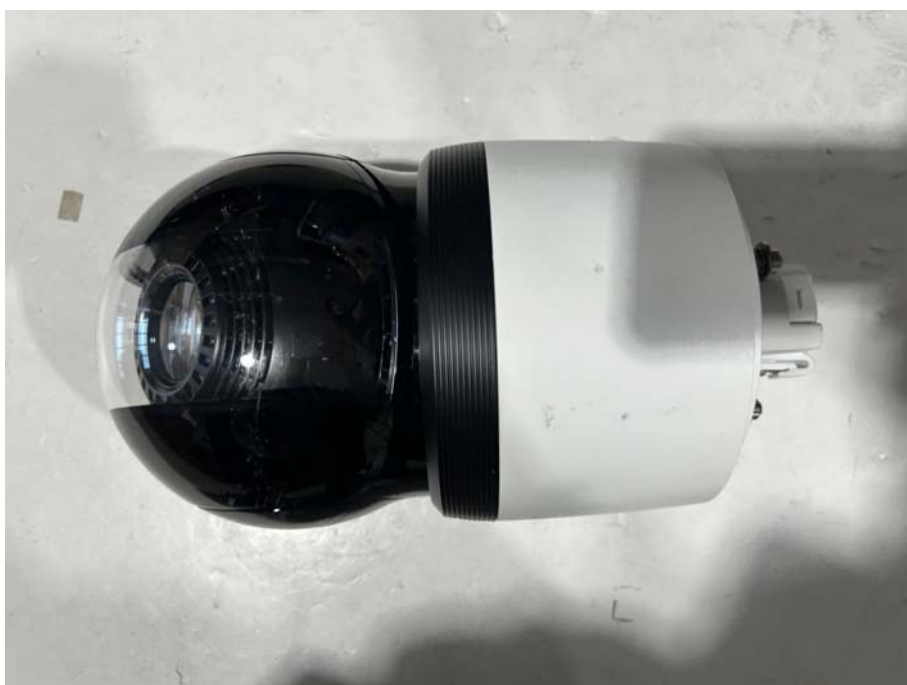
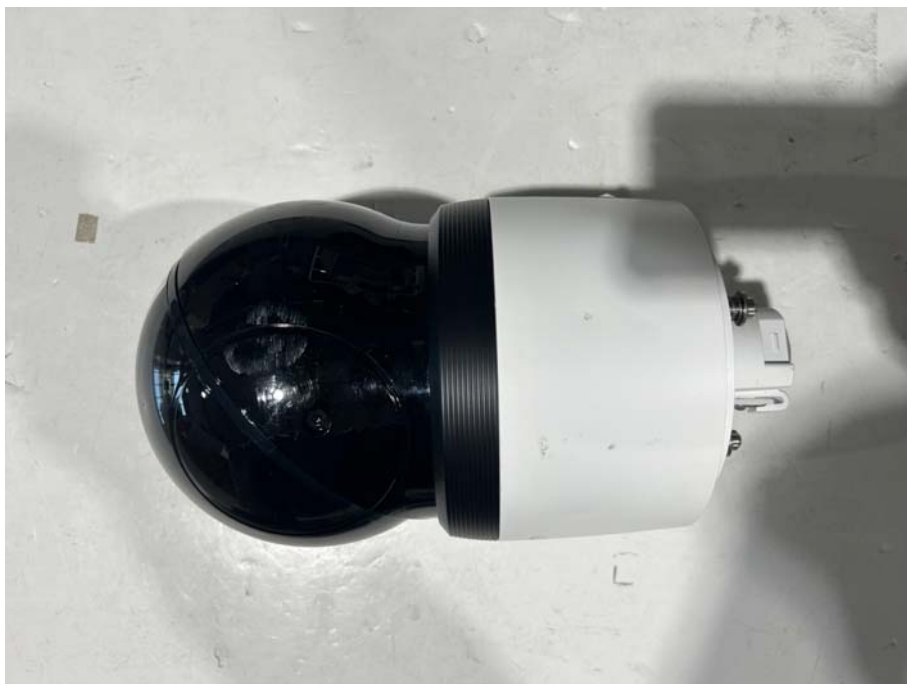
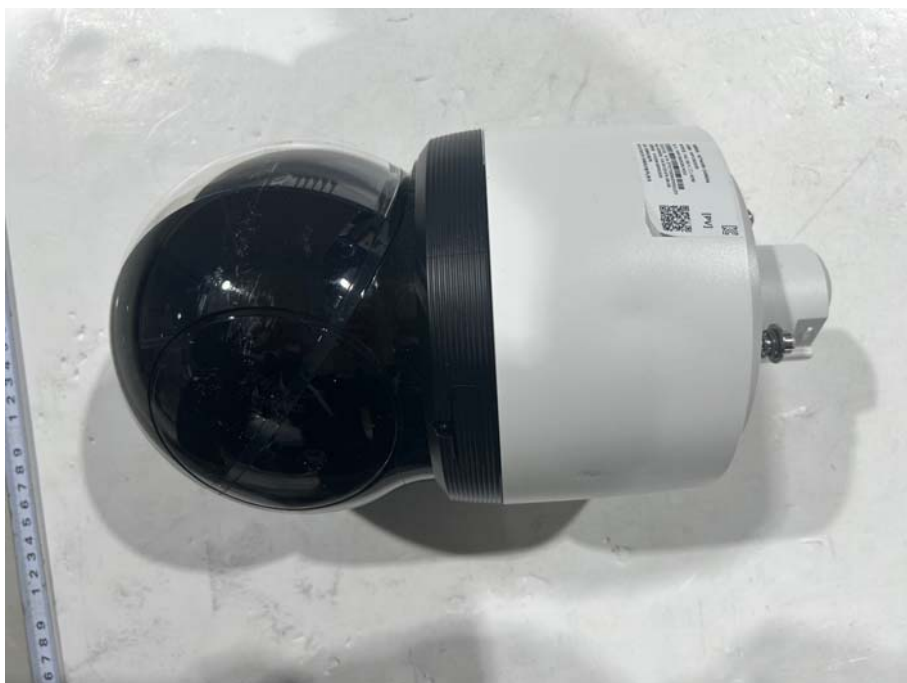
2.3. Photos after test

Item	Contents	Result
External protection Enclosure	No damage	Pass
Comment Some scratches were generated on the outside of the product.
