TEST REPORT

REPORT No.:
CTK-2023-02182
Page (1) / (7) pages

: NETWORK CAMERA / XNP-C6403R
PoE Injector / PT-PSE106GBRO-AH-S

: Requested Test Specification by applicant :
NEMA TS 2-2013
[2.2.7.2 Test B : Transient Tests
(Power Service) - 13. C.]

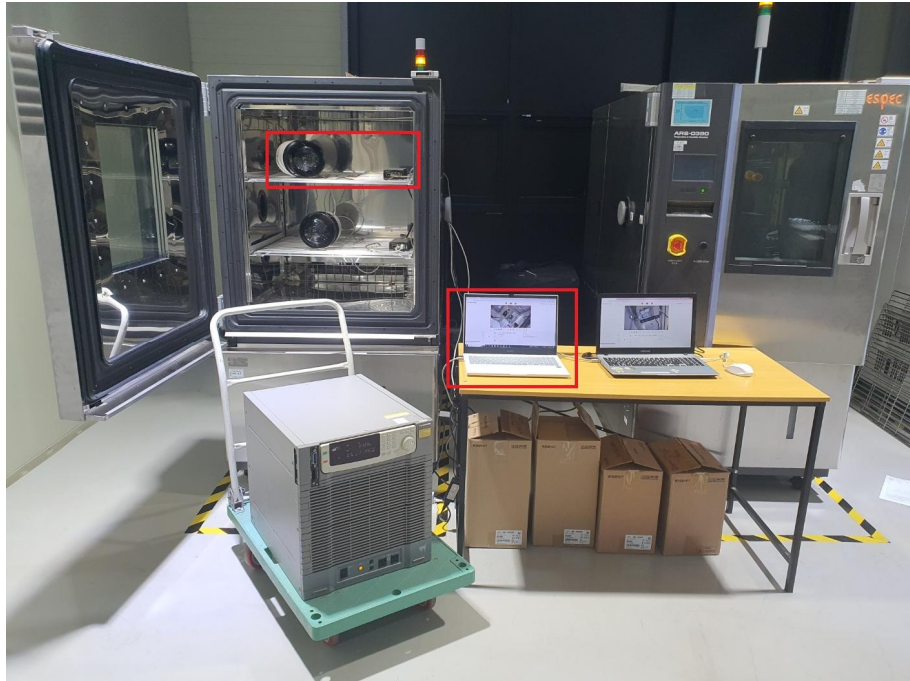
< Photo 4 >

[Red square, test sample]
